Life Expectancy and Durability Assessment

Water Take Resource Consent

Nelson City Council

Document Number: 14000-278-03

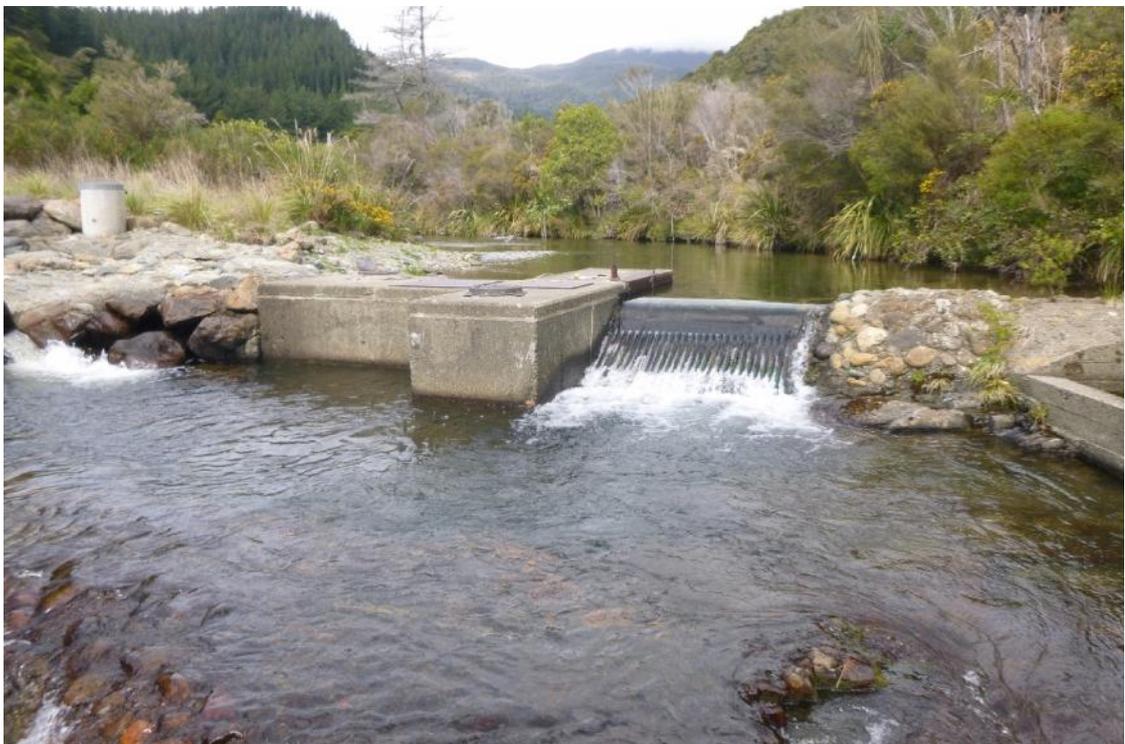
Plate 1 - Maitai Intake Structure – South Branch

Part	Classification	Issue	Possible Remediation	Estimated Residual life (yrs)
Post Stress strands	Critical	Where the ends of the post stresses were accessible, grouted ends appear to be in good condition. They were grouted the whole way through so are likely to be ok throughout the duct, assuming consistent construction.	N/A	30
Steel Lids and manhole covers	Non-critical	Most of the steel lids are in an aged condition. Surface rust is present but does not look to have caused considerable pitting at this stage. Their housings are held down with ramset inserts and/or a mortar pack beneath them. These hold downs are either in poor condition, missing or not used. This could go missing in a flood event.	Repaint the steel lids with an appropriate coating. Replace ramset inserts and secure lids as originally designed. Will likely need an oversize chemical set anchor as the original hole is damaged. Mortar pack around one of the manholes lids could be replaced

Grout seam between Precast Panels	Non-critical	This seam is in moderate condition for the most of the seam. In some points it has started to peel off of the concrete and was able to be picked off with a fingernail.	To improve this the old grout will require removal and repacking with an equivalent product.	0
Concrete Spalling	Critical	Small portion of concrete spalling at normal flow water level on the vertical trailing edges of the structure. Maximum original concrete cover is likely to be 63mm. NZS 3101 states concrete cover requirements are 45mm for 50 year durability. At time of construction 63mm cover translates to approximately 70 year durability. Concrete cover to reinforcing steel could now be less than required in areas of spalling.	Over all areas of spalling, including possible ones not noted internal to structure, remove loose concrete and trowel a mortar topping over to the desired original level.	30

Precast Retaining walls	Critical	As these were buried and unable to be seen without excavation, no external wall inspection was carried out.	N/A	
Manhole lids	Non-critical/Safety	One of these was neither locked nor bolted down and was able to be lifted off freely, posing a safety hazard.	Lock lid and fasten properly.	
Steel Sluice	Critical	Surface corrosion is evident with significant pitting noted below the water level. Further assessment of sluice gate guides is required	Replace sluice gate	
Valve false cap	Non-Critical	This has been damaged and inserts have pulled out on one side. Access to valve and operation of valve in flood flows is significantly reduced.	Remove valve cap, remove inserts, reinstate valve cap with chemical inserts. Review operations and location.	
Roof Hold Down Bolt detail	Non-critical	One of the hold down bolts has become exposed as the concrete has spalled. No reinforcement has been exposed. This hold down bolt is anchored to the top of the roof.	Remove loose concrete and trowel a mortar topping over to the desired original level.

Site concrete	Non-critical	Some site concrete poured on top of river bank, true right downstream of intake. This has now been undermined.	This poses no immediate threat to the life cycle of the intake structure but will require maintenance.	2
Screen Hut Discharge Pipe	Non-critical	Pipe end degraded or damaged and reinforcing has been exposed.	No immediate risk to life cycle of intake structure but will require maintenance.	
Foundations	Critical	Not inspected.	N/A	
Overflow weir screen and chamber	Critical	Not inspected.	N/A

Inspections have shown that the structure is in good aged condition with some aesthetic defects, however some areas need attention with regard to design, maintenance and review of operational procedures. In particular the steel sluice valve should be assessed further and replaced if required. Lack of maintenance and difficult operational procedures have an effect on the life expectancy of the structure. Overall this structure is considered to have weathered well and is estimated to have a residual life expectancy of approximately 30 years.

It is recommended that a regular inspection and maintenance program is implemented to ensure deterioration in observed conditions can be identified and repaired as required. In particular, depth of concrete spalling should be monitored and a protective coating should be applied if the rate of spalling rapidly increases. Further inspection of steel sluice valve should be completed to determine the extent of corrosion on the sluice gate and guide channels. This may involve inspection from the waterway.

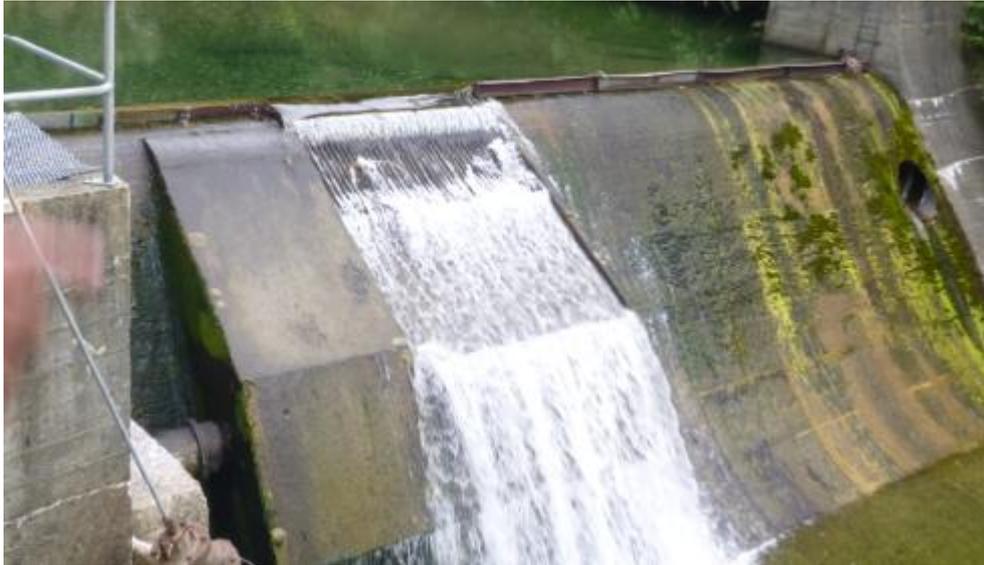
Plate 3 - Spillway face and water intake

The concrete spillway face has steel channels directing the mean water flow over the intake structure. The intake structure was added to the spillway face in 1986. Behind the dam is full with gravels almost to the level of the spillway crest. It is not known whether the dam is reinforced or not, but it is expected that it is an unreinforced mass concrete structure.

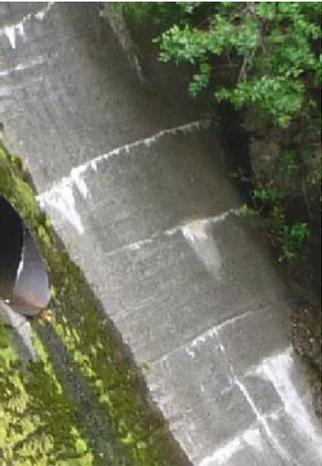
Item	Classification	Issue	Possible Remediation	Estimated Residual life (yrs)
Spillway Lime Leach

Non-critical	Lime leach is present on the spillway face. This indicates the location of a concrete joint which water has seeped through. If structure is reinforced this could indicate that the steel has possibly corroded. Water seepage also lowers the pH of the concrete, reducing the concrete's effectiveness of protecting the steel if present. As the dam/spillway structure is not expected to be reinforced water seepage is unlikely to have caused critical degradation.	Typically not a durability issue, Phenolphthalein test could indicate pH of cement paste and its remaining protection ability for the concrete. But as the steel content and layout is not known this would not be a complete test to verify any steel degradation.	Refer to discussion
Spillway Cracking	N/A	No major cracks noted. Some of the construction joints are of unknown quality. In some cases cracks were thought to be present, but were later deemed construction joints.	N/A

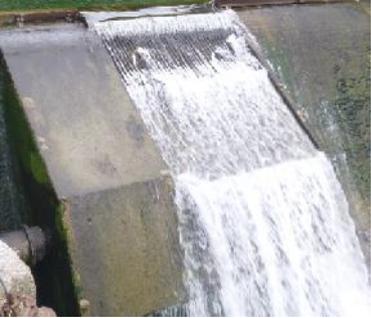
<p>Designed in 1986; drawings indicate maximum likely concrete cover over reinforcing is 63mm. NZS 3101 states concrete cover requirements are 45mm for 50 year durability. At time of construction 63mm cover translates to approximately 70 year durability. Running water over the structure may have reduced cover to any reinforcing steel cover. This cannot be measured whilst structure is in operation</p>	<p>Overall not an immediate concern but a 25mm mortar topping applied to the concrete structure could extend the life of the intake structure.</p>	<p>30 years</p>

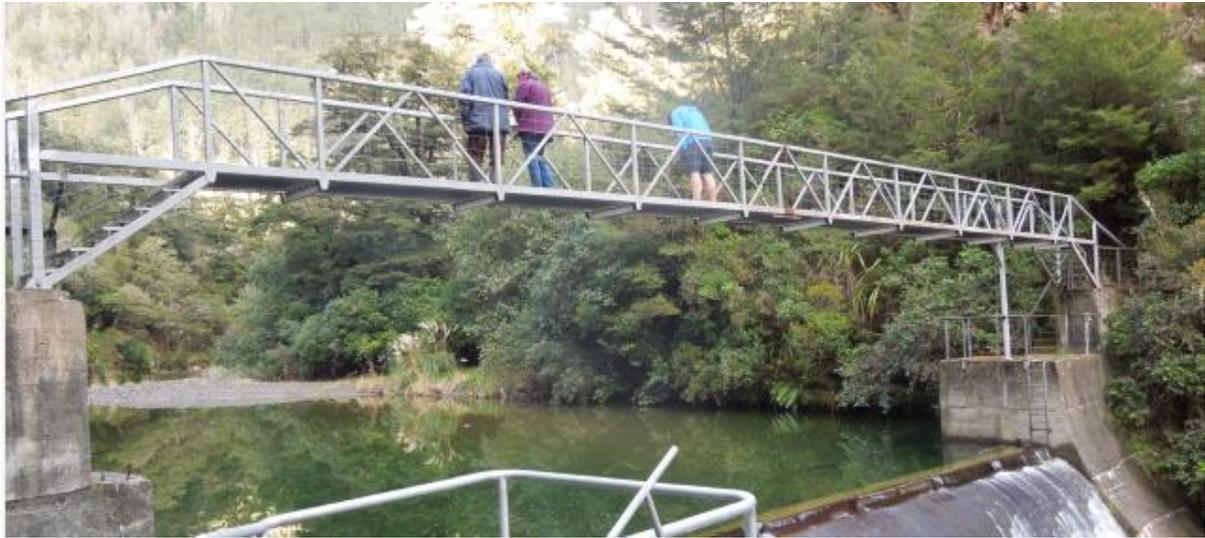
Plate 4 – Steel Truss Bridge

The bridge spans approximately 20m and is of steel construction. The top rail is constructed from Square Hollow Section steel (SHS) and the bottom is a steel angle. There is a Parallel Flange Channel (PFC) transom running between the vertical truss members. There is no current load restriction on this bridge and it is open to public access.

Non-critical/Safety	This part of the bridge is under the largest bending moment demand. The joint is also the point where the most significant corrosion has occurred. At this stage rust penetration does not appear to be deep.	Further inspect corrosion depth and strengthen locally as required. It is possible that the entire bridge coating is reaching its life expectancy. Recoat entire bridge with appropriate paint system.	Refer to discussion
Anchor bolts/plate	Non-critical/Safety	Details of these bolts are not shown on plans. Possible issues for these bolts are edge distances, embedment depth, unknown substrate strength and unknown	Carry out a structural analysis on this bridge to determine reactions on bolts to determine their capacity.

The Transit New Zealand Bridge Inspection Manual states that the re-application of protective coatings for a steel bridge should occur within 15-25 years of construction to ensure the service life is not compromised. In this case, it is understood the bridge was constructed in 1986 and it is unclear if any re-application of protective coatings has been completed since. The areas of the structure which could be observed during the site inspection revealed some corrosion which did not appear to have penetrated deeply at this stage. Actions recommended to prolong the life of this bridge are as follows

- 1) Treat corrosion and apply an appropriate protective coating
- 2) Complete an assessment of the loadings resulting from current work procedures and comment on any likely affect upon the service life of the bridge

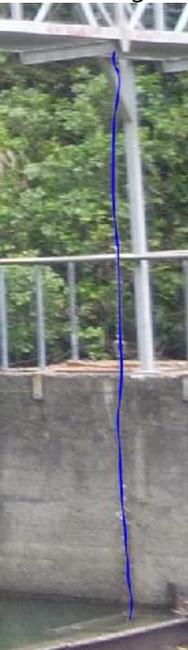
Non-critical/Safety	The bridge appears to be reasonably robust but may not be designed for anything more than pedestrian load use only. Block and tackles are routinely attached to lift gates and sluices, possibly overloading structure.	Confirm capacity of bridge to check resistance against the ultimate load being applied. Review design and operation procedures to lift gates and sluices.

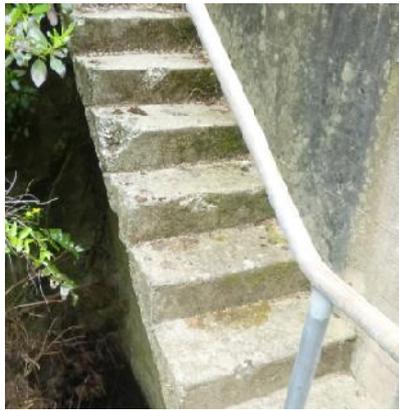
Non-critical/Safety	These are cantilevered off of the abutment. Based on the original design drawings, it appears that steel mesh has been bent as reinforcing in the steps in a manner which would not be considered an acceptable solution based on current design standards. There has been significant spalling from the old handrail locations and off of the bottom of the staircase. Stairs are doveled into abutment, likely with plain round bars only.	Options include Replace with stairs which comply with current standards Make stairs inaccessible to the public. Remove stairs and replace with ladder	
Handrails	Non-critical/Safety	Removal of old handrail caused concrete to blowout. The handrail is generally just a single handrail. In some cases, deer fencing has been used in an attempt to block the gap between the stairs and hand rail. This does not comply	Replace with handrail compliant with current standards Mortar over the areas of damage.

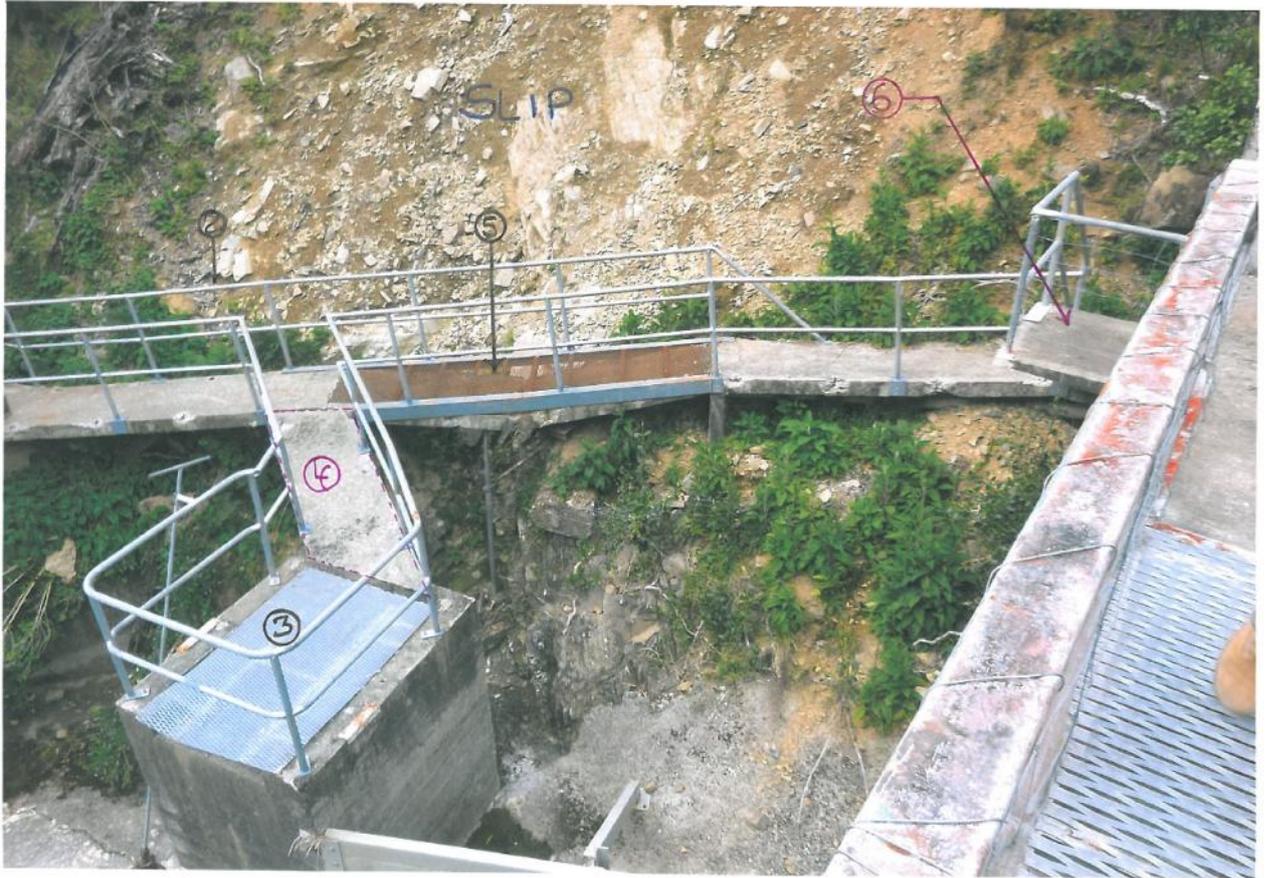
Plate 5 – Eastern Access

Item	Classification	Issue	Possible Remediation	Estimated Residual life (yrs)
Steps on side of screen tower	Non-critical/ Safety	There are two types of stairs, a precast cantilevered stair and an in situ stair. These finish in a cantilever platform off the screen tower. The insitu stairs are in good condition but the precast steps are at the end of their life cycle. The ends have spalled off and are poorly repaired. One step has a large crack through the entire the step.	Replace cantilevered stairs.	0

Handrail (Refer 2 in Plate 5 above)	Non-critical/ Safety	The existing walkway handrails have suffered impact from slip debris causing damage to the fixings and concrete. The replacement handrail appears adequate however design requirements are unknown and the fixing bolt edge distances appear to be inadequate for the thin concrete slab.		
Mesh Grating at scour valve chamber (Refer 3 in Plate 5 above)	Non-critical/ Safety	It has failed and permanently deformed.	Replace.	0

Walkway to scour valve chamber (Refer 4 in Plate 5 above)	Non-critical/ Safety	Appears to be acting as a strut for the rest of the walkway resisting horizontal loads. This would represent unintended design forces on viewing platform abutments	Replace as part of walkway replacement works.	0
Temporary Metal Deck Walkway	Non-critical/ Safety	Temporary solution using metal deck over slip damaged concrete	Redesign and replace.	0

(Refer 5 in Plate 5 above)		appears inadequate. The steel angles that provide most of the support are connected to concrete separate from the stable strata. This should have been extended past the failed portion of decking. Temporarily supported by an acrow prop.		
Upper Cantilever steps (Refer 6 in Plate 4 above)	Non-critical/Safety	Similar issues to the other set of stairs, ends spalled off. Handrails are not connected to the steps here. It is assumed steps are doweled into abutments with round bars.

The eastern access stairs are still providing access to the required sections of the dam. They do not meet current standards and are accessible to the public. The temporary metal deck walkway is of particular concern. There are numerous areas of damage; for this reason their

service life is considered to be over. Staff using this stairway should conduct regular inspections to ensure the walkway is not further deteriorating whilst a solution compliant with current standards is implemented. Consideration should be given to restricting public access until a permanent solution is implemented.

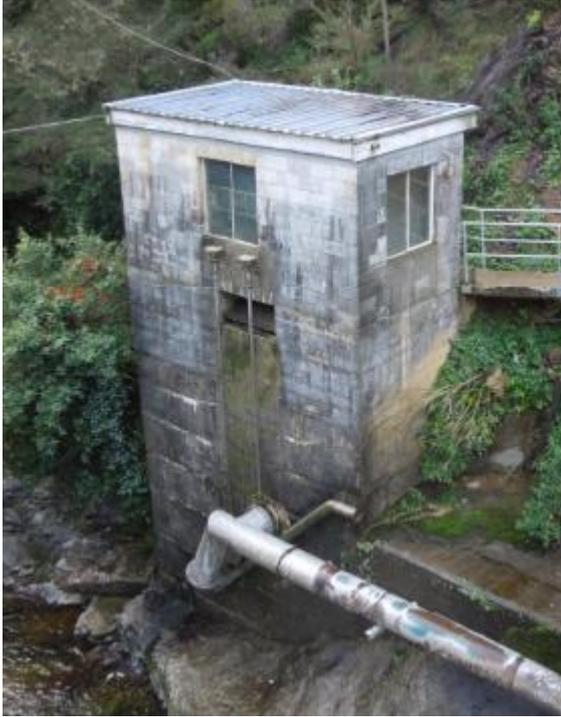
Plate 6

This is a reinforced concrete and reinforced masonry building. The overall construction seems to be in good condition and drawings show the concrete masonry portion to be well reinforced. This was built in two parts, the lower insitu concrete structure first c1937. Some concrete levelling was added to the original insitu portion with the masonry portion built on top c1972.

Non-critical	There is significant corrosion on the roof. Likely to have gone too far to be remedied by recoating.	Replace with new steel	0
Concrete around bottom of structure

Non-critical	Looks to be site concrete to contour site. Some cracking and very rough finish to concrete. Unlikely to be serving a structural purpose.	N/A	
Insitu structural concrete at bottom of structure (c1937)	Critical	Although old drawings indicate reinforcing the exact type and content as built is unknown. No major cracking noted. Foundations depths unknown.		20-30
Masonry Portion (c1972)	Critical	Good condition fully grouted and reinforced masonry. The openings are all trimmed out with reinforcing. Plans show reinforcing is doweled to structure below. There is a bond beam around the top of the entire structure. The masonry is uncoated. Coating with a suitable paint is likely to increase the service life of this structure		20-30

Hard Board Soffit	Non-critical	This has deteriorated. Likely to have been an oil based hardboard. Likely to be requiring replacement soon.	Replace at next maintenance	0
Door	Non-critical	Paint finish is peeling	Re paint

The service life of this structure is likely to be limited by the original concrete foundations upon which the newer masonry section of the building is constructed. Based on assumed service life of 100 years, and an age of approximately 77 years, the residual service life is expected to be in the order of 23 years. The structure appears in generally sound condition and with a maintenance program including replacement of the roof and application of an appropriate coating, the structure is likely to provide adequate service beyond this point.

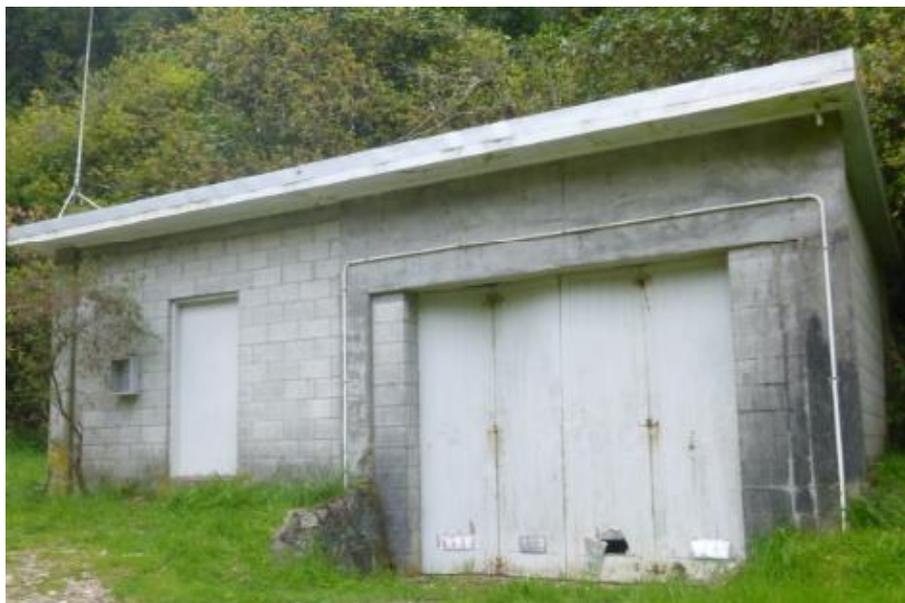
Plate 7

Item	Classification	Issue	Possible Remediation	Estimated Residual life (yrs)
Soffits	Non-critical	These are hardboard which typically perform poorly outside.	Replace in next maintenance cycle.	0
Folding Vehicle Doors	Non-critical	Showing age, vents broken, paint finish poor	Recoat and repair vents	
Roof	Non-critical	Looks to be recently replaced and is in good condition	N/A	15
Overall	Non-critical	The structure is in quite good condition, moulds and mildews growing on some parts	Keep structure clean.	25

Overall, the chlorinator house is assessed to be in sound condition. A minimum residual service life of 25-30 years has been assumed based on an expected service life of 70 years and an age of approximately 40 years. With a regular maintenance program it is likely this service life can be extended.

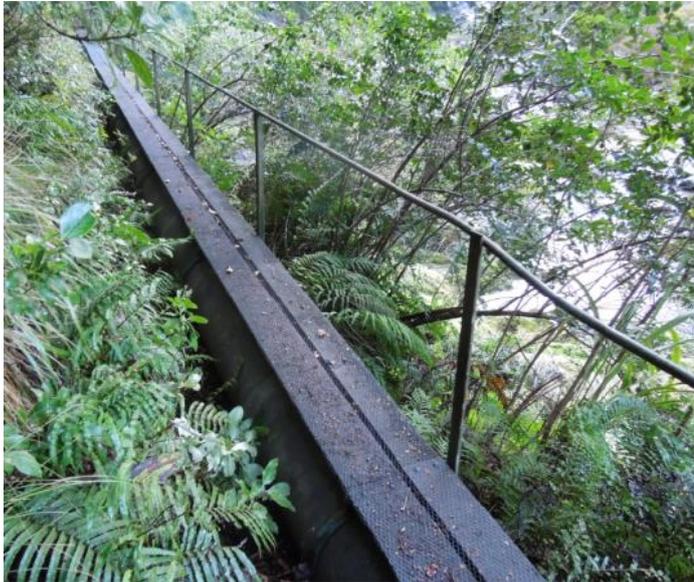
Plate 8

The walkway follows the eastern access along the same path as the water supply pipeline to the tunnel through to Marsden Valley. The pipe has not been assessed, obvious defects are noted however.

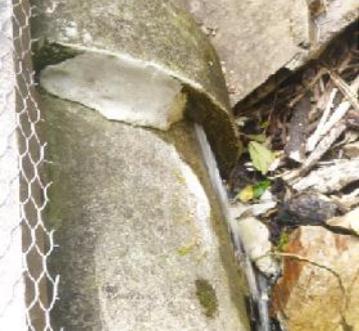
Item	Classification	Issue	Possible Remediation	Estimated Residual life (yrs)
<p>Leak in pipe</p>

Critical	There is a large leak in the pipeline	Repair	Refer to discussion

The observed deterioration of several components including the pipe supports and hold downs could result in a critical failure of the pipeline which would prevent the supply of water to Nelson via this system. The observed leak could lead to washout/erosion of material which could cause a similar failure.

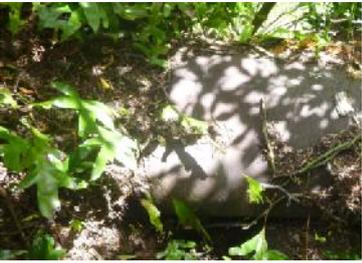
<p>Metal pipe by screen tower</p>

<p>Critical</p>	<p>There is a dent in the pipe which requires confirmation whether this represents a critical structural weakness or is acceptable</p>		<p>Refer to discussion</p>
<p>Pathway Handrail</p>

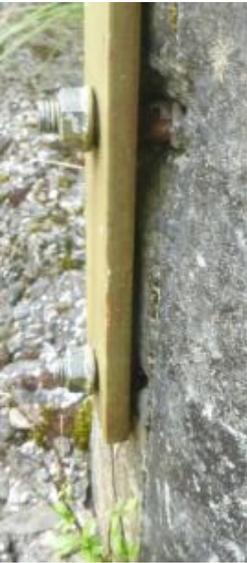
<p>Pipe Hold Downs</p>

<p>Critical</p>	<p>These are connected to studs inserted into the pipe supports. They are mostly in poor condition with a wire or the stud is near the end of its life.</p>	<p>Replace</p>	<p>0</p>
<p>Walkway Timbers</p>

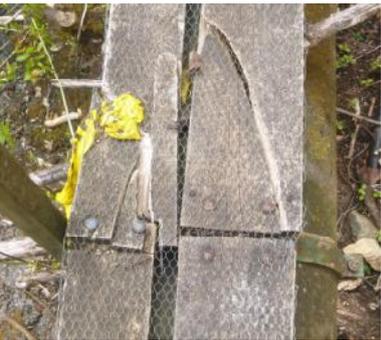
<p>Non-critical/Safety</p>	<p>They are in poor condition and deflect a different amount each. Some are broken or rotten.</p>	<p>Replace</p>	<p>0</p>
<p>Bannister to pipe</p>	<p>Non-critical/Safety</p>	<p>This connection allows for rotation about the pipe in some places.</p>	<p>Replace Handrail</p>	<p>0</p>
<p>Steel pipe across long gully</p>	<p>The original design drawings (5/77 Sheet 4a) show a bridge to support the pipeline crossing. The actual pipeline crossing is a steel pipe with no bridge. It is unclear if this was a change made during construction in 1937 or a replacement section of pipe following damage to the original</p>		<p>Review NCC plans database or confirm structural adequacy for span.</p>	<p>N/A</p>

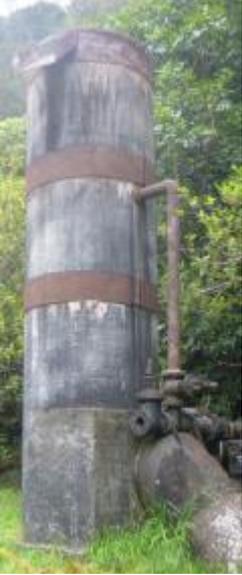
Surge Chamber

Non-critical	Some corrosion of steel components and weathering of concrete	Clean and treat steel corrosion. Consider application of an appropriate coating	
Thrust block/Support	Non-critical	Undermined due to erosion. Unlikely to cause critical failure in short to medium term	Backfill material around thrust block and compact to prevent further erosion
