REPORT NO. 2730

**MAITAI SOUTH BRANCH WEIR FISH PASSAGE
REMEDICATION EFFICACY MONITORING**

Prepared for Nelson City Council

ISSUE DATE: 23 June 2015

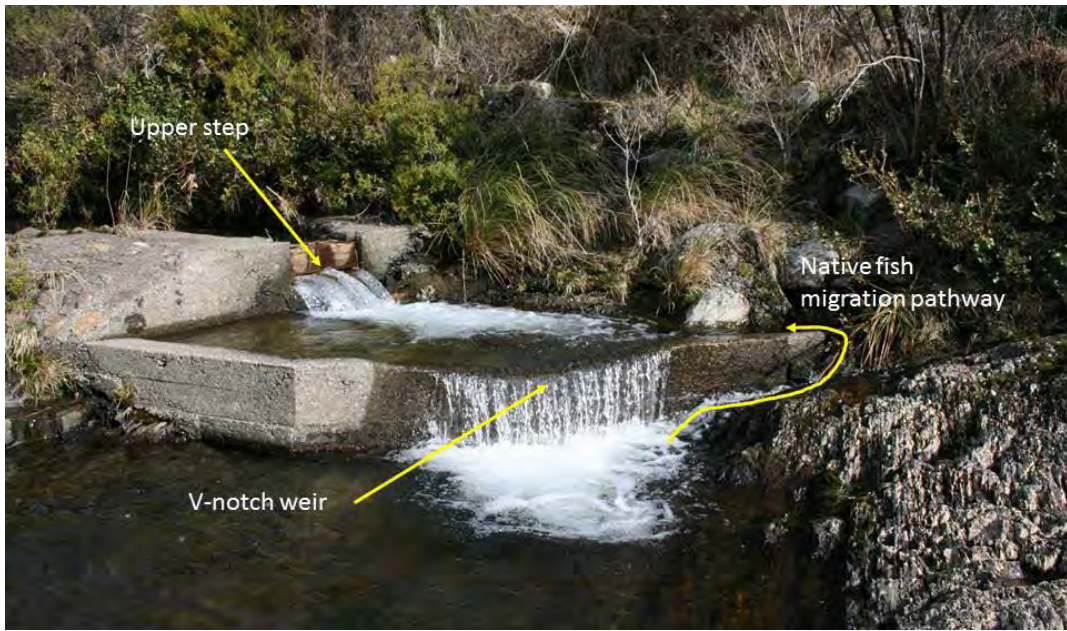
Figure 2. Step-pool fish pass on true left of the Maitai South Branch weir, prior to remediation work.

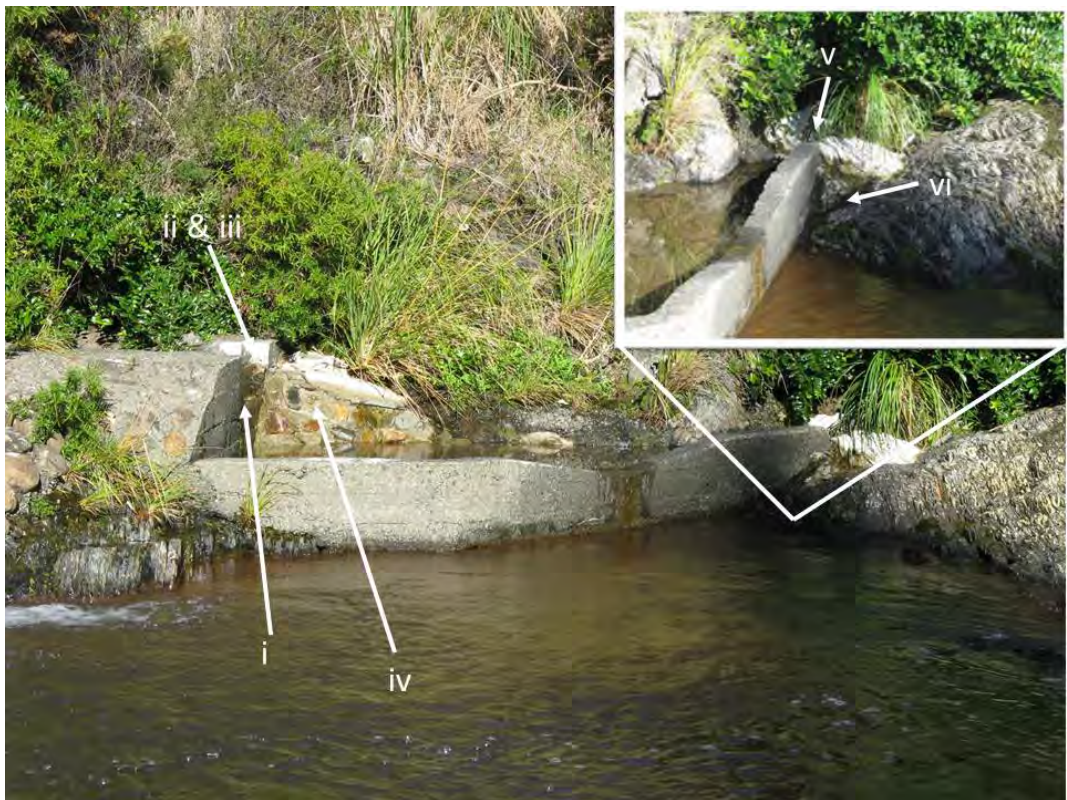
Figure 3. Step-pool fish pass on true left of the Maitai South Branch weir, following remediation work. Numbered arrows indicate remediation undertaken, with numbers referring to the points outlined under heading 3 of the recommended remediation actions in section 2.1.1, above. Note: river flow in this image is substantially lower than in Figure 2.

Only two elvers were observed attempting to climb the modified step-pool fish pass on the true left of the river. These elvers were both observed during the first spotlight survey. One was observed beginning to climb at the very bottom of the lower step, while the other was climbing the vertical face of the wooden water level regulator board that forms the top of the upper step of the pass. The low rates of use of this fish pass are almost certainly due to the lack of attractant flow to draw fish to this route. The fish pass conducts a negligible flow compared with discharge from either the back-feed or over the intake screen (as recognised in the recommendations of Doehring and Hay 2014).

Video footage reinforced the spotlighting observations of relative intensity of use of the two alternative fish passage routes (true left step-pool pass versus ramp adjacent to intake screen) by elvers. Only a single elver was observed passing the step-pool fish pass on the true left bank. This elver climbed the vertical face of the wooden water level regulator board, forming the top step of that pass, rather than the lower gradient rock ramp constructed as part of the remediation works.

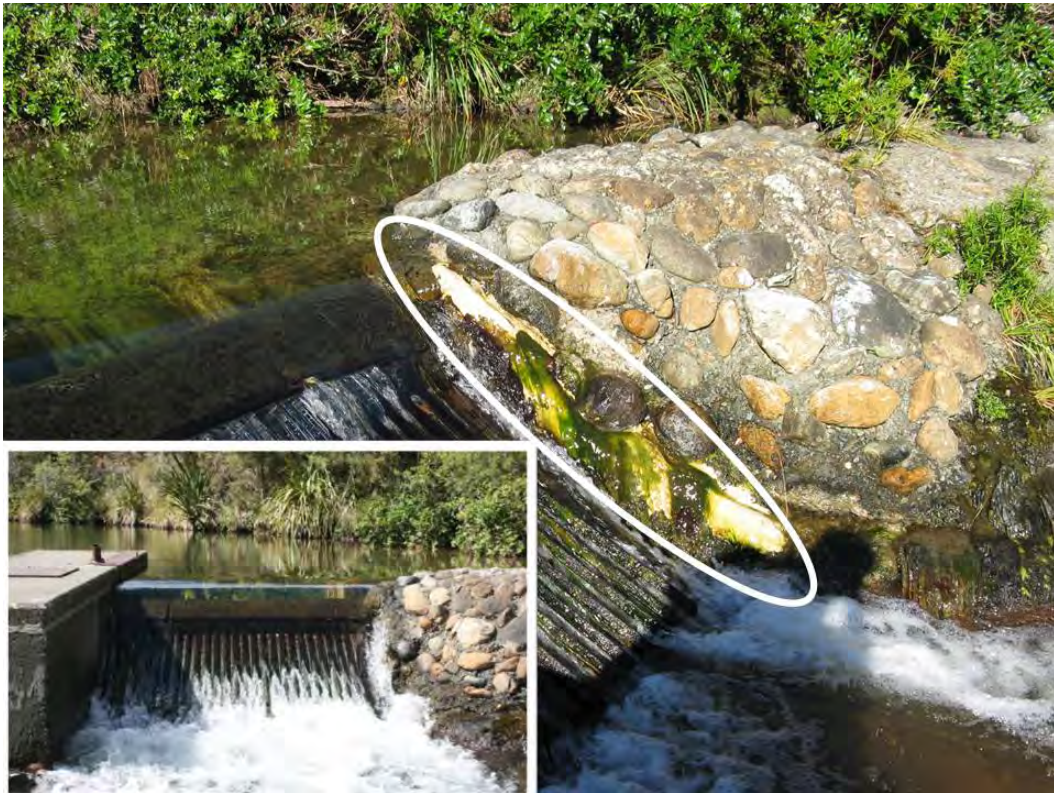
Figure 4. The water intake screen in the Maitai South Branch weir, showing the smooth wetted margin constructed with epoxy cement as part of the remediation works (highlighted within the white oval). Insert shows the screen prior to remediation.

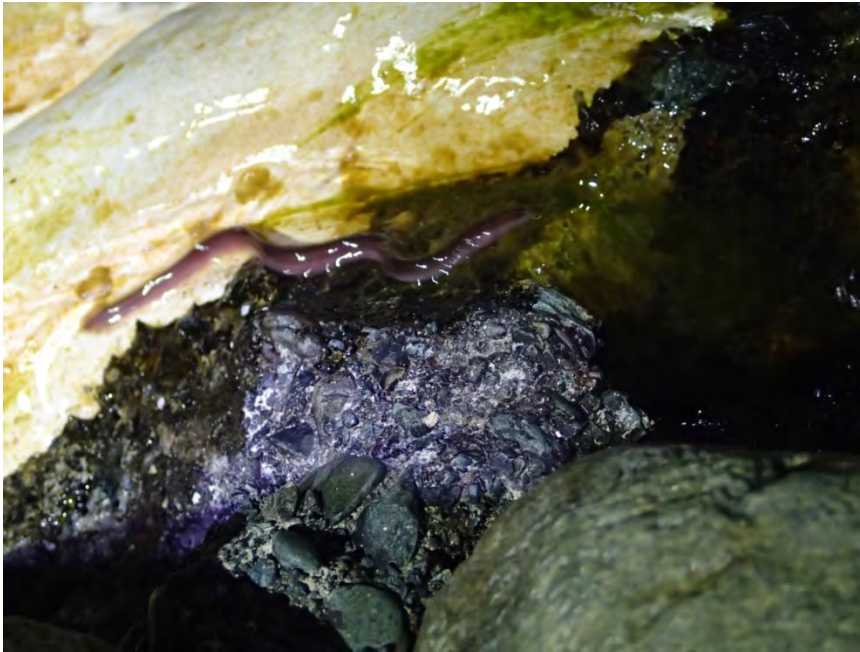
Figure 5. Elver attempting to climb the wetted edge constructed on the true left of the intake screen at the Maitai South Branch weir.

By contrast the wetted splash zone adjacent to the intake screen in the middle of the weir has a substantially larger attractant flow, while the back-feed discharge appears to be the dominant attractant flow across the weir – although this is likely to vary with the rate of discharge from the back-feed. During January and February the back-feed discharge ranged between 0 - 314 L/s, median 156 L/s. During this same period the median flow at the Maitai Forks recorder was 269 L/s, suggesting that the back-feed discharge contributed close to 60% of the median flow over this period. The disparity in numbers of elvers observed attempting to climb the weir by each of these three routes serves to illustrate the critical importance of attractant flow to successful fish passage design.

By contrast, approximately 30 elvers per night (average count 28 and 32 on the two nights, respectively) were observed to pass over the weir via the ramp on the true left of the intake screen.

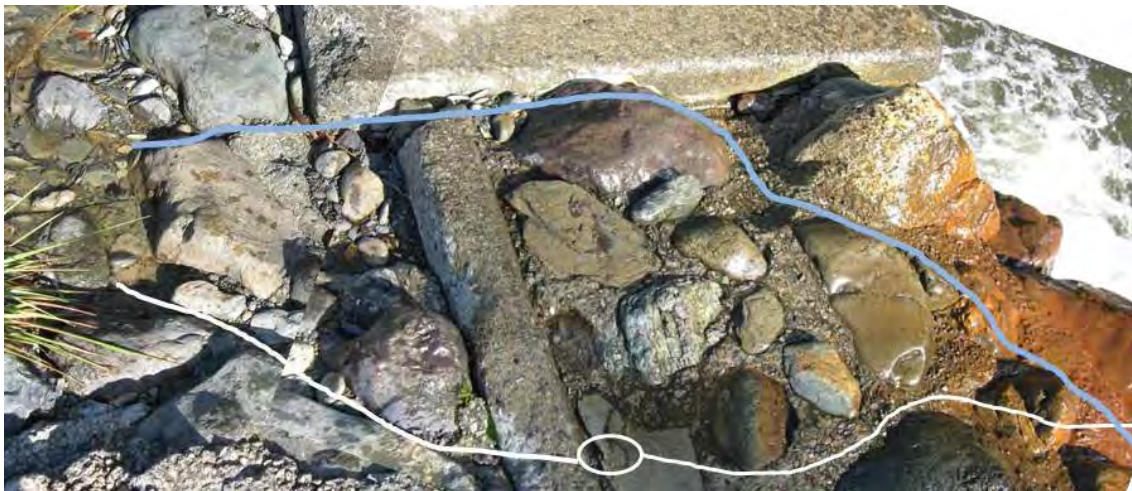
The propensity of the back-feed discharge to attract upstream migrating fish into a migratory dead end was recognised by Doehring and Hay (2014) (as discussed in section 2.1.1). This remains a key issue for fish passage at the South Branch weir. This contention is supported by the large numbers of elvers observed attempting to climb the wet rocks in the splash zone around the back-feed, as well as on the back-feed pipe itself. Doehring and Hay (2014) suggested two possibilities to alleviating this issue:

Figure 7. Two options for connecting the back-feed splash zone below the Maitai South Branch weir with the water upstream on the true right of the river. Option 1: Cut new flow path, approximately following blue line. Option 2: Pump water to approximately position of oval, and let water spill back both directions from this point, approximately following white lines.

Another option that would help to address this problem, at least for strong climbing migrants (e.g. kōaro and eel elvers), would be to connect the splash zone from the back-feed to the water above the weir, with a continuous wetted surface or channel. This idea has been discussed on site with Alex Miller (NCC Investigator/Contracts Supervisor) and he expressed support for the concept. Two alternative approaches to achieve this were discussed (Figure 7).

With respect to fish passage, the ideal situation would still be to move the back-feed discharge point close to the entrance of the step-pool fish pass on the true left bank (or construct something similar, such as a rock ramp pass, close to the existing back-feed discharge point on the true right). This would help attract upstream migrating fish to the fish pass and would have potential benefits for weaker climbers than elvers and kōaro, since the step-pool pass provides a lower gradient passage alternative. However, the options depicted in Figure 7 offer a lower cost mitigation possibility for strong climbing migrants. It is possible that under higher flows the true left step-pool passage may offer more effective passage for poorer climbing species than observed in this study. It is recommended that some additional surveillance work be conducted under a wider range of flows.

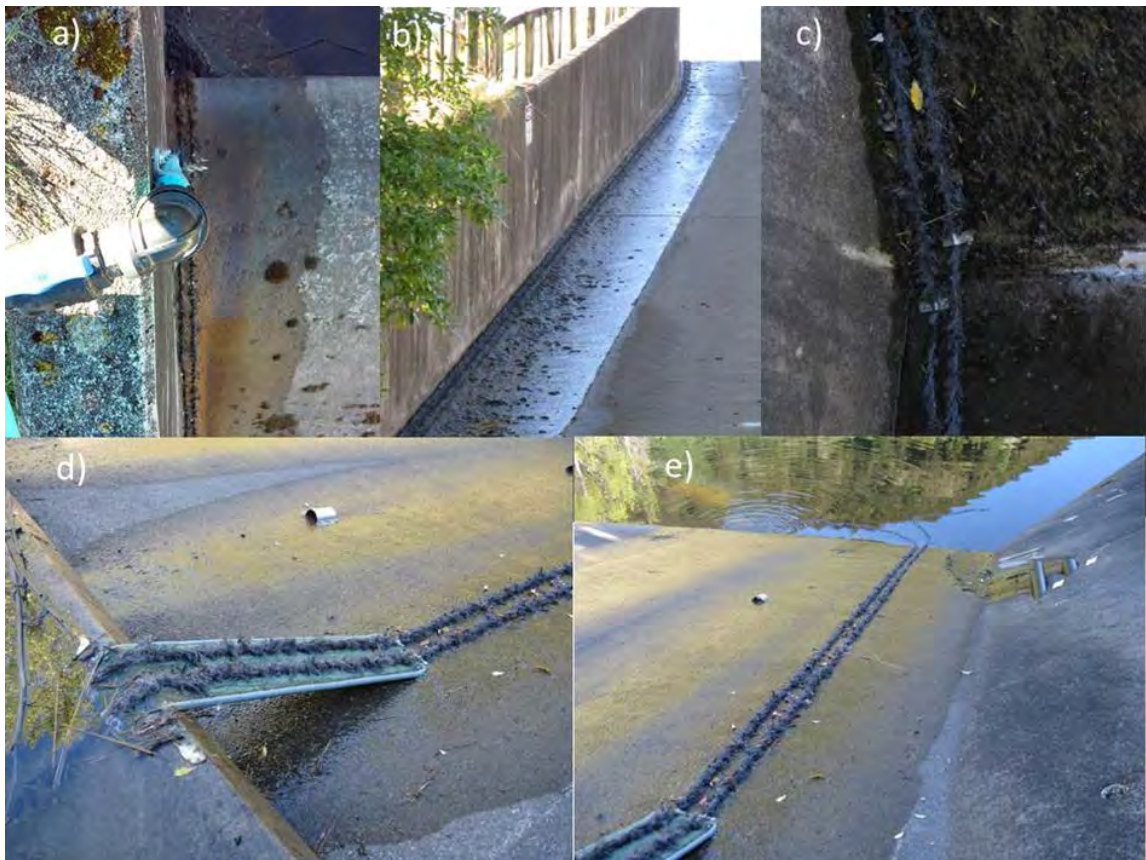
Figure 8 illustrates the fish passage remediation work undertaken on the Maitai Dam spillway. All of the recommendations from Doehring and Hay (2014) were implemented, with the exception of the concrete bevel inserts along either side of the apron / spillway.

Figure 8. Fish passage remediation works undertaken in late March 2015 on the Maitai Dam spillway: a) pump delivering water to the spillway crest (reservoir water level >1 m below the crest), b) paired spat ropes fixed along the true right edge of the spillway from above the crest to the spillway and continuous flow provided by pump in previous image, c) close up of paired spat ropes where the spillway enters the flip-bucket, d) synthetic turf lined ramp at downstream end of flip-bucket, e) paired spat rope continues below flip-bucket ramp into plunge pool below spillway.

elvers were attempting to climb a trickle of water issuing from one of the flip bucket drains (visible in the top right of Figure 8). This trickle of flow almost certainly represented a migratory dead-end.

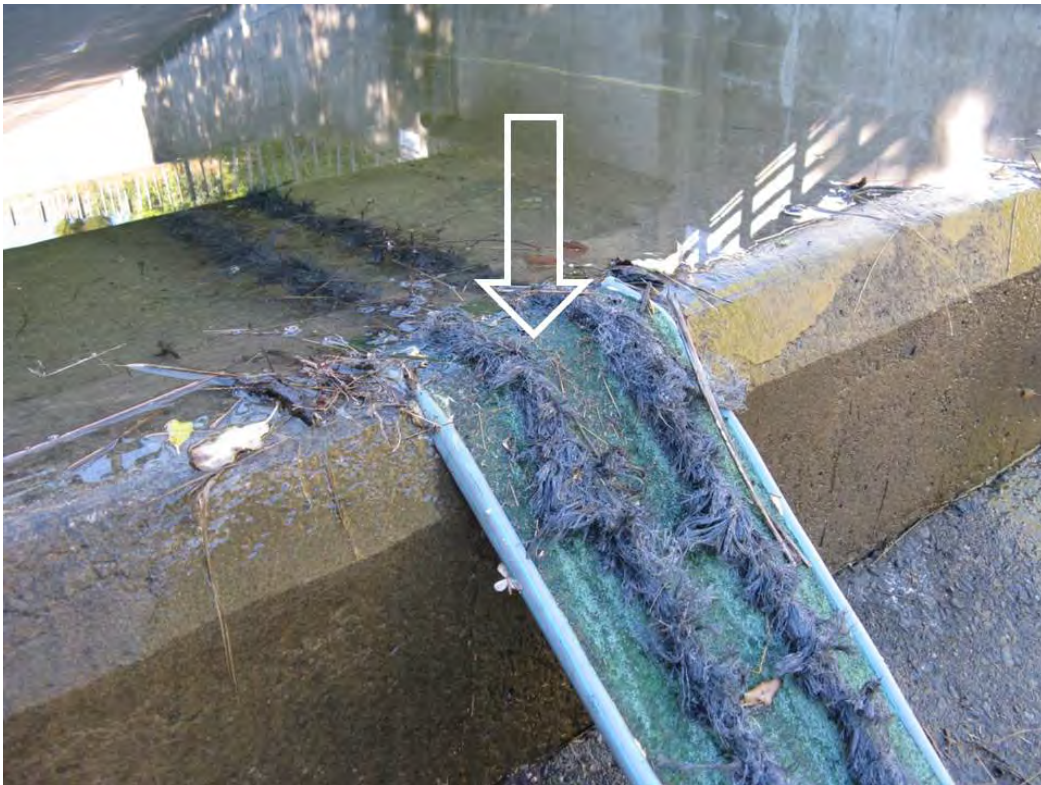
Figure 10. Top of the ramp fitted during March 2015 to help provide easier access for climbing migrant fish to the downstream edge of the flip-bucket on the spillway of the Maitai Dam. The white arrow shows where it is recommended that this ramp be dished into the flip-bucket lip to ensure preferential flow down this ramp during periods of low flow.

1. The ramp providing access to the spillway flip-bucket should have the upper end slightly dished into the flip-bucket lip (Figure 10), so that water flowing out of the flip-bucket preferentially flows down this ramp, during periods of low flow. Currently, water spills around the ramp (Figure 10), potentially making it difficult for climbing migrants to find their way onto the ramp.
