Nelson City Council

Maitai Dam
Intermediate Dam Safety Review
2015

Tonkin & Taylor

May 2015

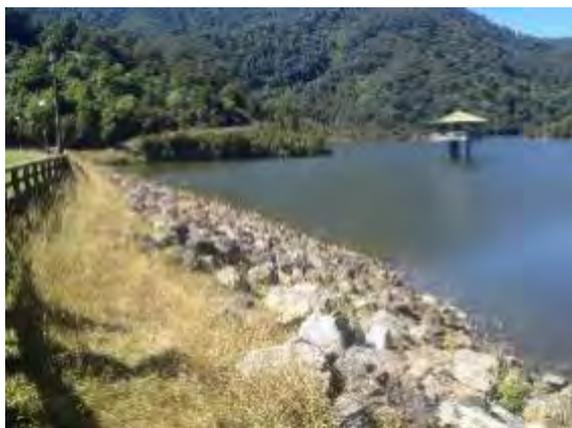
The embankment and abutments were inspected from a walkover of the toe of the dam, the mid height downstream berm and the dam crest (Photograph 3.1 and Photograph 3.2). The upstream armour above the reservoir level was also visually assessed by boat (Photograph 3.3). The condition of the rip rap is comparable to last year with some “lean” patches to the right of the service spillway.

Photograph 3.1 - Upstream armour viewed from crest adjacent to spillway with “lean” area at front

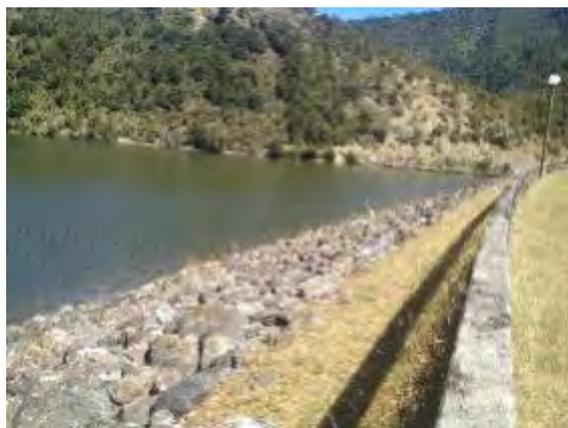
Photograph 3.2 - Upstream armour viewed from crest near right abutment.

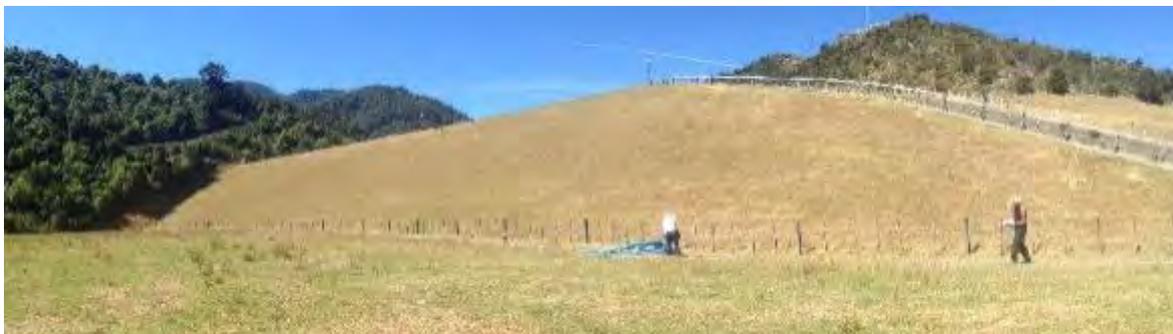
The downstream dam face is in good condition and has good grass cover (Photograph 3.4). A runnel formed by the erosion of a sheep track was noted near the footpath next to the spillway (Photograph 3.5). This has since been filled and compacted with soil (Photograph 3.6). The berm drains were in good condition and well maintained.

Photograph 3.4 - Downstream dam face viewed from mid height berm.

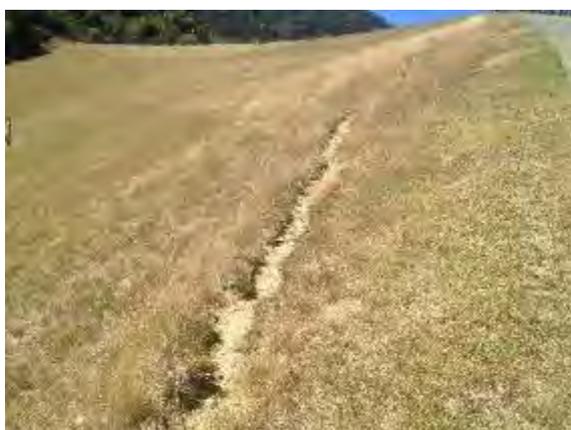
Photograph 3.5 - Runnel in downstream dam face 10 March 2015.

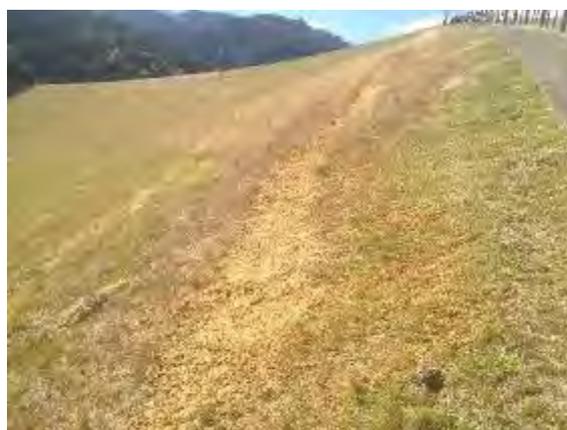
Photograph 3.6 - Runnel filled and compacted with soil 13 March 2015.

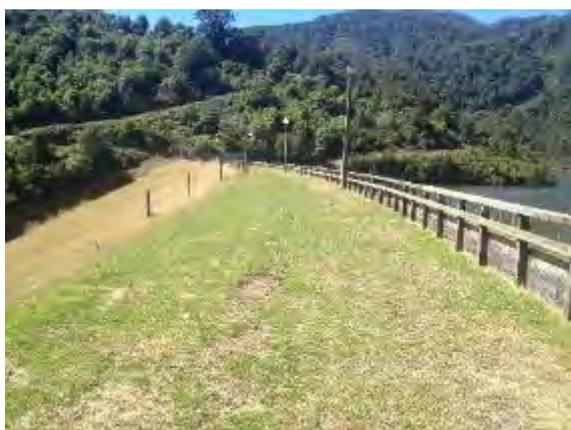
Photograph 3.7 - Crest looking towards right abutment.

The crest track is in satisfactory condition with no sign of settlement, cracks or displacement (Photograph 3.7). The mid height berm has good grass cover (Photograph 3.8) and the access track is in good condition.

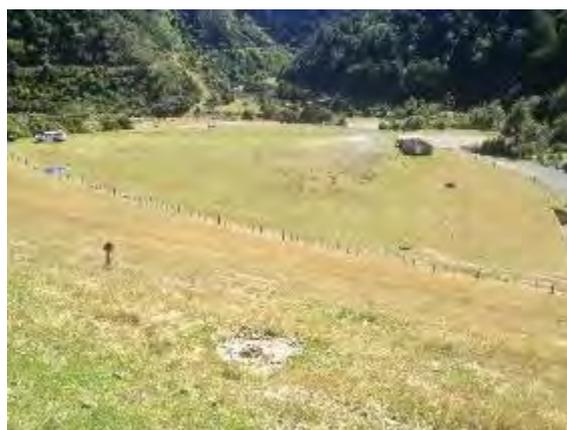
Photograph 3.8 - Mid height berm viewed from dam crest.

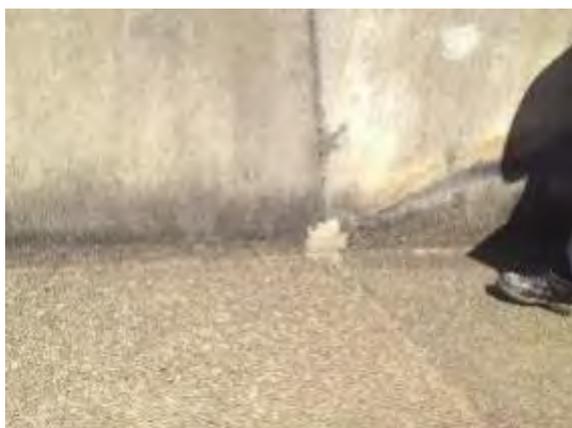
Some patched areas of the spillway require further attention (Photograph 4.3 and Photograph 4.4). A few minor additional areas on the spillway were identified and marked with spray paint that require patching. We understand that Nelmac had been contracted to patch the spillway.

Photograph 4.3 - Section of patch has chipped away and requires re-patching.

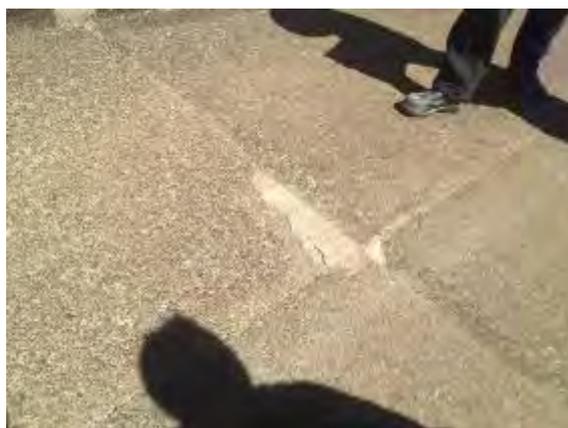
Photograph 4.4 - Patch is starting to wear and requires smoothing.

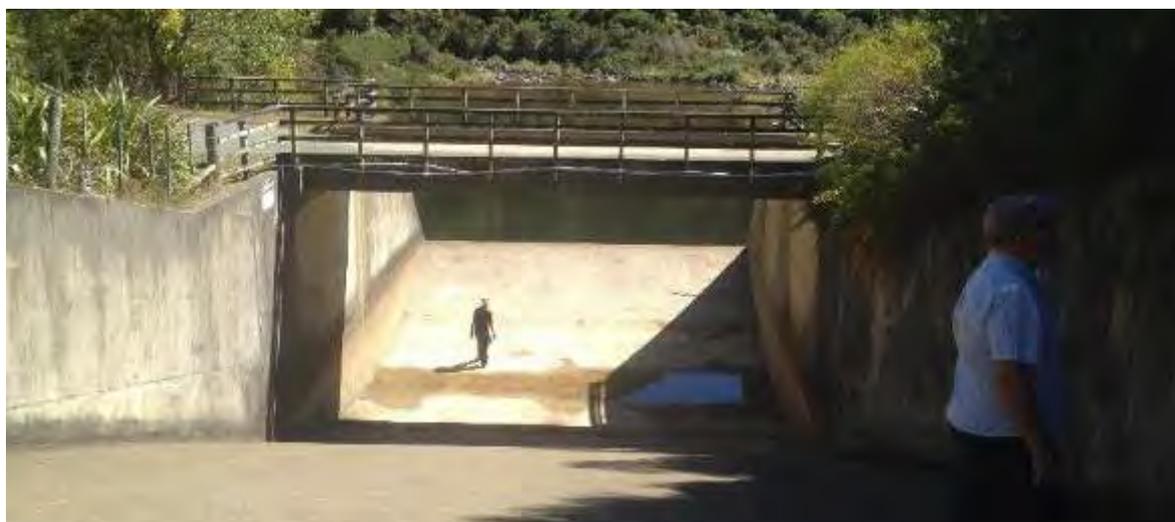
The spillway flip bucket and armour are in good working order (Photograph 4.5). The shields for the relief holes on the spillway apron are in good condition (Photograph 4.6 and Photograph 4.7).

Photograph 4.5 - Service spillway flip bucket.

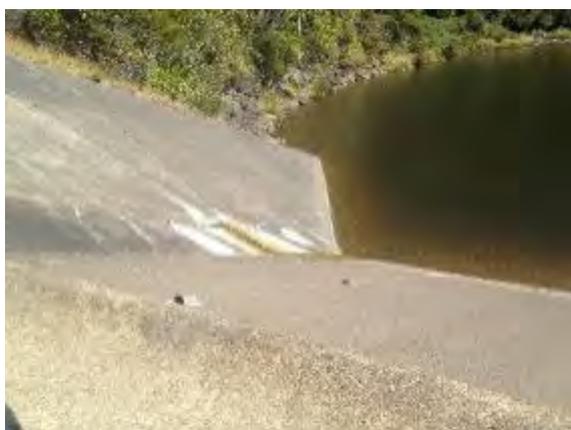
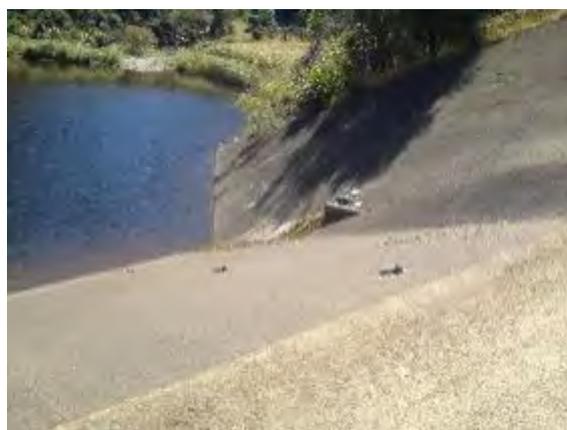
Photograph 4.6 - Service spillway apron and plunge pool.

Photograph 4.7 - Service spillway apron and plunge pool.

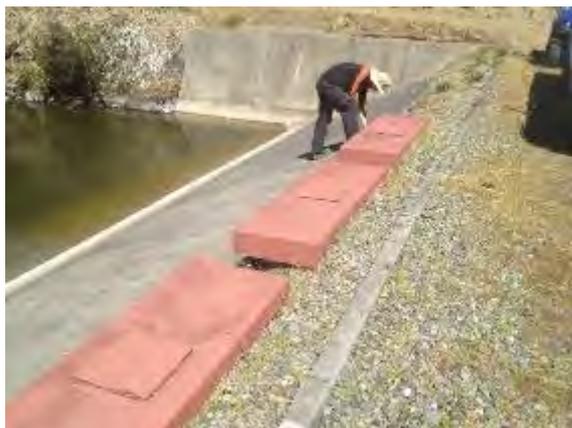
The auxiliary (fuse plug) spillway was inspected for overgrowth, surface erosion, slumps and obstructions and found to be satisfactory (Photograph 4.8). The downstream ground surface shows no sign of surface erosion. No evidence of rabbit burrowing was found during this inspection. The outlets of the overflow priming boxes were exposed and found to be generally satisfactory. The sand at the true right outlet (Photograph 4.9) is thought to be the same as that identified during the 2014 inspection.

Photograph 4.8 - Auxiliary spillway priming boxes.

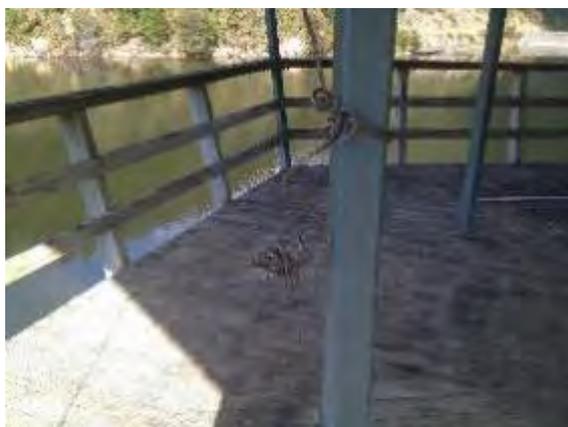
Photograph 5.3 - Broken winch.

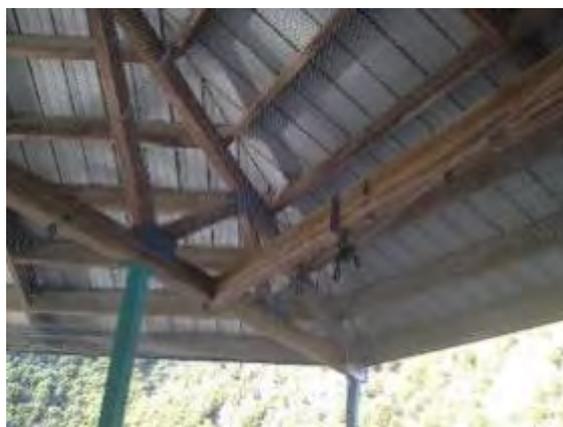
The netting to the ceiling of the tower structure was replaced around June 2005 (Photograph 5.4) and we understand from discussions with the Caretaker that it is in good condition.

Photograph 5.4 - Intake tower bird netting in good order.

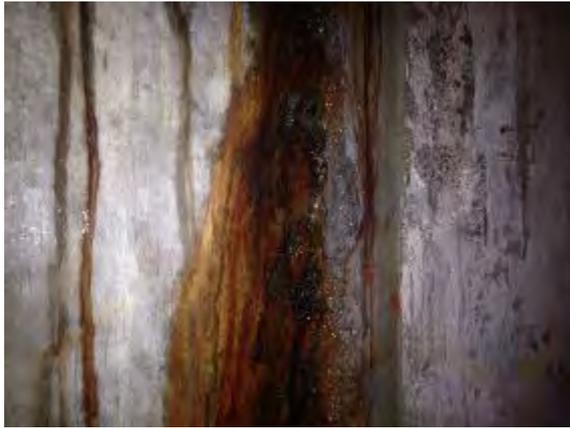
Photograph 6.2 – Joint sealant deteriorating in several locations along the culvert.

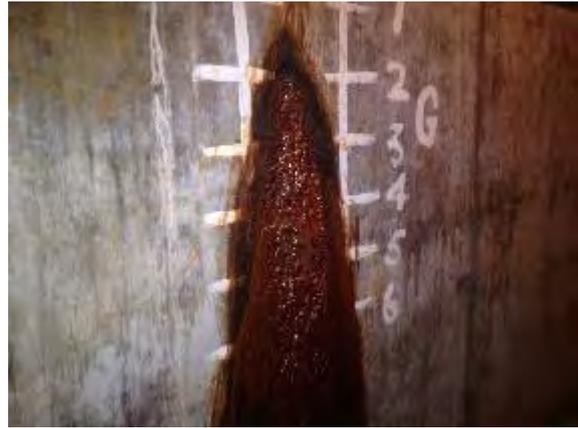
Photograph 6.3 - Seepage and staining evident at several locations along true right wall of culvert.

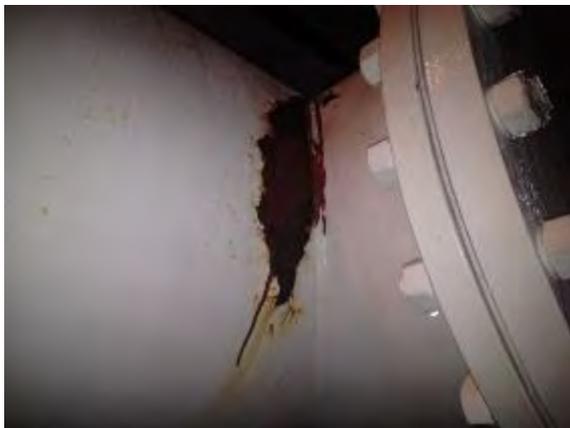
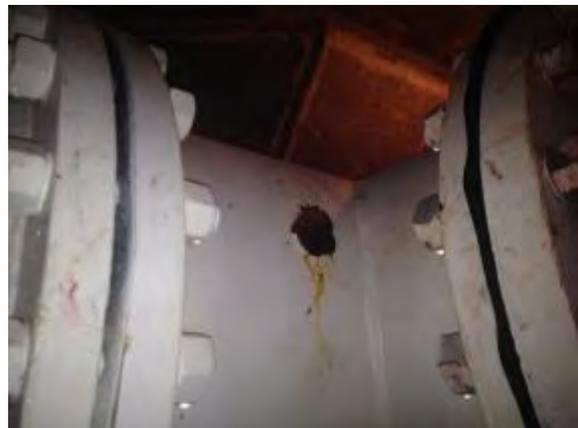
Photograph 6.4 - Corrosion and flaking paint evident on pipework in several locations.

Photograph 6.5 - Corrosion and flaking paint evident on pipework in several locations.

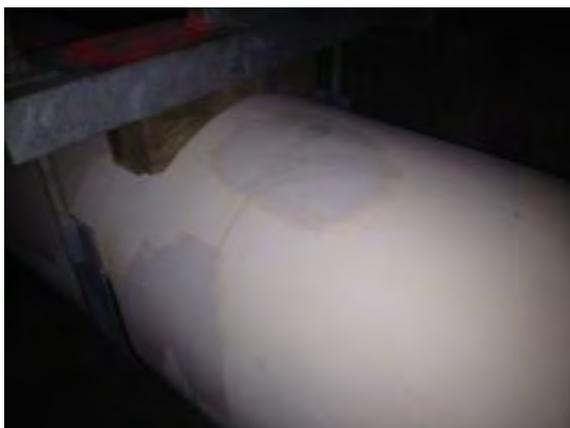
Photograph 6.6 - Evidence of repair work on lower pipe.

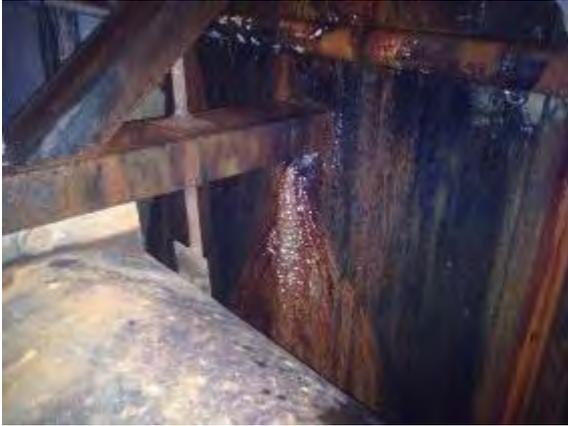
Photograph 6.8 - Leakage below diversion channel.

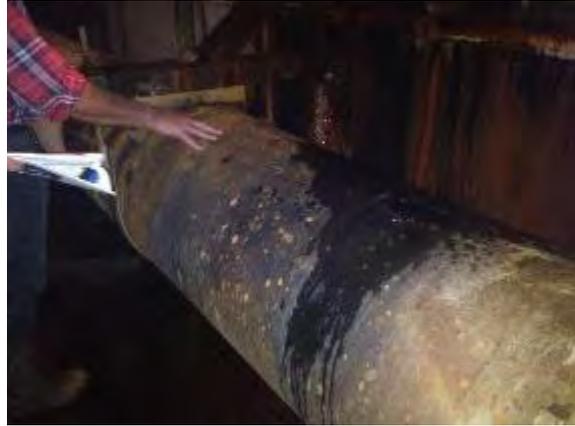
Photograph 6.9 - Staining of pipe below diversion channel.

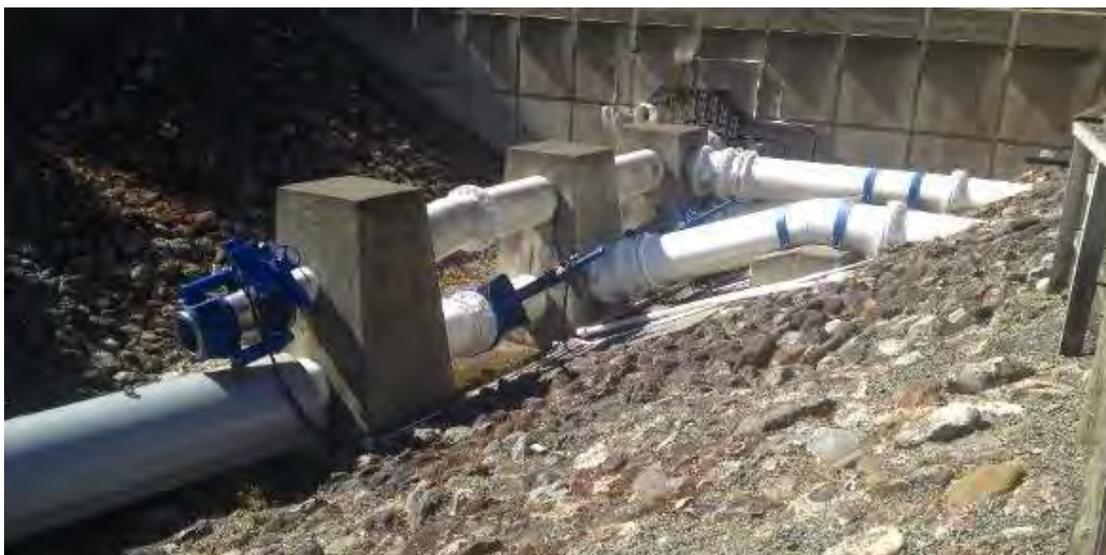
An external visual inspection of the piping and outlet valves indicates that they are in generally good condition (Photograph 6.11). However, the new paintwork on the upper pipe is stained and wearing thin (Photograph 6.12). Any required repair work should be done as required (as part of routine maintenance).

Photograph 6.11 - External piping downstream of culvert.

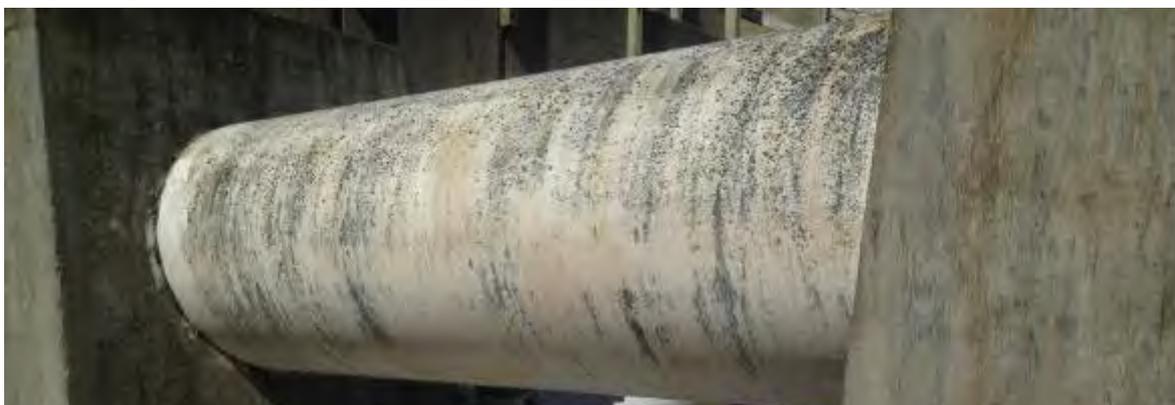
Photograph 6.12 - Stained and thinned paint on the upper pipe.

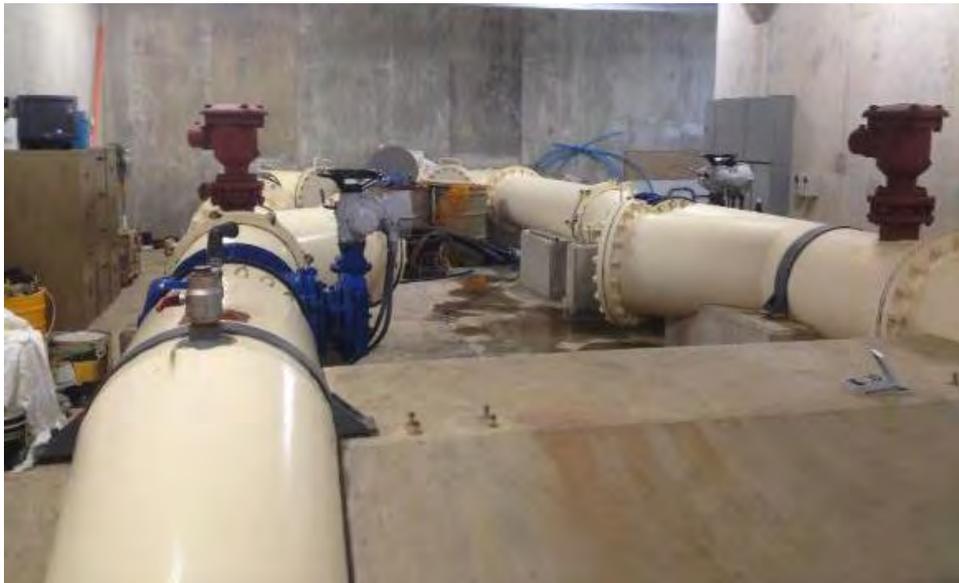
The Control building and doors and adjacent walls are sound. The pipe work within the building appears to be in generally good order. Some minor areas of corrosion are evident at valves, pipe joints and brackets. Some of the valves are leaking, with water ponding below them. From discussions with the Caretaker we understand that the air valves are not functioning properly and may require replacement in the near future.

Photograph 6.13 - Pipe work in the control building.

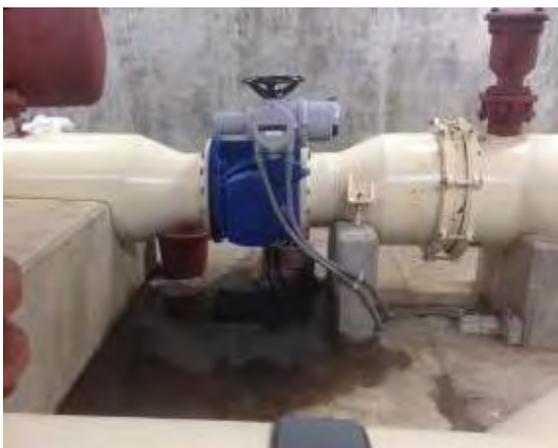
Photograph 6.14 - Water ponding beneath leaking valve.

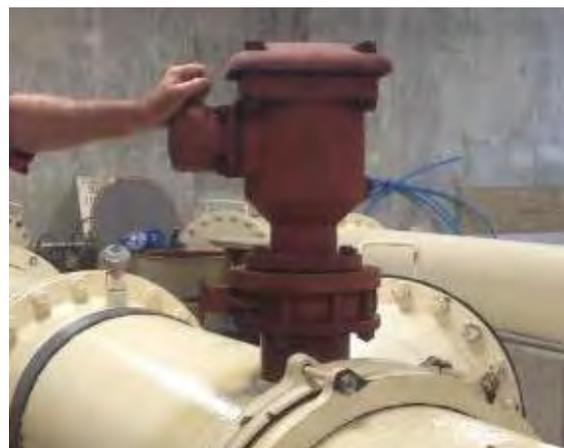
Photograph 6.15 - Air valve not working properly.

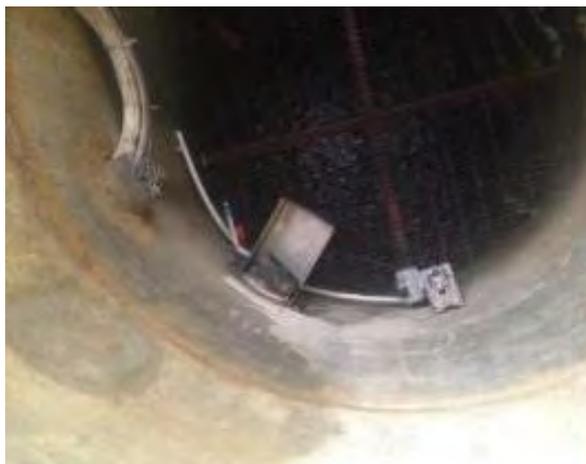
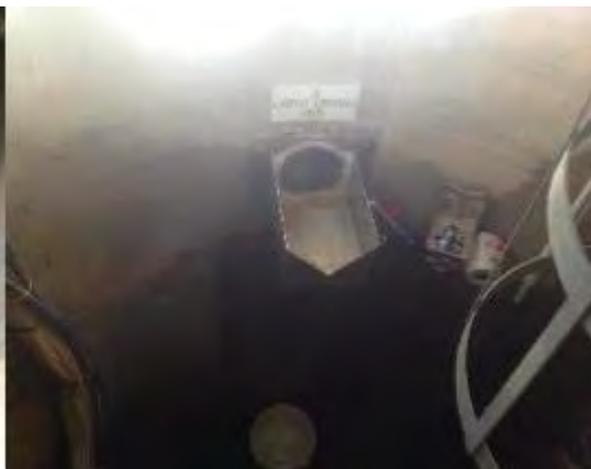
New automated flow meters consisting of a metal plate v notch weir and ultrasonic level detector have been installed on the LHS and RHS abutment drains (Photograph 6.21 and Error! Reference source not found.) in the seepage collection well. The flow meters resolve the health and safety issue arising from previously carrying out these readings manually (the central collector drain flows are not measured in the seepage collection well but are measured via the total outflow from the seepage well at the downstream of the outlet pipe).

Photograph 6.21 - Abutment drain RHS with new flow meter above central collector.

Photograph 6.22 - Abutment drain LHS with new flow meter

DSR 2015 - 8 Review and update OM&S manuals to ensure all flow measurement procedures are up to date.

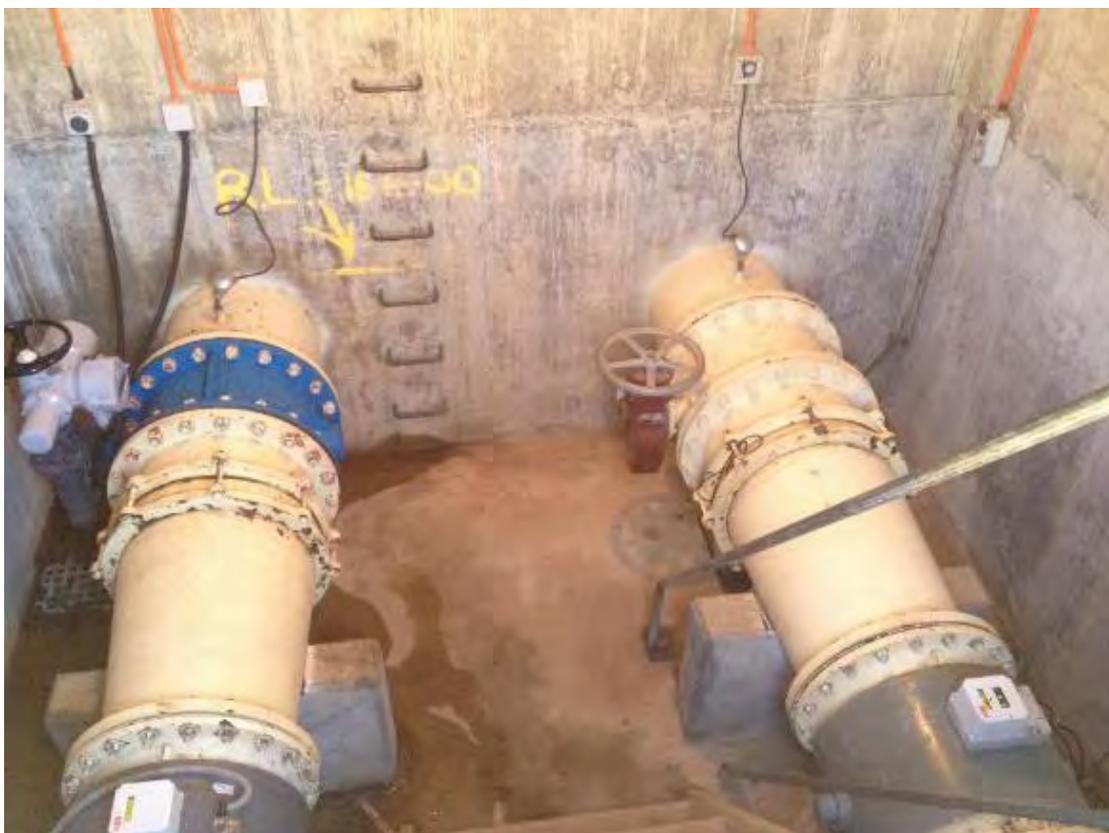
Inspection of the mixing box valve room indicates that the valves and pipework appear to be in good working order. The access ladder handrail corrosion at the plate/bolt interface identified in the 2013 annual inspection still requires maintenance.

Photograph 6.23 - Mixing box valve room.

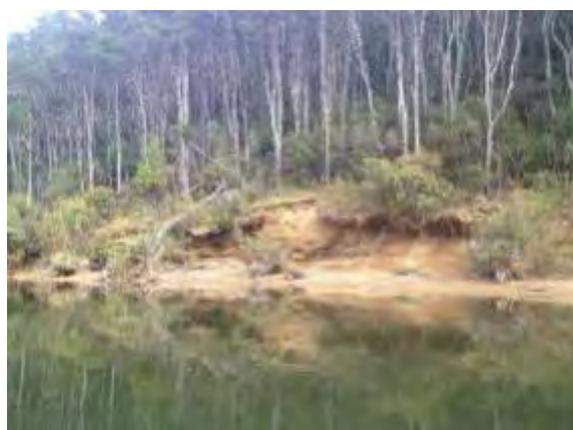
The reservoir's shoreline was inspected visually by boat and from the dam crest (Photograph 7.1). One minor area of erosion was identified along the left bank of the reservoir (Photograph 7.2). It was also noted that the bank at the inlet of the stream to the reservoir has eroded (Photograph 7.3), most likely from heavy rain in the weeks prior to the inspection. None of the erosion noted was considered significant enough to affect reservoir performance. No specific monitoring is proposed.

Photograph 7.2 - Erosion next to reservoir.

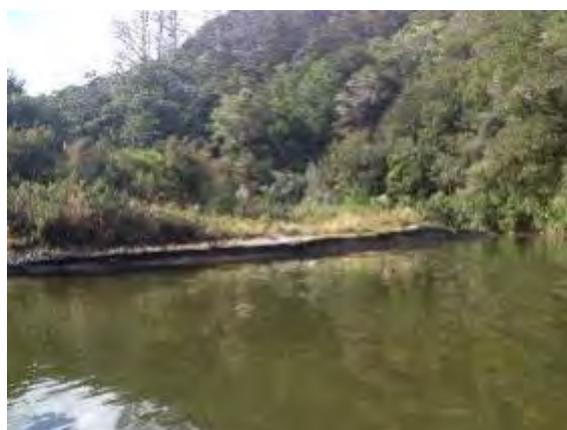
Photograph 7.3 - Bank where stream enters reservoir has eroded.

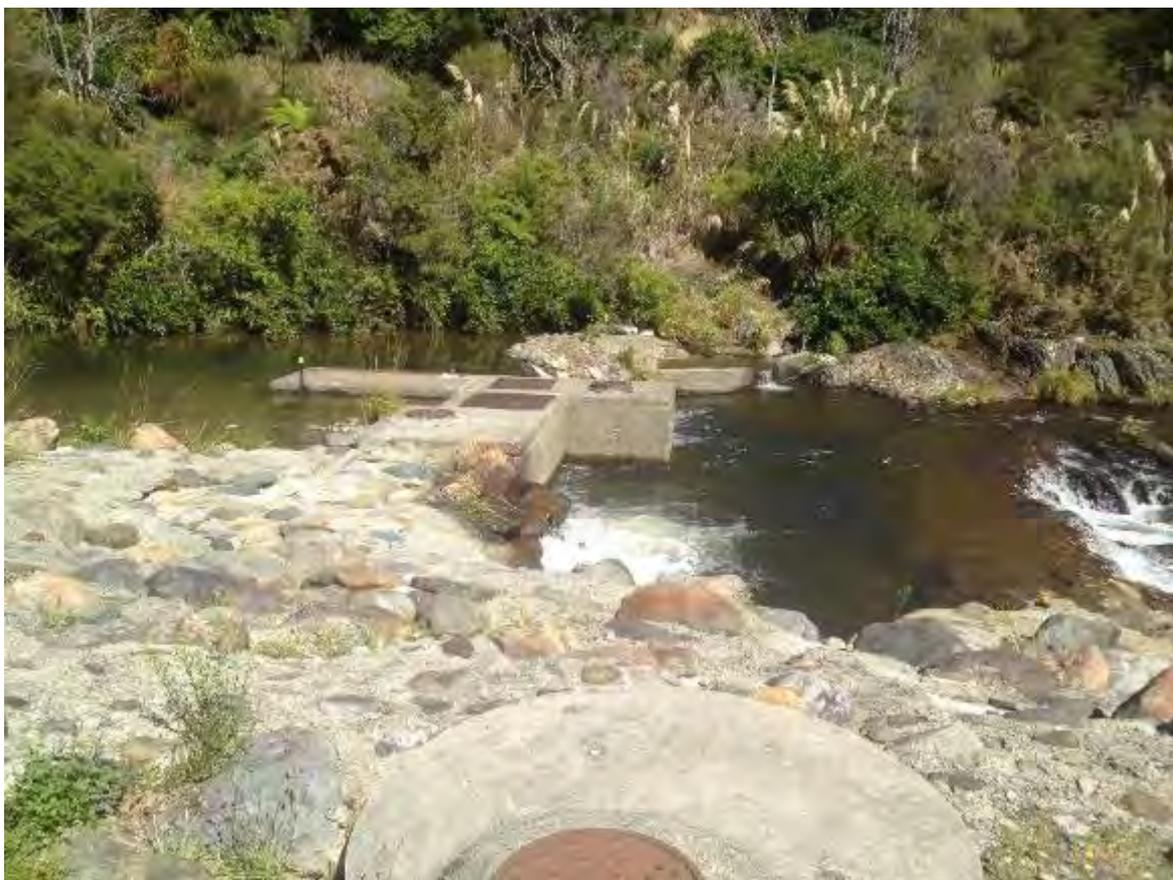
The South Branch Intake was in good condition with no evidence of significant damage, debris or obstruction (Photograph 8.1). However, a strong sulphur smell was evident on approach to the intake and at the intake itself caused by the backfeed water from the reservoir to the stream.

Photograph 8.1 - South branch intake weir.
