## Tahunanui Slump

Monitoring report November 2022 - April 2024

Nelson City Council

Tonkin & Taylor Ltd

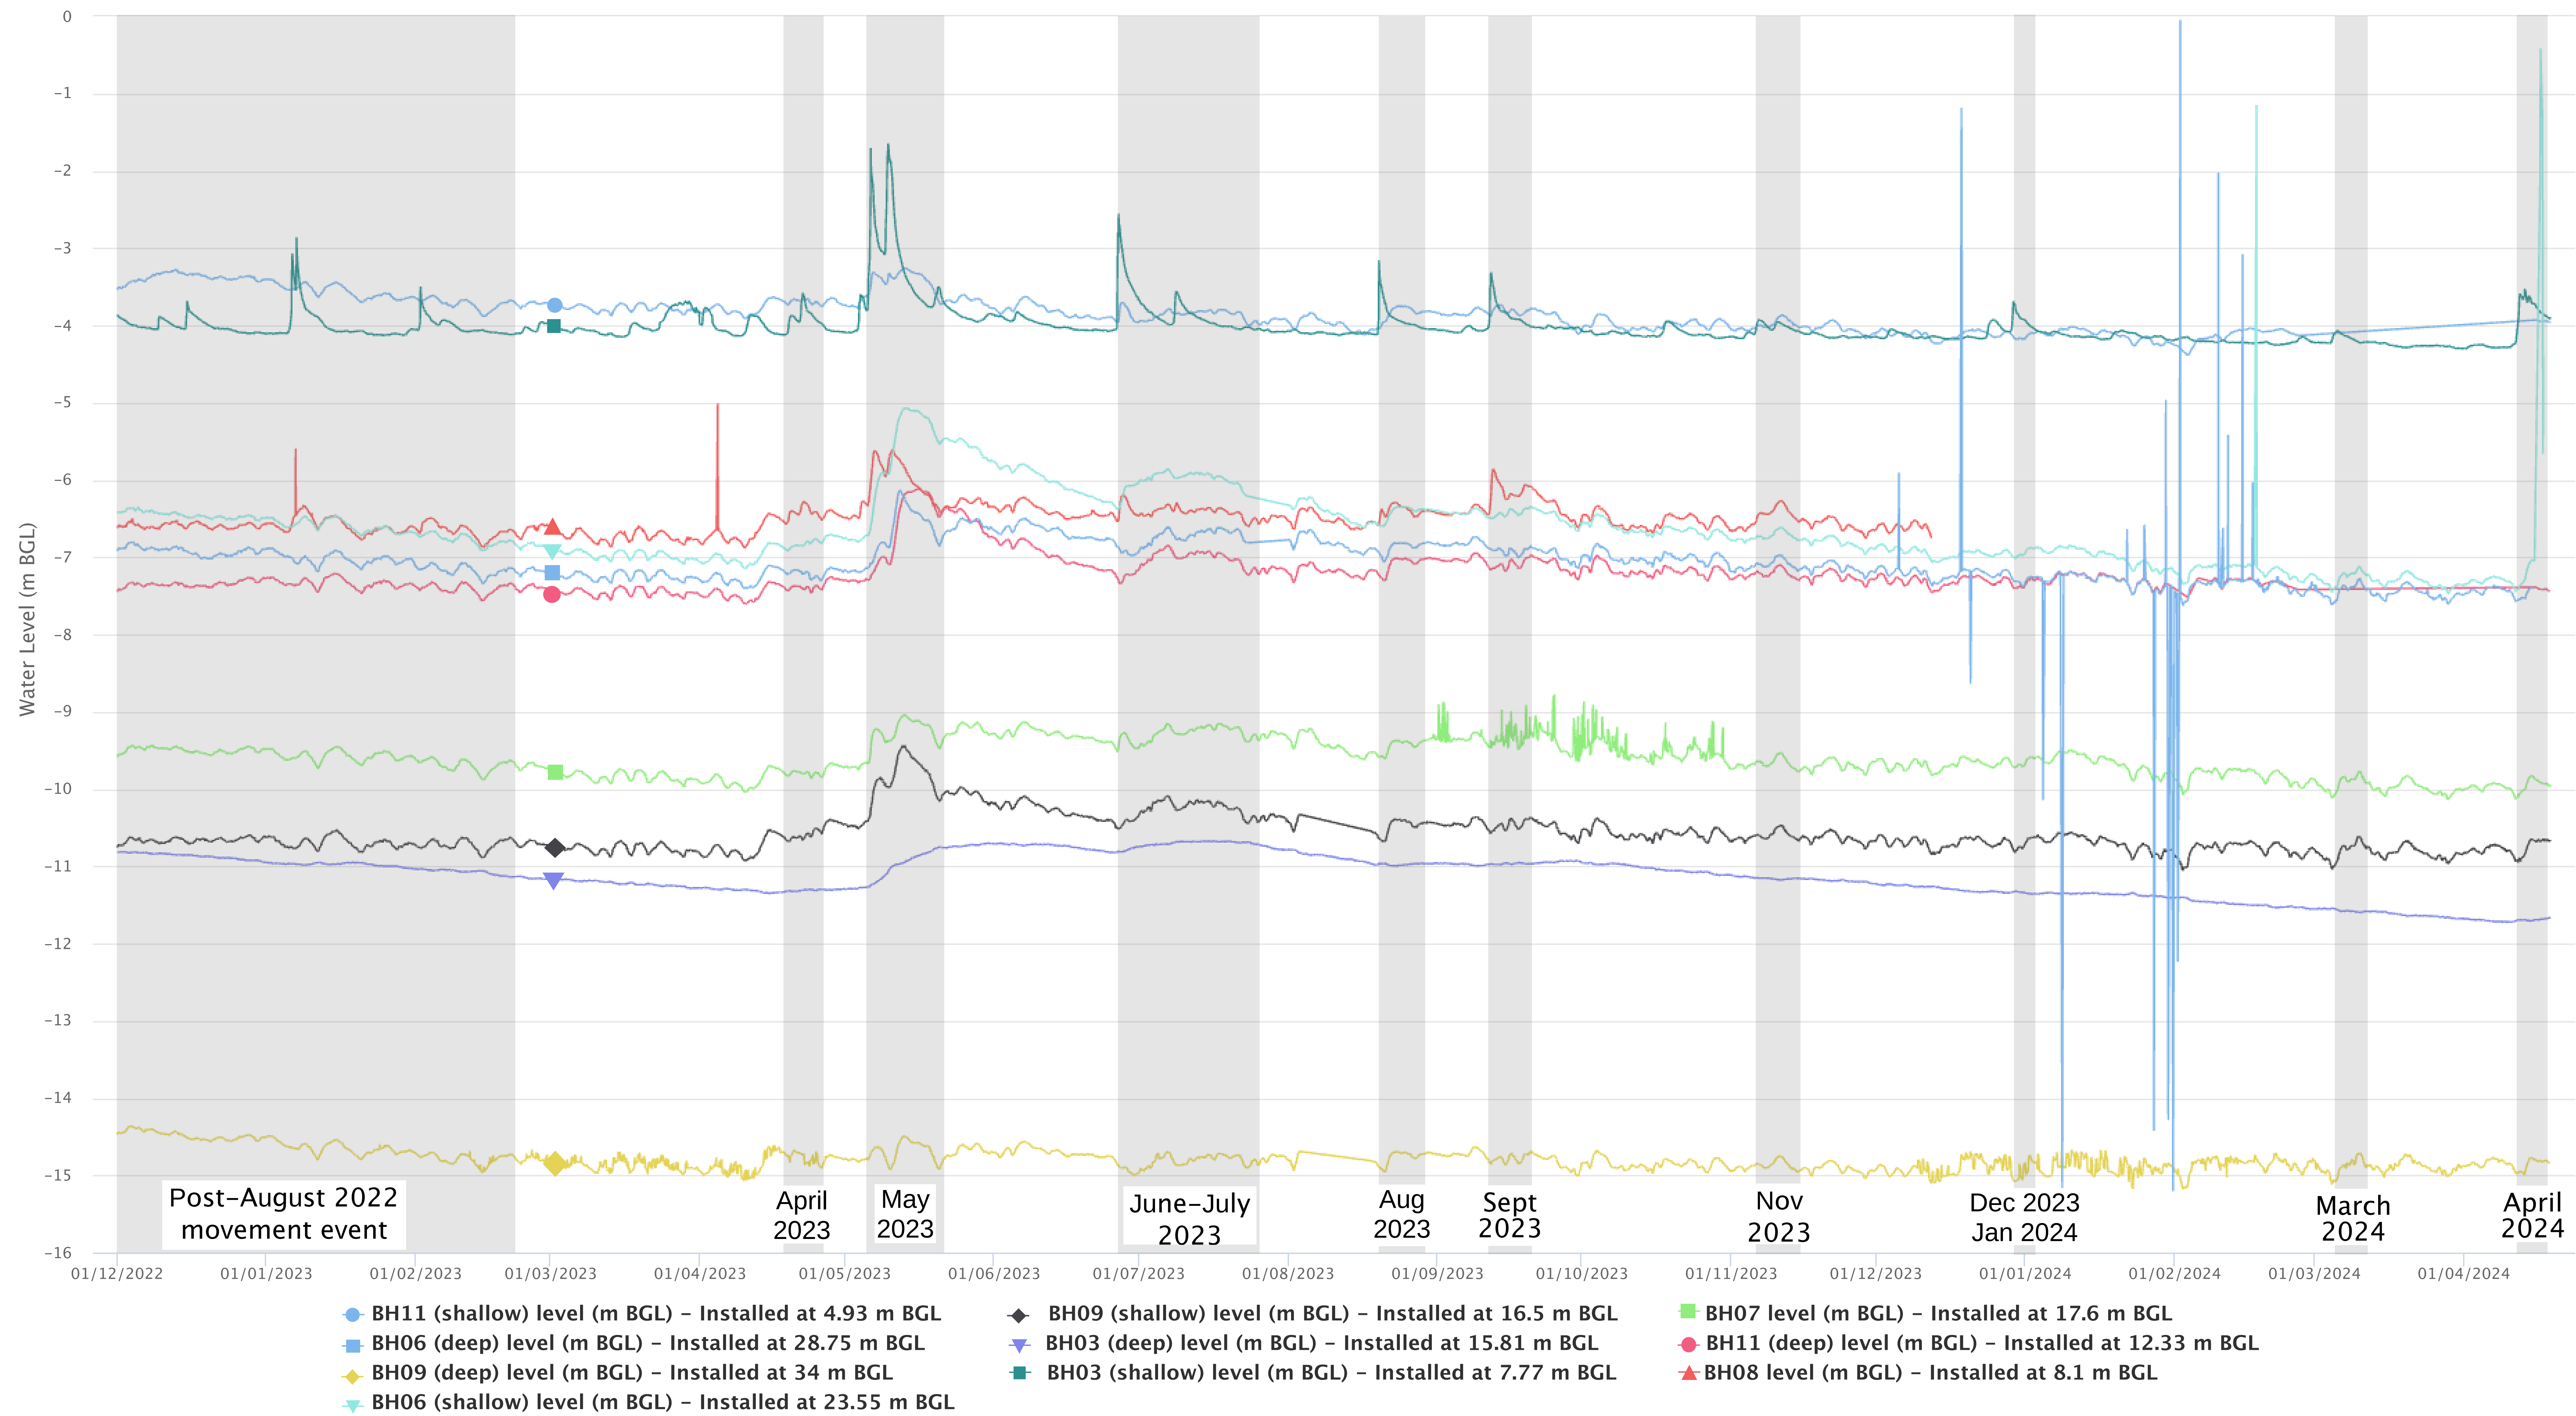
B.1 – All VW piezometers groundwater levels (m bgl)

- Groundwater in BH03 (shallow) shows a significantly more rapid rise following rainfall than all other monitored piezometers. This may indicate that this piezometer is connected to one of the steep tension cracks that have been mapped in this location, are thought to separate different blocks of movement within the TS, and which potentially transmit rainfall infiltration to the slide plane at the surface of sliding of the TS.

- BH03 (shallow) also shows the highest degree of fluctuation of groundwater level of the monitoring period – approximately 2.6 m.
- Groundwater recorded in BH03 (deep) shows a slower and more suppressed response to rainfall events than all other wells containing vibrating wire piezometers. Groundwater recorded in BH09 (deep) installed within bedrock below the base of the deep-seated TS at 34 m bgl shows a significantly lower degree of fluctuation than piezometers installed above the failure surface within the TS – in the order of 0.6 m over the monitoring period.

- Missing data in BH08 in December 2023 relates to damage to the telemetry electronics caused by contractors carrying out repairs to an accessway.

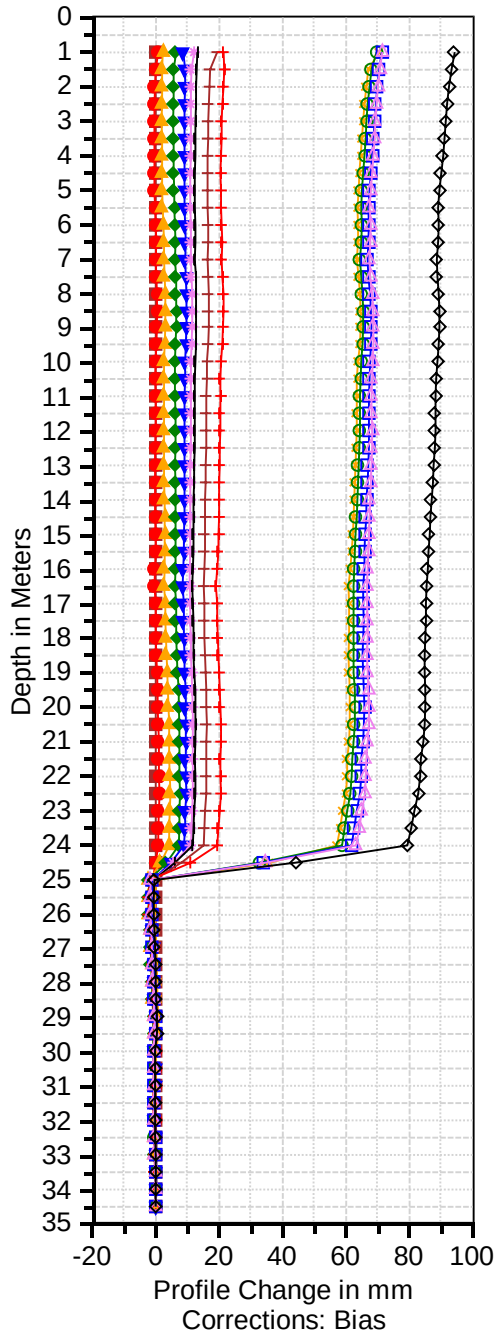
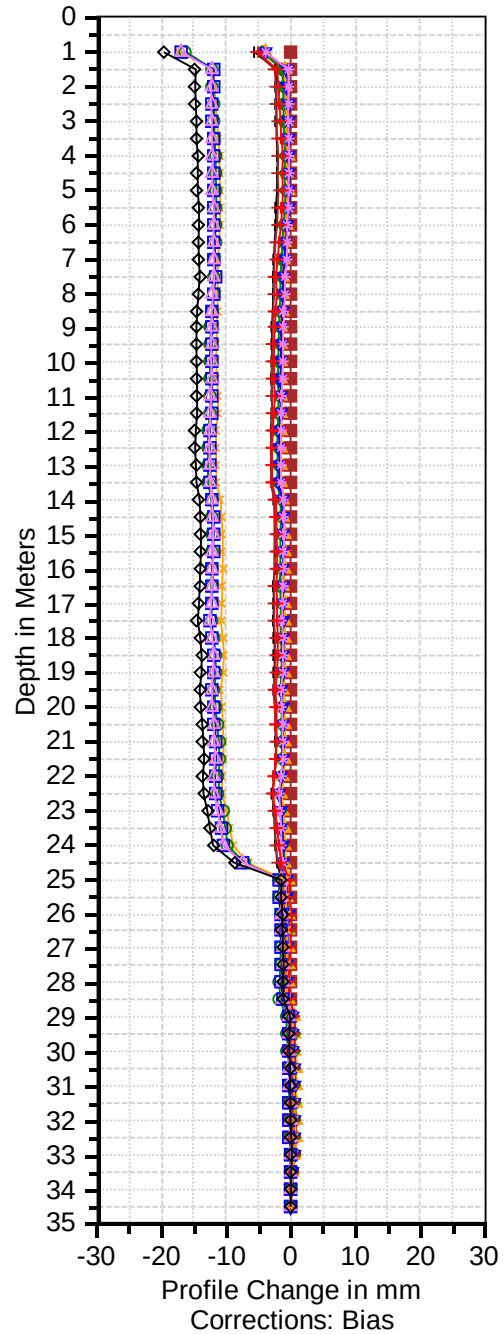
**BH1A A0 = 310°**

- BH1A located in central Grenville Terrace was previously monitored on 15 August 2022, the day prior to the August 2022 storm. However, the instrument could not be read past 23 m depth below ground level (bgl) during the next inclinometer round on 26 August 2022 indicating that further movement had occurred. At the time of failure of the instrument in August 2022, it had recorded a total of approximately 100 mm of displacement at a bearing of 305° between 23 and 24.5 m bgl since it was first installed in January 2012. Over this 10-year period, this equates to an average movement rate of approximately 9.5 mm/yr.

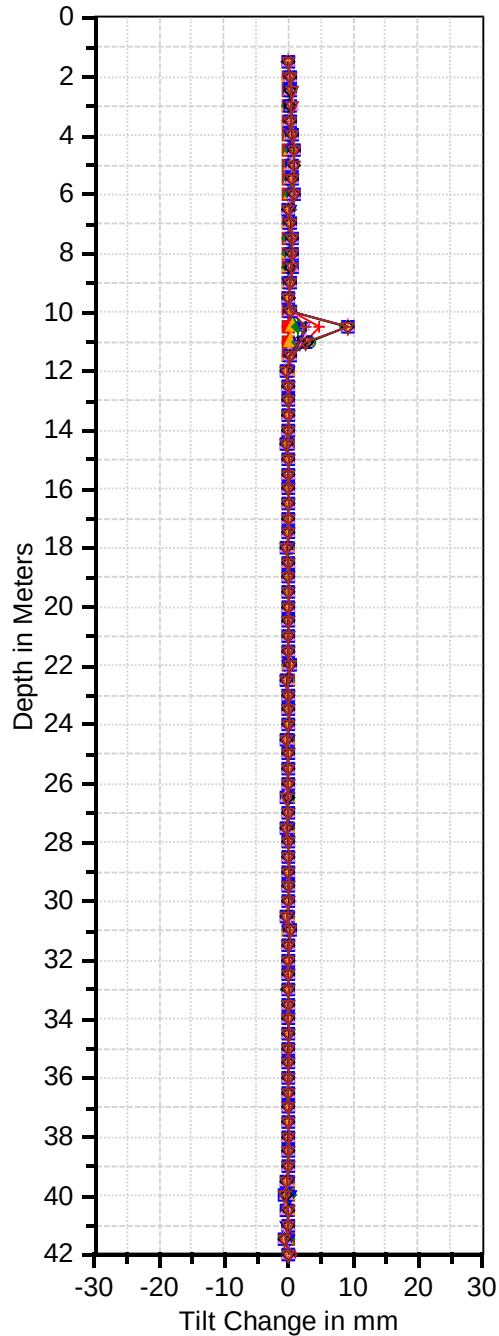
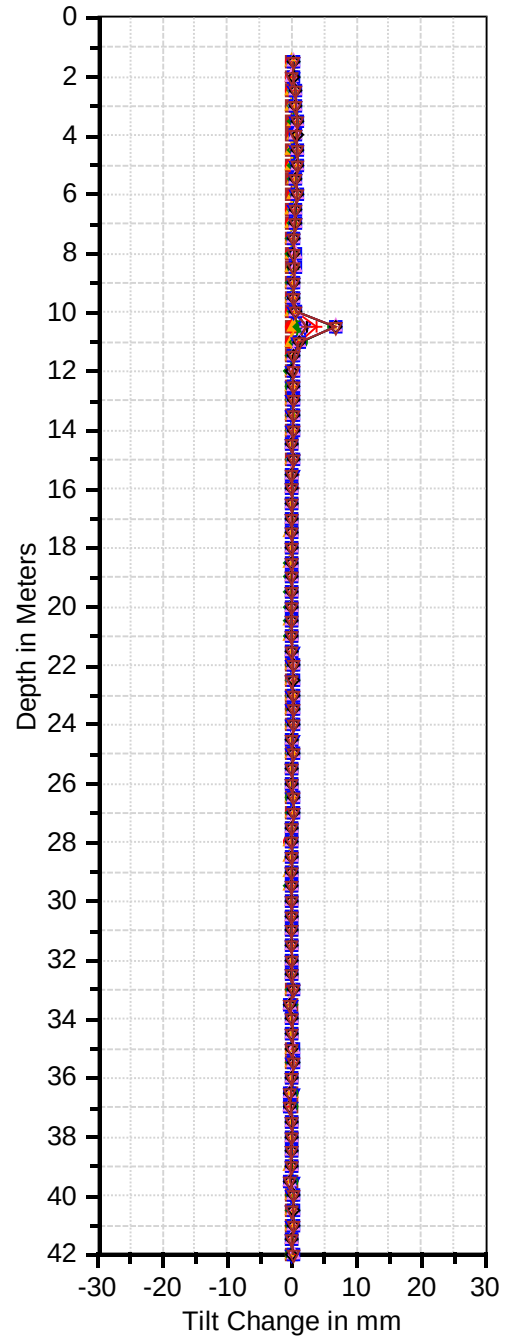
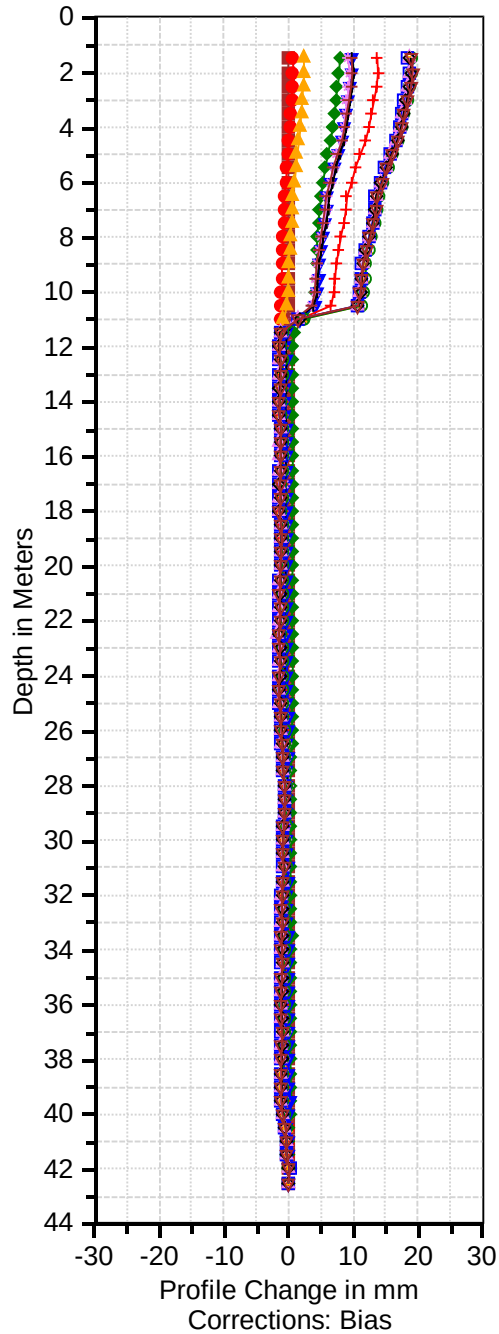
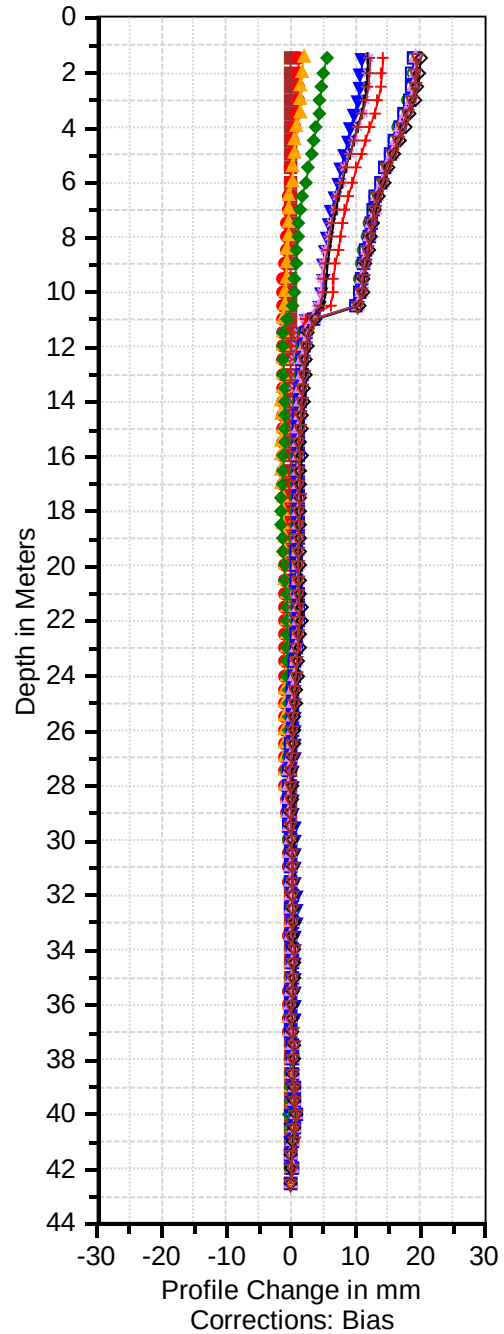
Tahunanui Slump Inclinerometers  
 BH2A - Tilt Change Plots  
 563 Rocks Road, Moana, Nelson (next to Days Track)  
 Baseline reading: 19/03/2012  
 Job number: 1006192.2000.0.0

- BH2A located midway between Grenville Terrace and Rocks Road showed a displacement of approximately 7 mm at a bearing of 345° at 10.5 - 11 m bgl as a result of the August 2022 event (as measured from 15 August – 26 August 2022). The total amount of displacement recorded from installation on 10 March 2012 and the last monitoring round carried out on 30 November 2023 is approximately 20 mm.

- BH2A has not shown movement since the 26 August 2022 monitoring round.

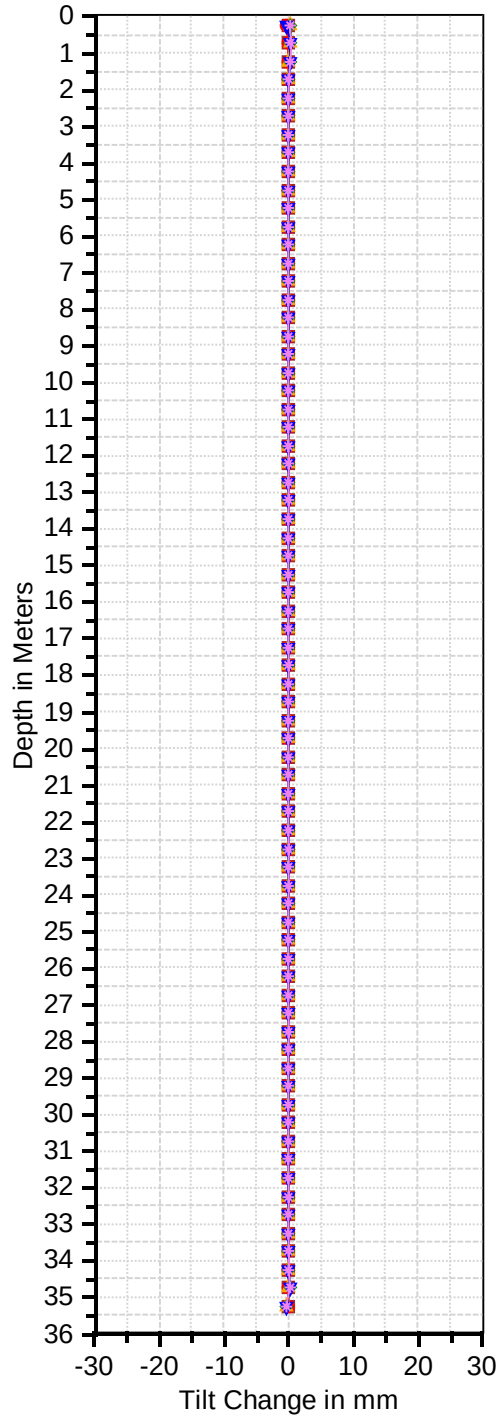
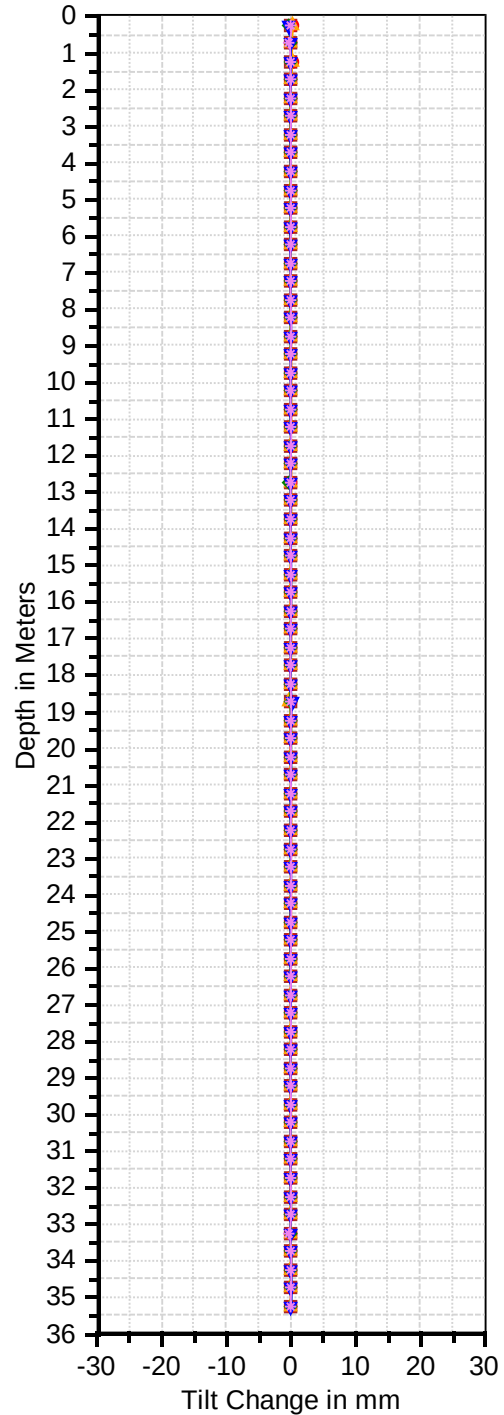
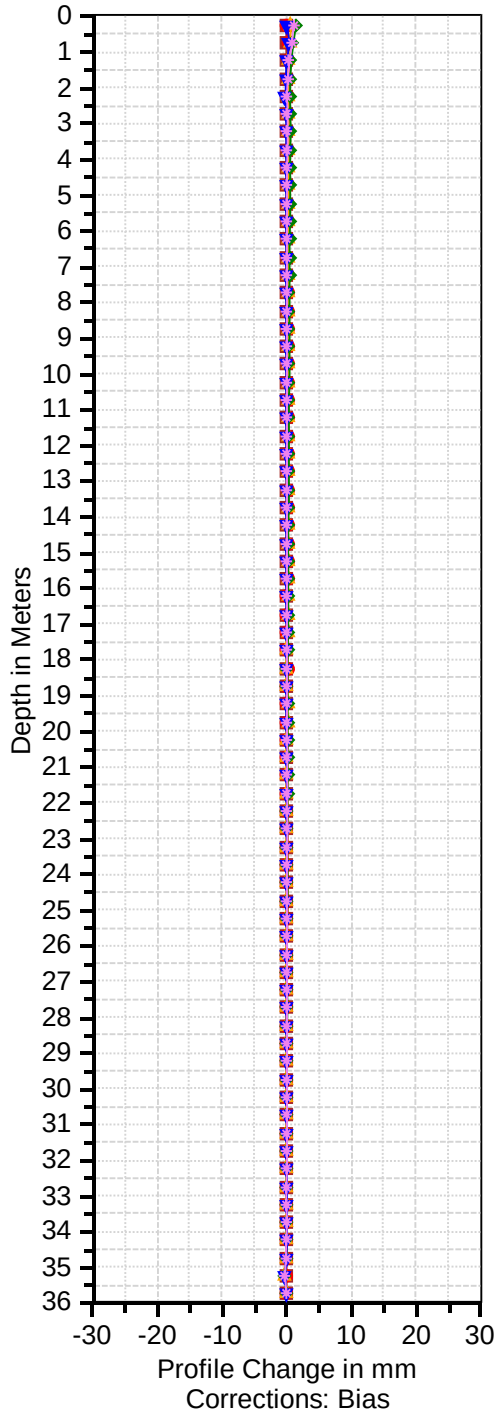
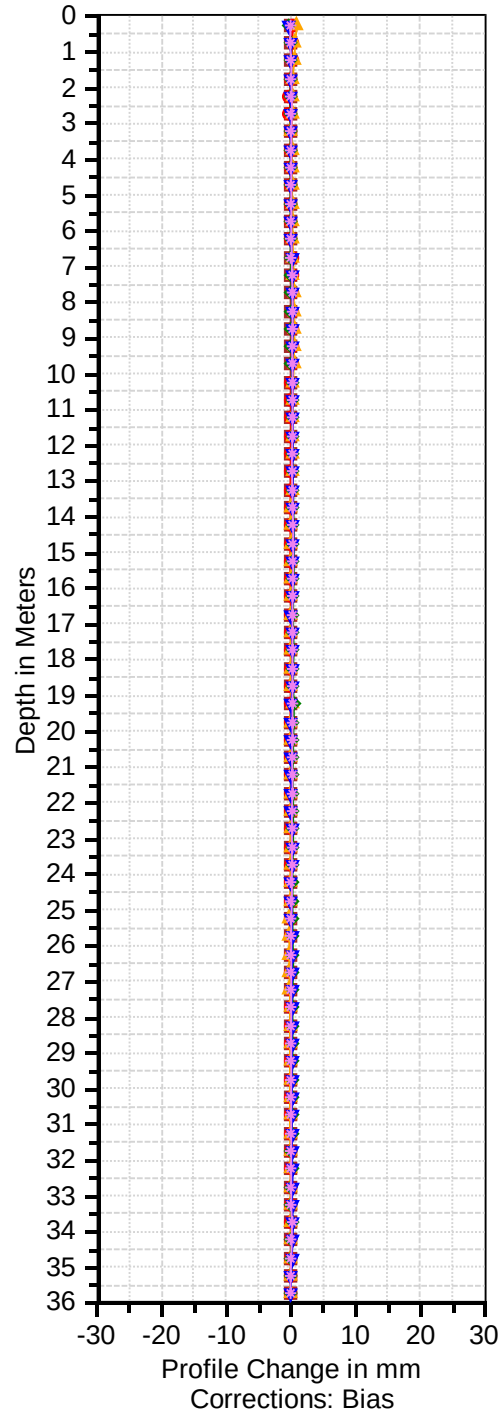
Tahunanui Slump Inclinometers  
BH07 - Tilt Change Plots  
15A Moncrieff Avenue, Britannia Heights, Nelson  
Baseline Reading: 26/10/2022  
Job Number: 1006192.2000.0.0

- No displacement has been recorded in BH07, located downslope of Moncrieff Avenue during any of the five (5) monitoring rounds since its installation on 26 October 2022.

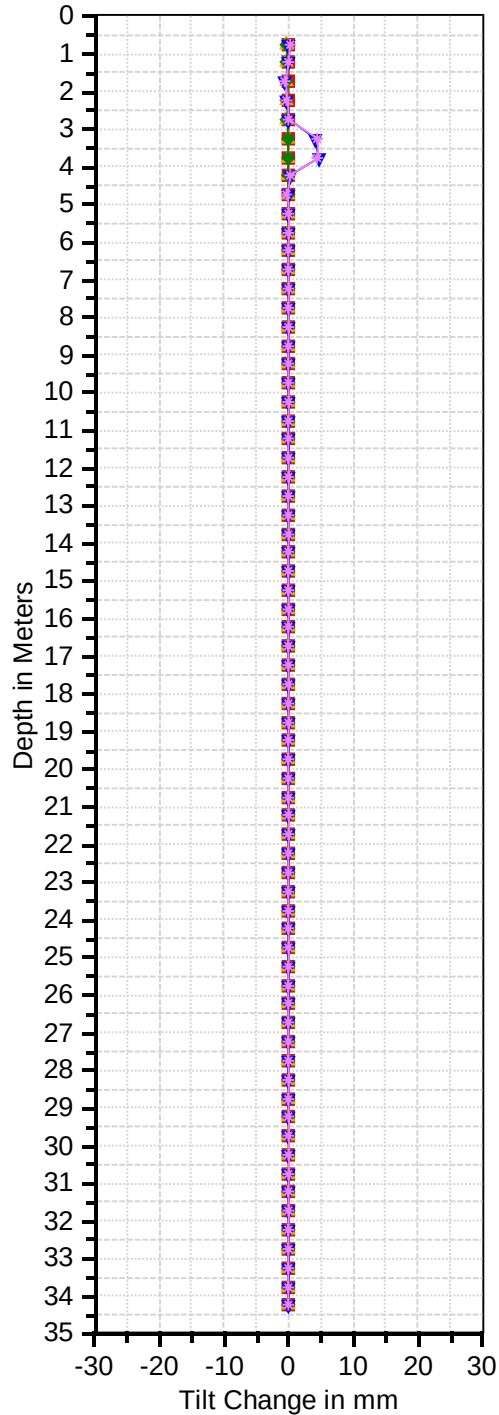
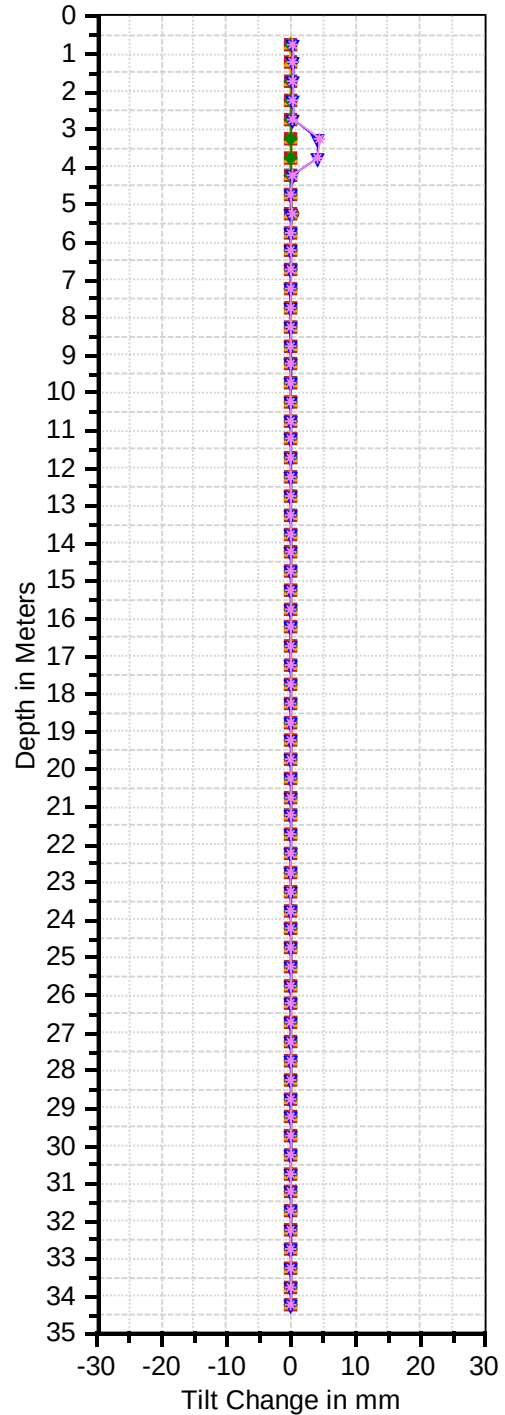
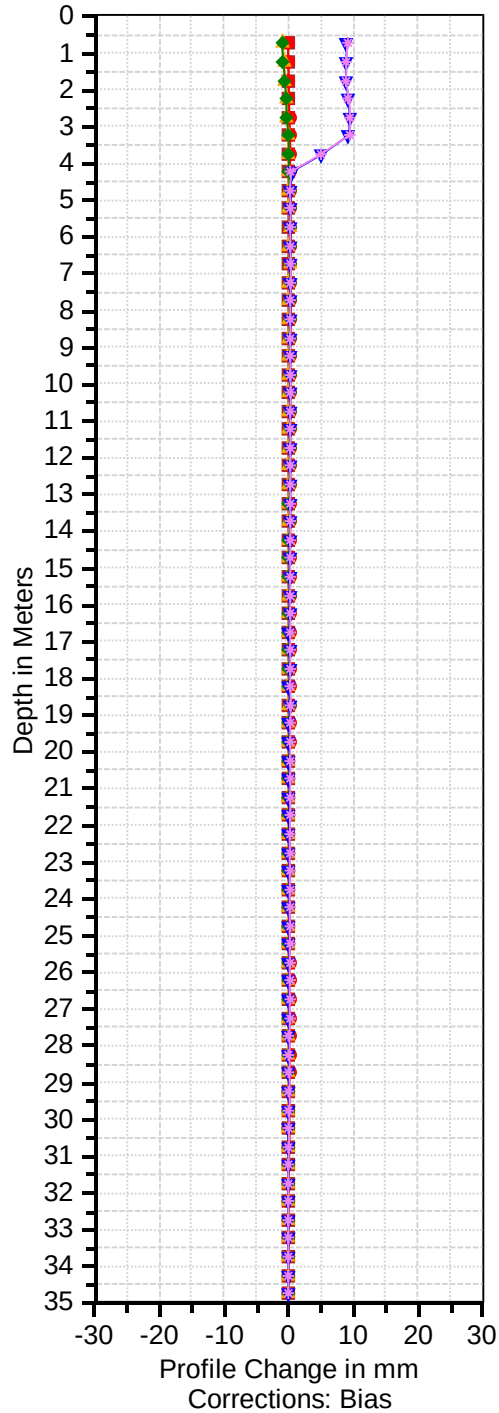
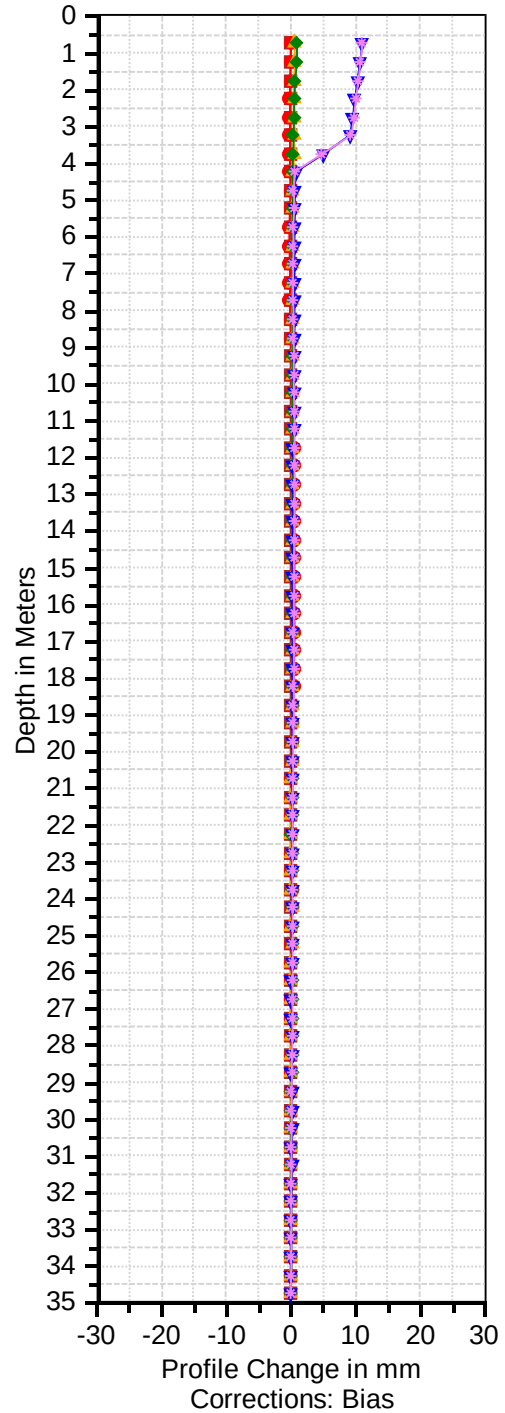
Tahunanui Slump Inclinometers  
 BH08 - Tilt Change Plots  
 33 Grenville Terrace, Moana, Nelson (on driveway)  
 Baseline Read: 27/10/2022  
 Job Number: 1006192.2000.0.0

- In BH08, located at the northern end of Grenville Terrace, within the Northern Gully, approximately 14 mm displacement at approximately 3.5-4.0 m bgl towards a bearing of 345° was recorded between the 12 April 2023 and 12 August 2023 monitoring rounds.

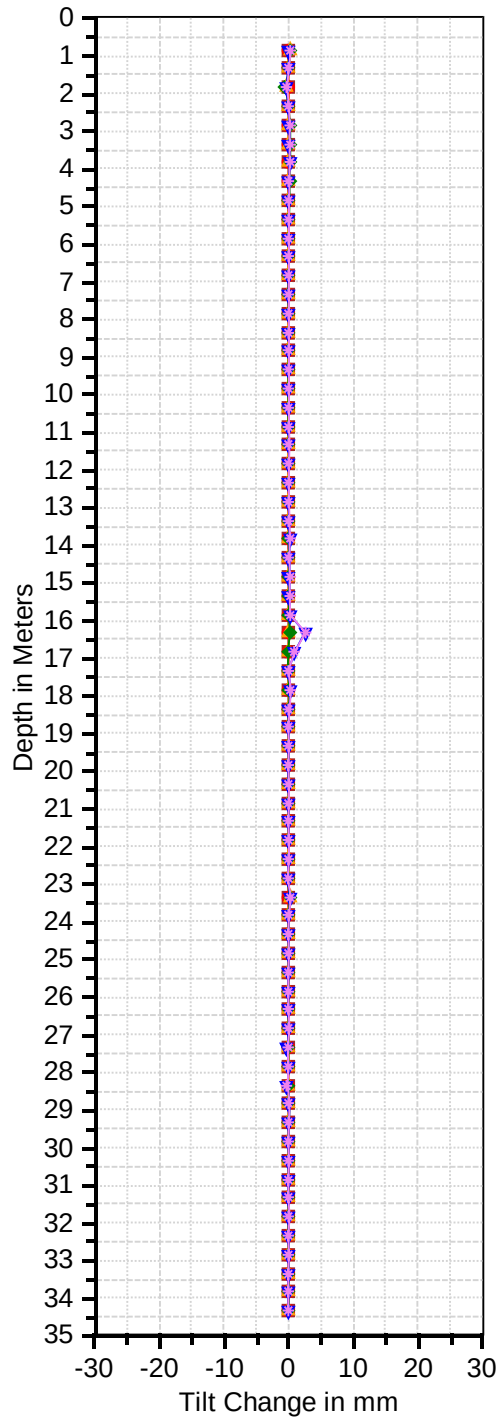
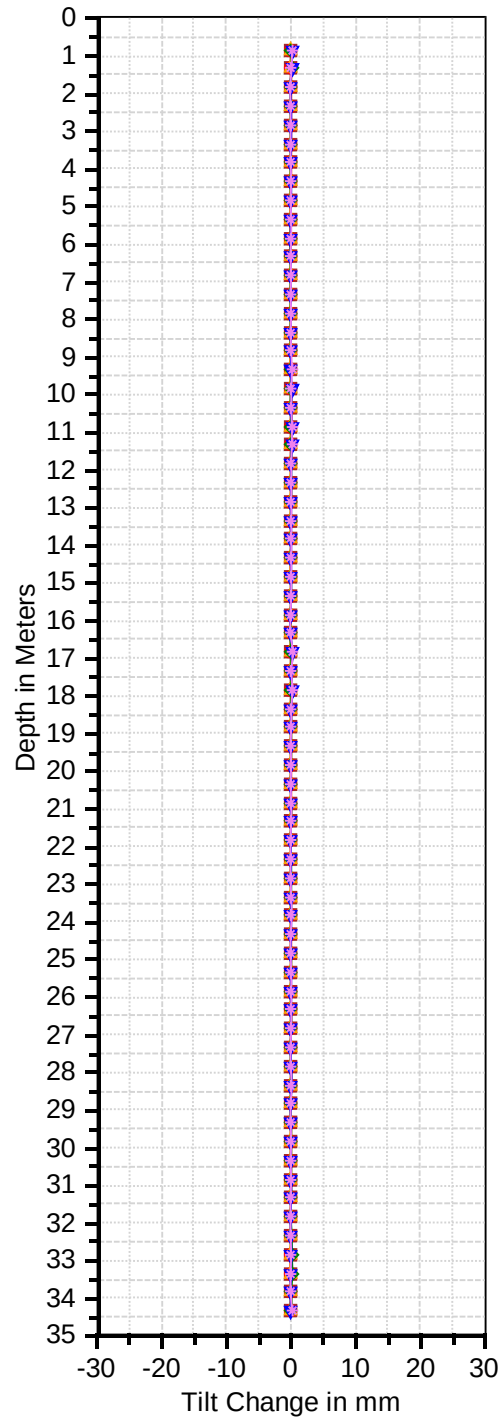
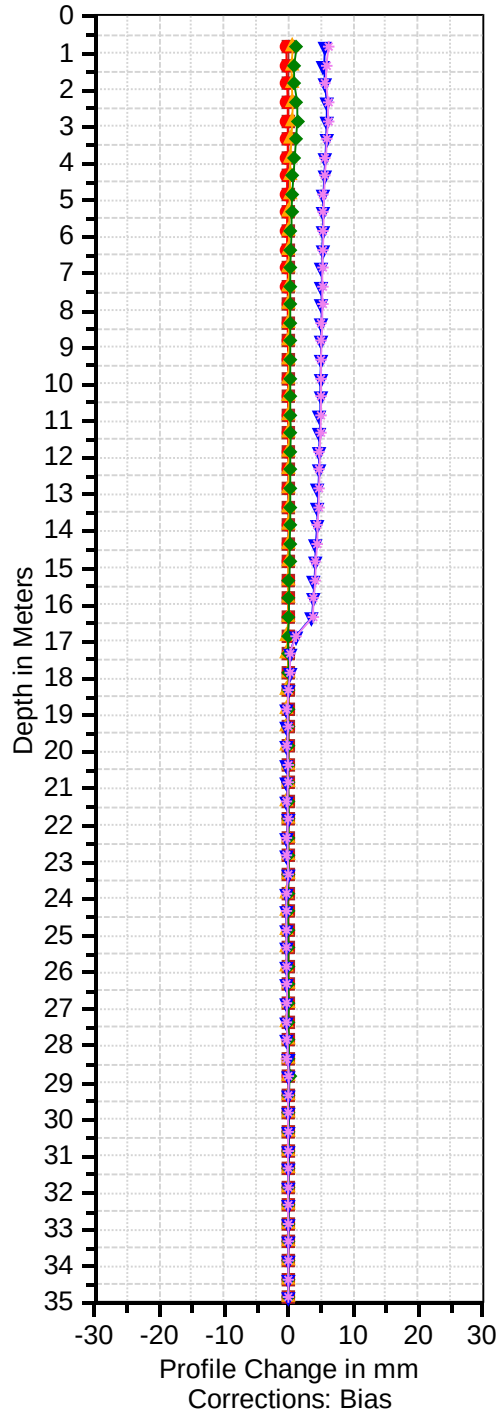
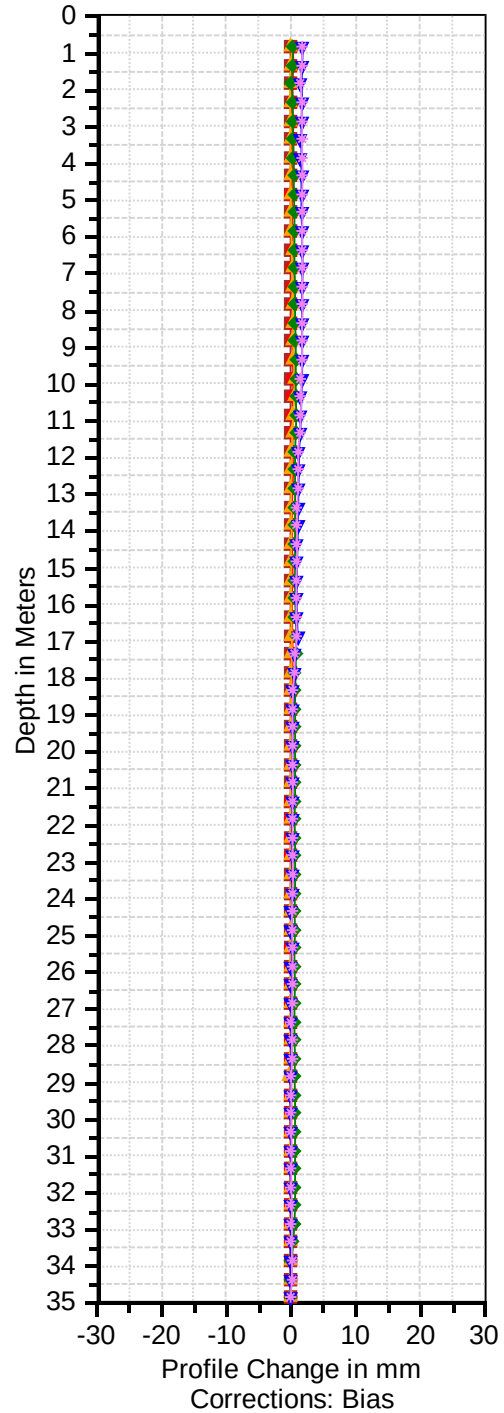
Tahunanui Slump Inclinometers  
 BH09 - Tilt Change Plots  
 7 Grenville Terrace, Moana, Nelson (on the road)  
 Base Read: 27/10/2022  
 Job Number: 1006192.2000.0.0

- In BH09, at the southern end of Grenville Terrace approximately 5 mm of displacement at approximately 16.3 m bgl towards a bearing of 305° was recorded between the 12 April 2023 and 12 August 2023 monitoring rounds.

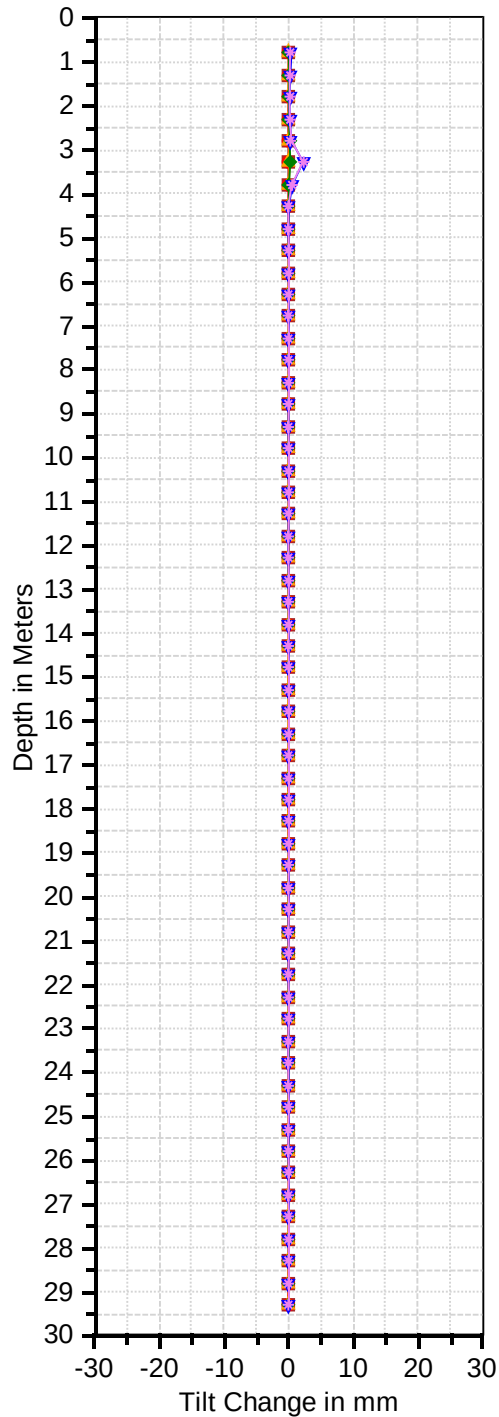
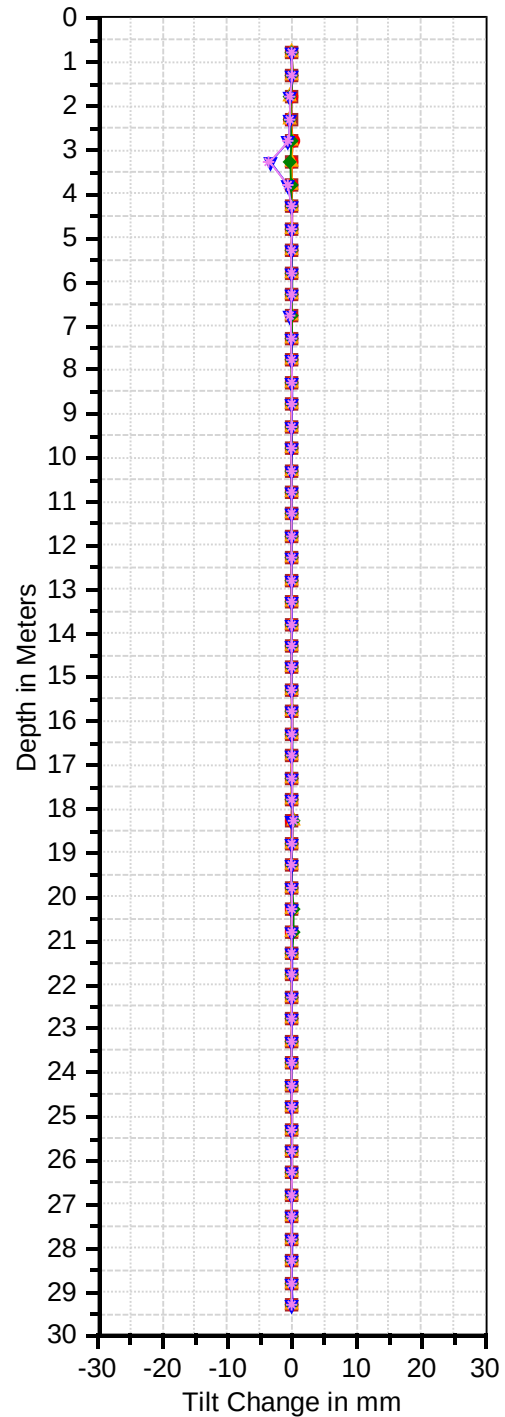
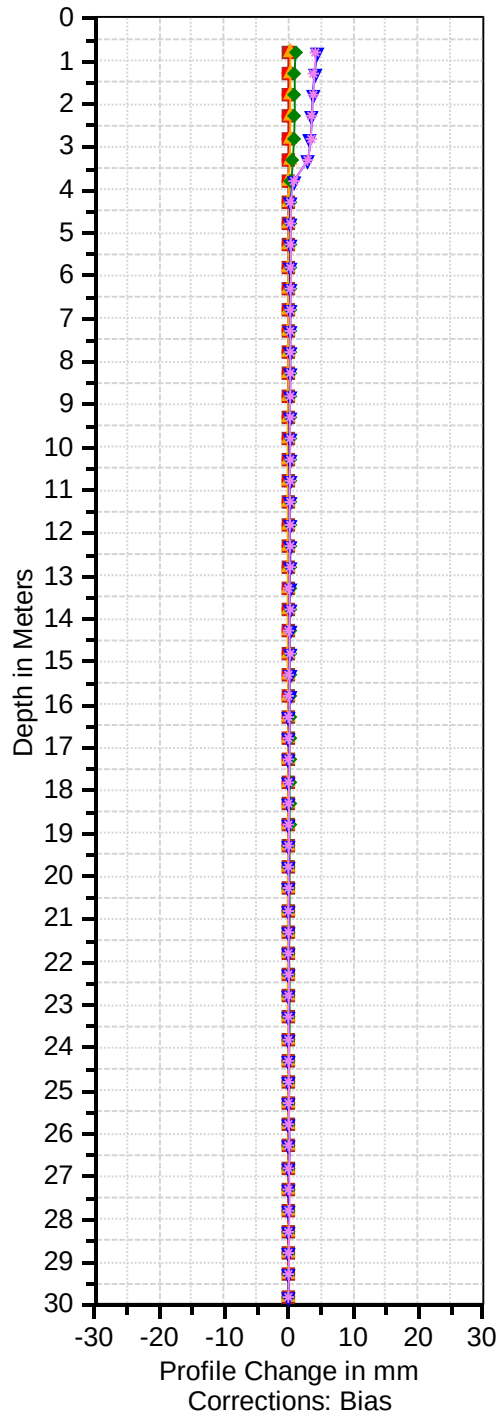
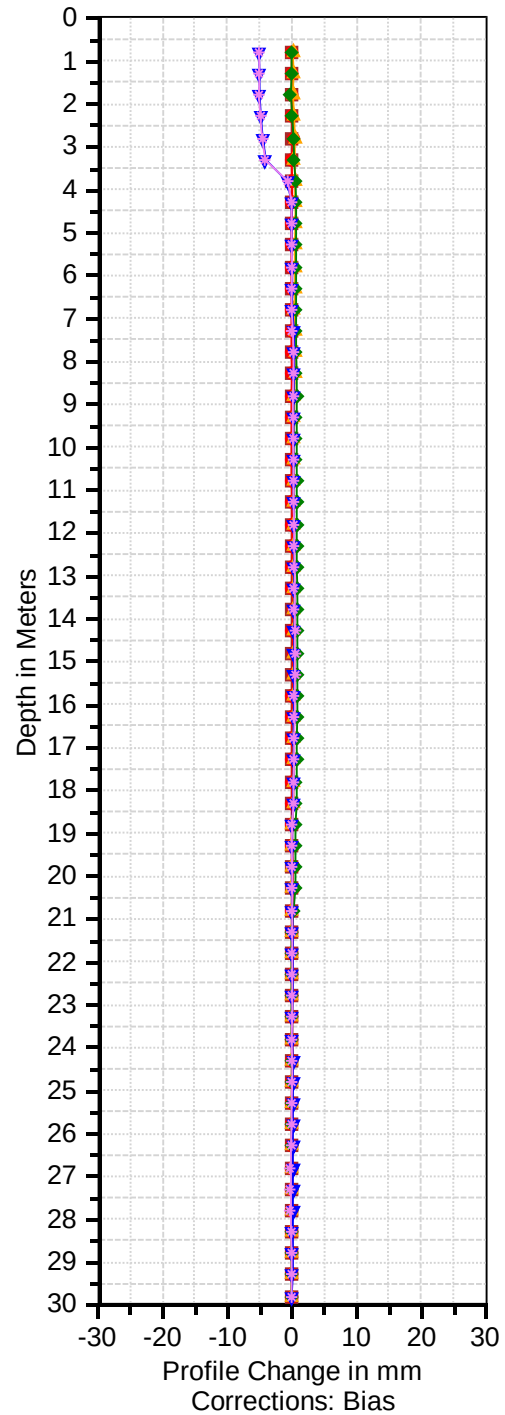
Tahunanui Slump Inclinerometers  
 BH11 - Tilt Change Plots  
 3 Grenville Terrace, Moana, Nelson (on lawn in backyard)  
 Base Read: 26/10/2022  
 Job Number: 1006192.0000.0.0

- In BH11, downslope of the southern end of Grenville Terrace approximately 5 mm displacement towards a bearing of 310° was recorded at approximately 3.3 m depth bgl between the 12 April 2022 and 12 August 2023 monitoring rounds.
