## Tahunanui Slump

Monitoring report November 2022 - April 2024

Nelson City Council

Tonkin & Taylor Ltd

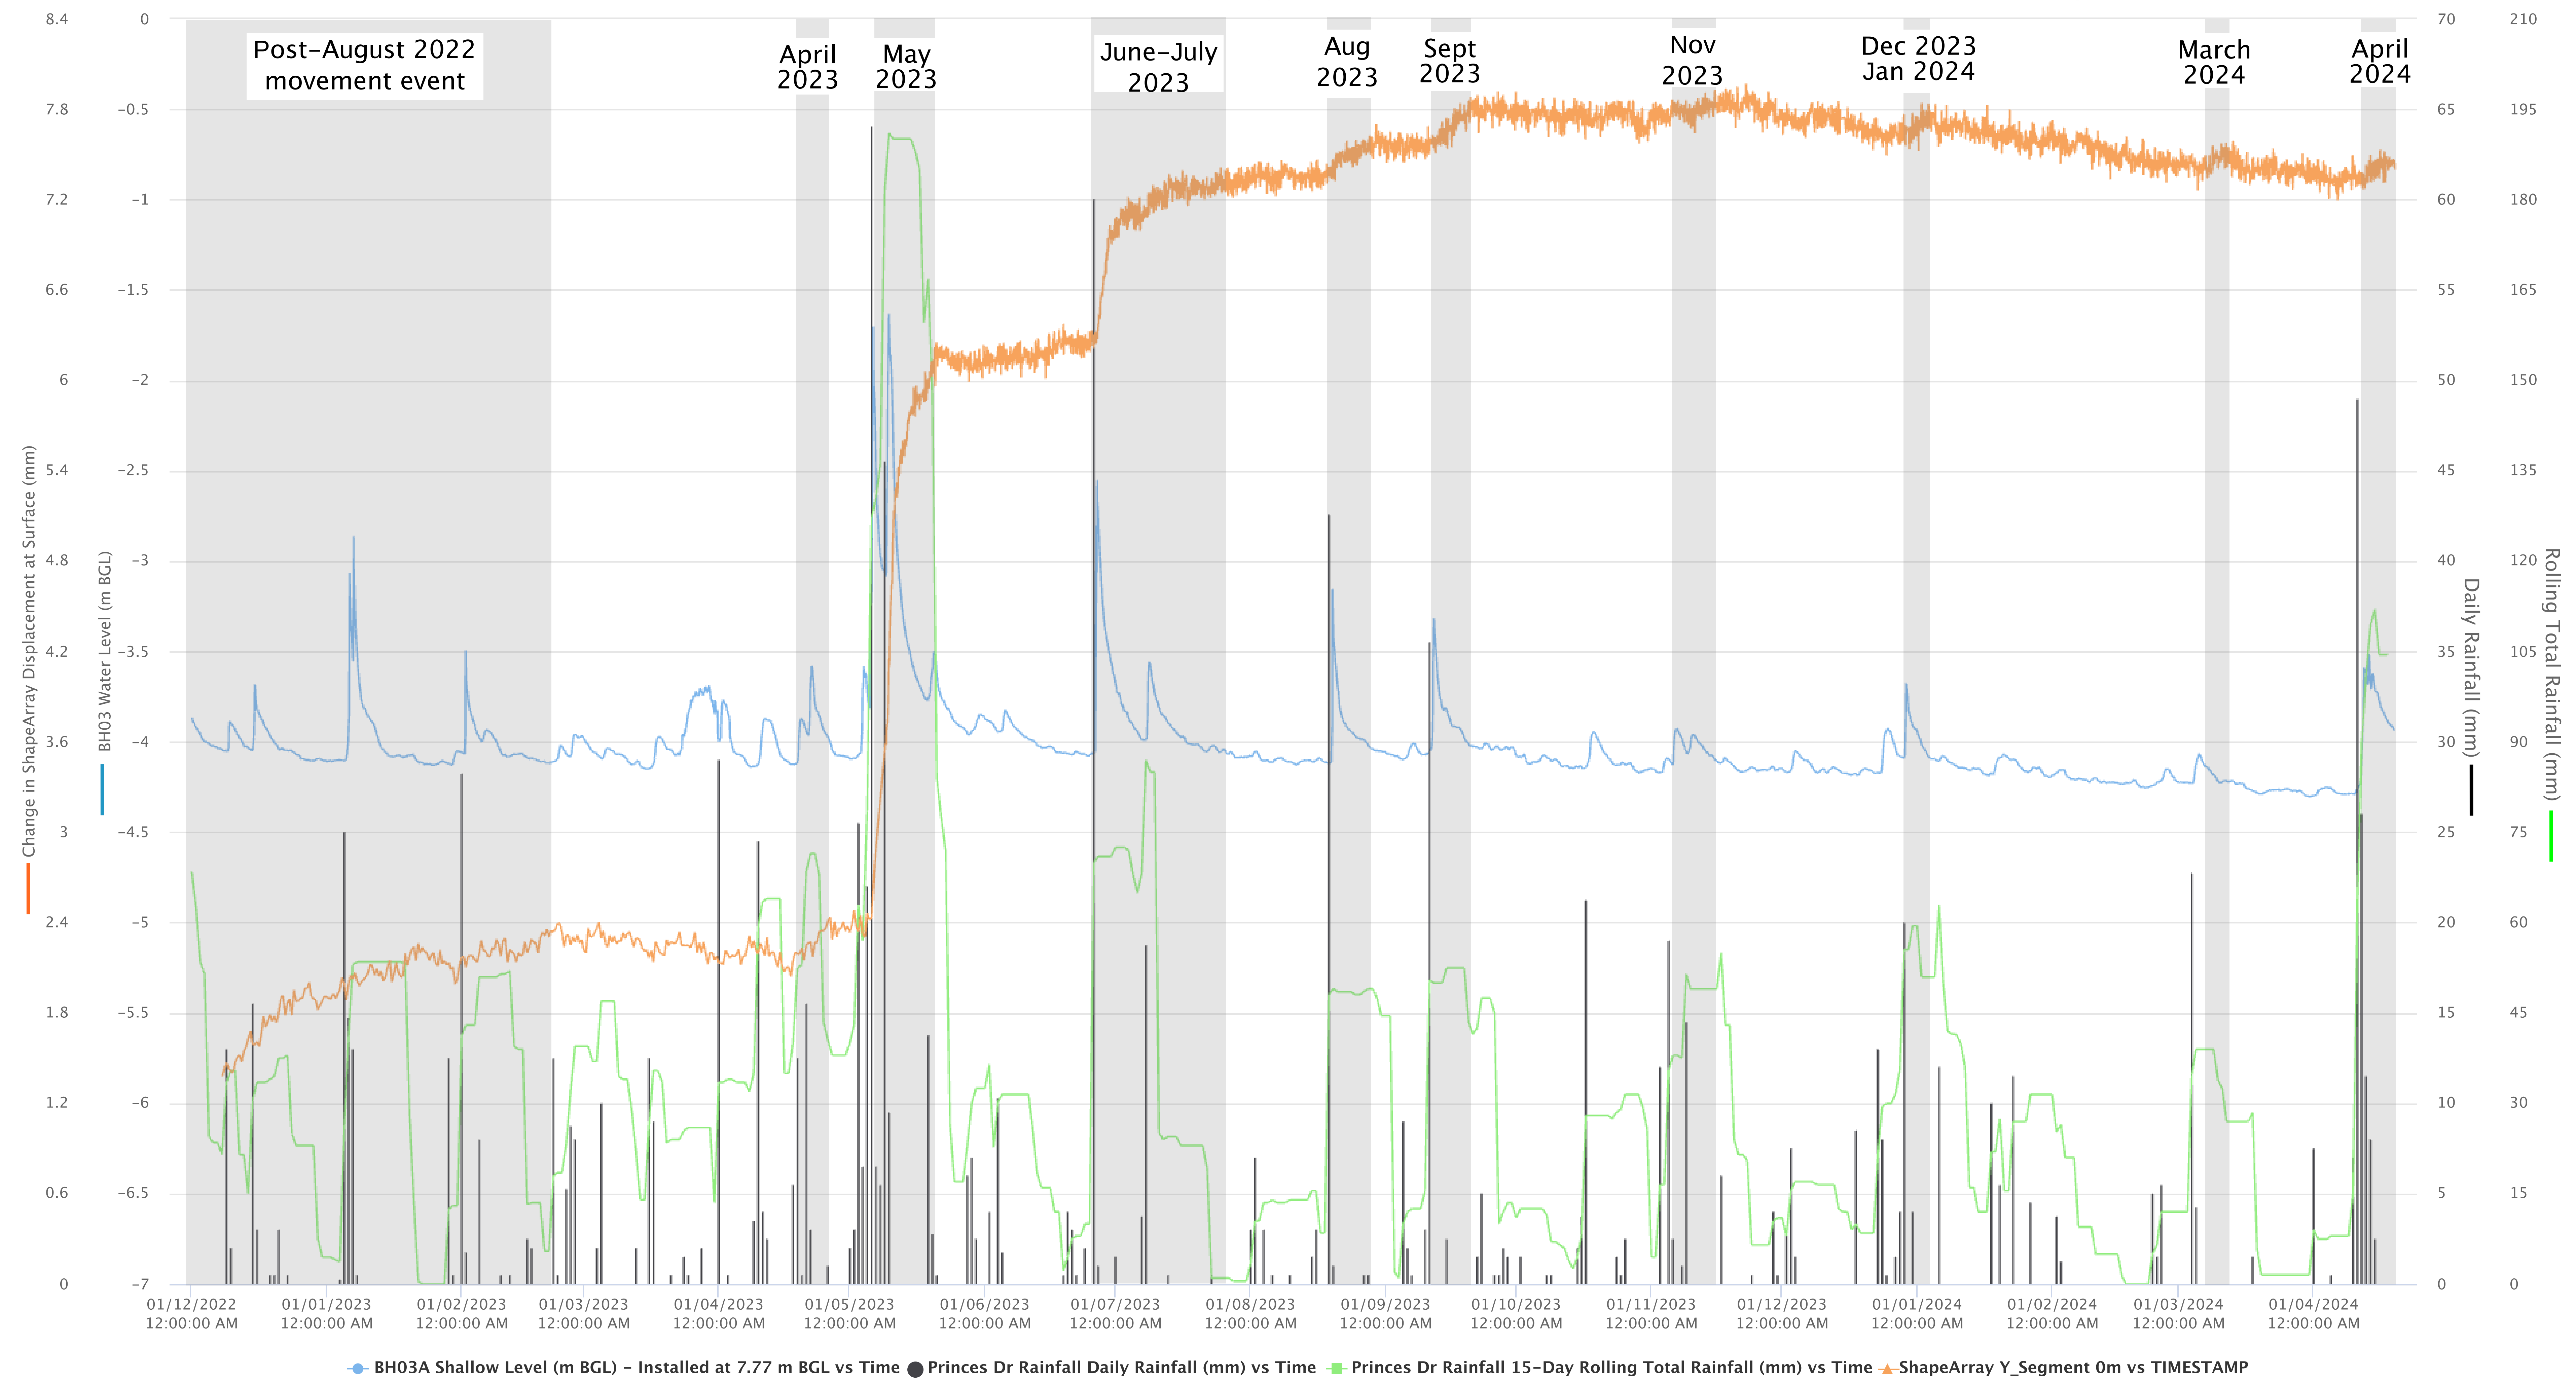
B.7 – ShapeAccelArray Y-Axis cumulative surface displacement (308 degrees) vs. daily/15-day cumulative rainfall and BH03 (shallow) groundwater level

The data to date indicates that displacements measured in the SAA show a correlation with groundwater levels in BH03 (shallow) and the 15-day antecedent rainfall totals at Princes Drive weather station.
