REPORT NO. 2601

**FISH PASSAGE ASSESSMENT OF THE MAITAI  
RIVER NORTH BRANCH DAM AND SOUTH  
BRANCH WEIR**

Prepared for Nelson City Council

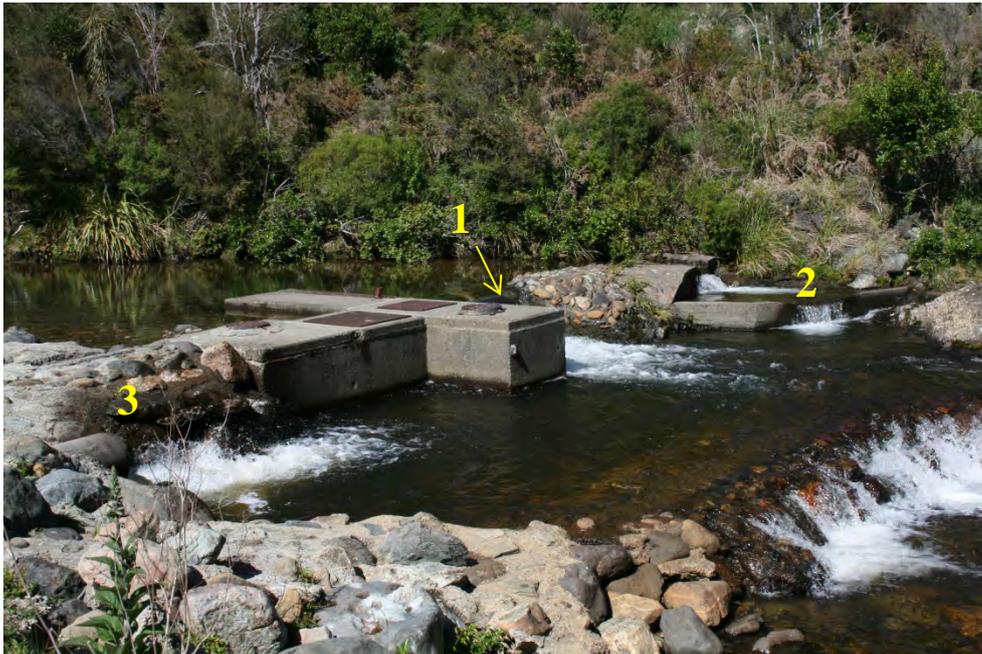
Figure 2. The Maitai River South Branch weir has a central intake screen (1), an existing salmonid fish pass (2) and the back feed discharge (3).

The existing fish pass was installed in the early 1980s by the Nelson Acclimatisation Society for the purpose of providing fish passage past the weir for trout (pers. comm. Lawson Davey [Fish & Game] and Alex Miller [NCC]). The presence of trout upstream of the weir suggests that the fish pass is successful for salmonids. However, passage past the weir for non-jumping fish species (see Table 1 for definition), such as kōaro, bully species and eels is likely to be compromised.

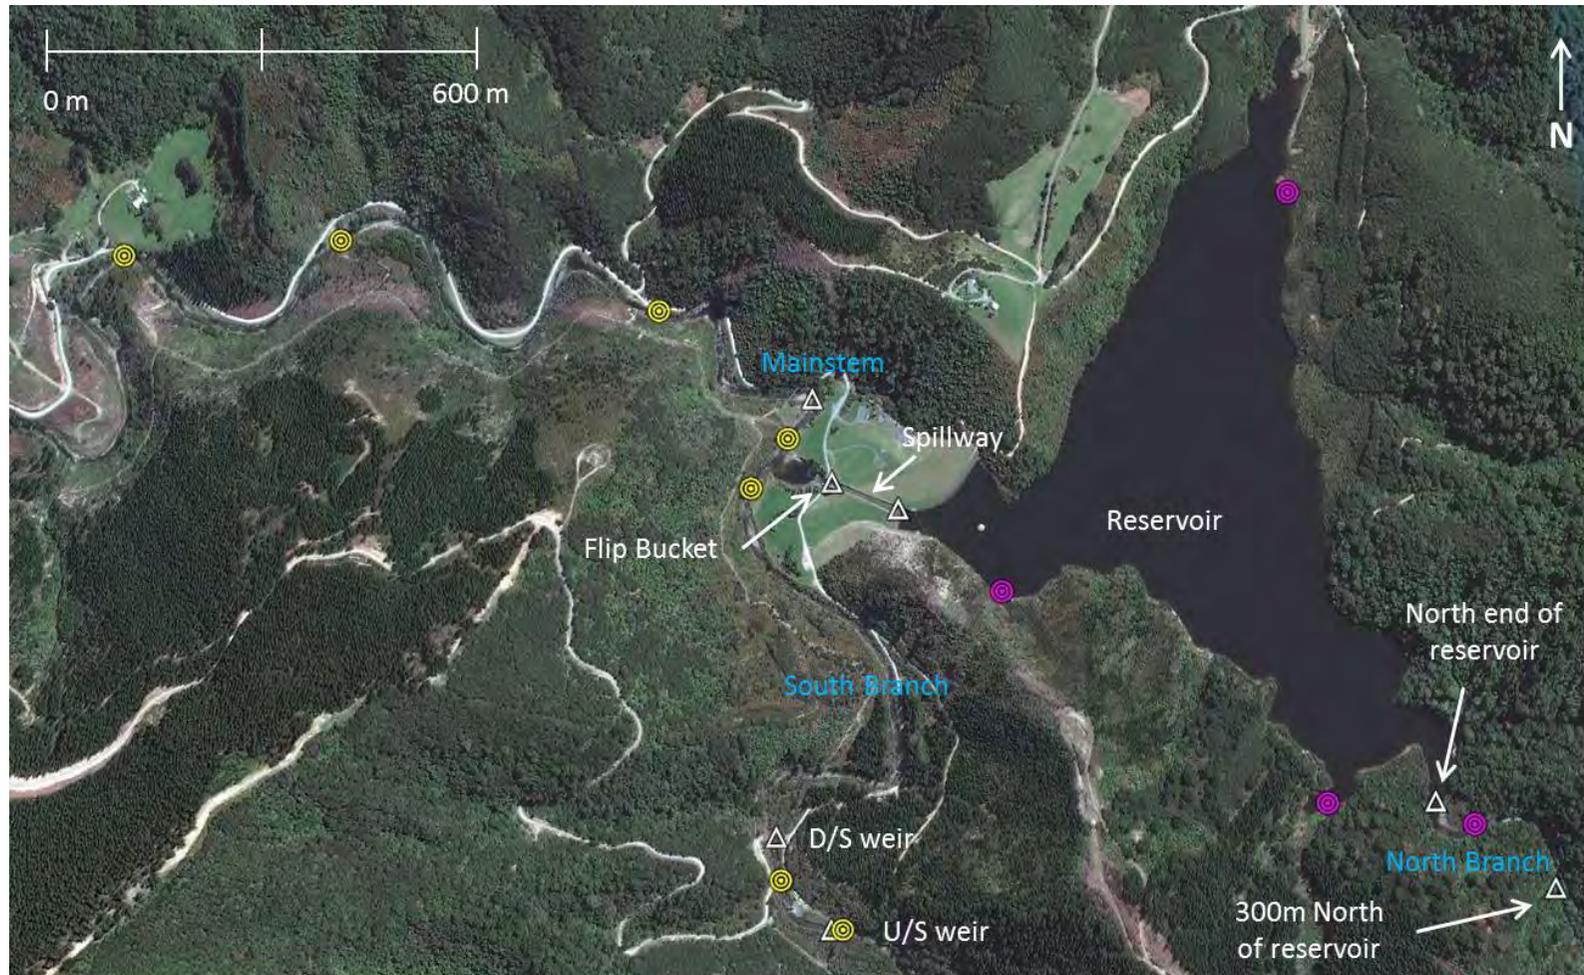
Figure 4. Freshwater fish sampling sites in the Maitai River Main stem, South and North branches that were surveyed as part of the summer 2013 / 14 fish passage assessment (spotlighting; seven sites; white triangle), Allen *et al.* 2014 (electric-fishing; seven sites; yellow circle) and Kelly and Shearer 2014 (trapping or electric-fishing; four sites; purple circle).

Trapping was conducted by Kelly and Shearer (2013) in April 2013 at three sites in the Maitai Dam reservoir (Figure 4). This included the setting of two lines of 10 Gee-minnow traps (mesh size ~ 5 mm) that were deployed overnight in April 2013. The lines were perpendicular to the shoreline and extended over a distance of 50 m (Kelly & Shearer 2013). In addition, three 4 m fyke-nets were also deployed at each of the three reservoir sites. Fish captured were identified, counted and measured.

active fish (such as kōaro and eel species) and complemented the electric-fishing of riffle areas and the netting conducted in the reservoir. The spotlighting method is most effective in pool and run habitats where the calm water surface allows good visibility into the water. These night-time spotlight surveys did not involve fish capture and were conducted on five occasions; 14 November 2013, 3 December 2013, 23 January 2014, 5 and 21 February 2014 at four key locations (Figure 4):

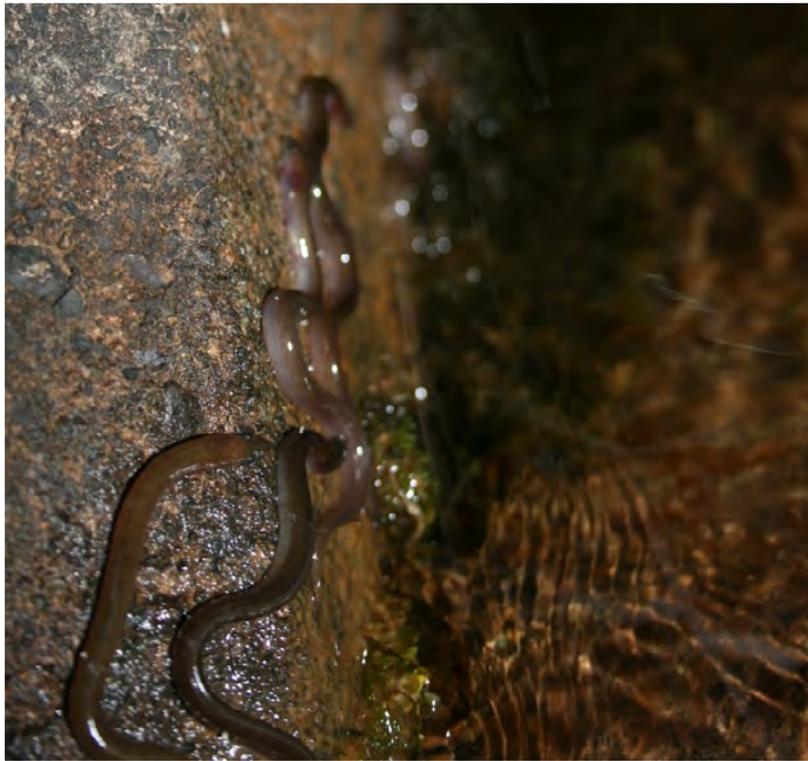
During the summer 2013 / 14 spotlighting surveys, 55 elver were observed attempting to climb the spillway (Figure 5). However, none were seen to successfully pass the entire spillway length and make it into the reservoir during any of the 2-hour surveys, suggesting only a limited amount of eel recruitment past the dam. No fish species, other than elver, were seen attempting to climb the North Branch spillway and none of the surveys found kōaro present in the main stem downstream of the dam. Records of kōaro in the North Branch, however, suggest that fish are able to overcome the dam, albeit in low numbers, or that this species has established a land-locked population using the reservoir, although the low densities observed make this seem unlikely (but this is based on sparse sampling efforts).

Figure 5. Elver climbing their way up a wetted margin past the apron of the Maitai Dam during low flow in the summer of 2013 / 14.

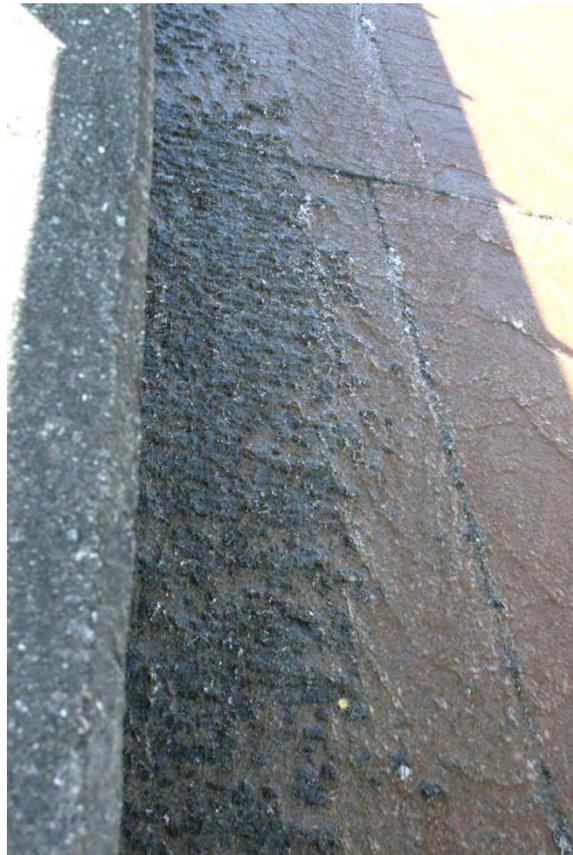
The spillway surface is concrete, with the true right of the chute partly covered by moss due to almost continuous shading (Figure 7). The established moss assists upstream fish passage as it slows down water velocities on the chute, creating a water velocity refuge, allowing fish to rest and potentially improving traction for climbing species. This, however, is only expected to be the case during relatively low flows, where water velocities are not excessive, so eel and kōaro are able to 'cling' onto the substrate. During high-flow events, the moss's ability to act as a water velocity refuge will be limited and upstream migration will be compromised.

Figure 7. Established moss on the true-right of the Maitai Dam spillway assists fish passage during low flows.

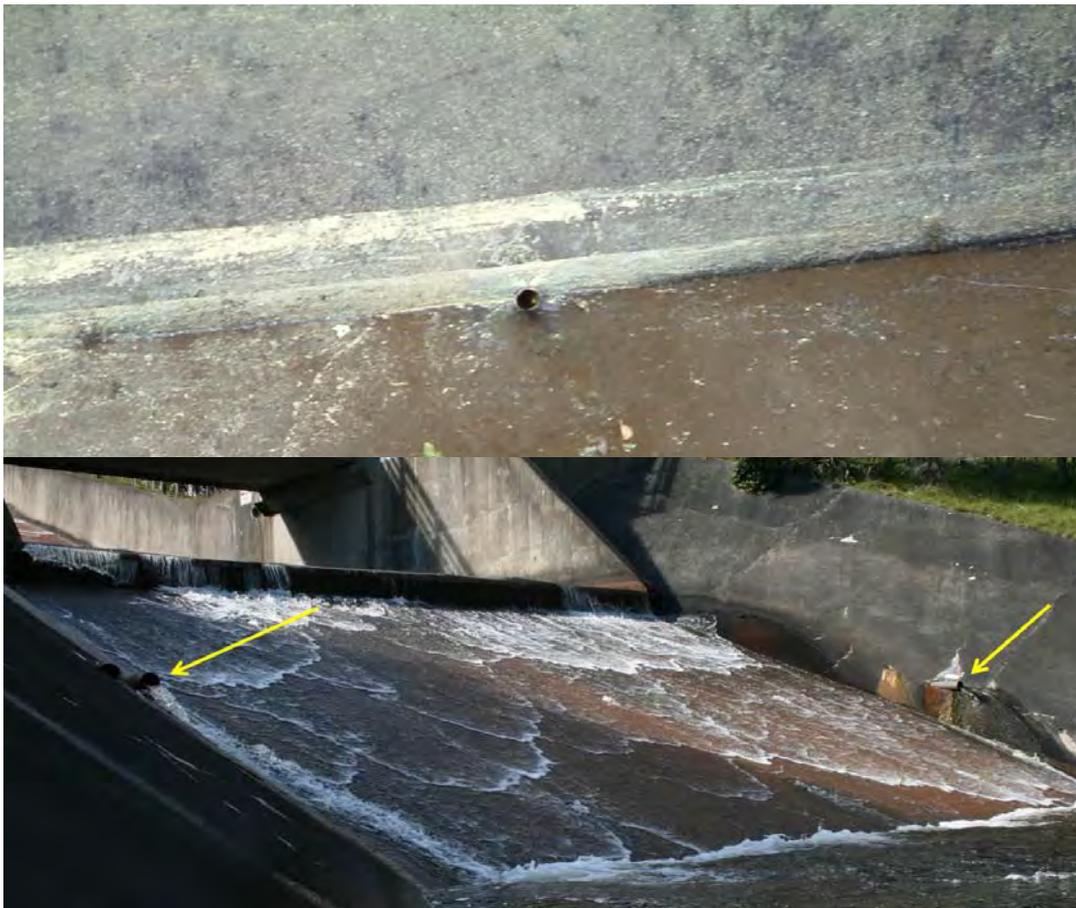
In addition to spillway drying the pool formed by the flip bucket can also sometimes dry out contributing to a significant barrier to fish passage. There are two 100 mm pipes with 50 mm entries, one each side of the flip bucket, which drain water from the flip bucket to the apron above the plunge pool during periods of no, or very low flow (Figure 9; Appendix 3). These drains seem to be blocked most of the time, but are cleared from periodically, between April and September each year (pers. comm. Alex Miller, NCC). When this is done the pool of water in the flip bucket dries up. Fish passage is not possible until the drains become re-blocked and the flip bucket pool refills and begins spilling water down the apron. Constant water flow over the spillway and the apron and maintaining the flip bucket pool full of water during fish migration periods is recommended to provide continuous fish passage over the dam (see Section 4.1.3 for more details).

Figure 9. Maintenance drains in the Maitai Dam spillway flip bucket (top) and drain outlets (bottom) at the apron cause the pool of water in the flip bucket to dry up during summer months, inhibiting fish upstream migration into the reservoir.

attempting to climb the spillway. In addition, we recommend that the drainage outlets in the flip bucket should be plugged with bungs to maintain the pool that usually forms in this bucket when spilling occurs.

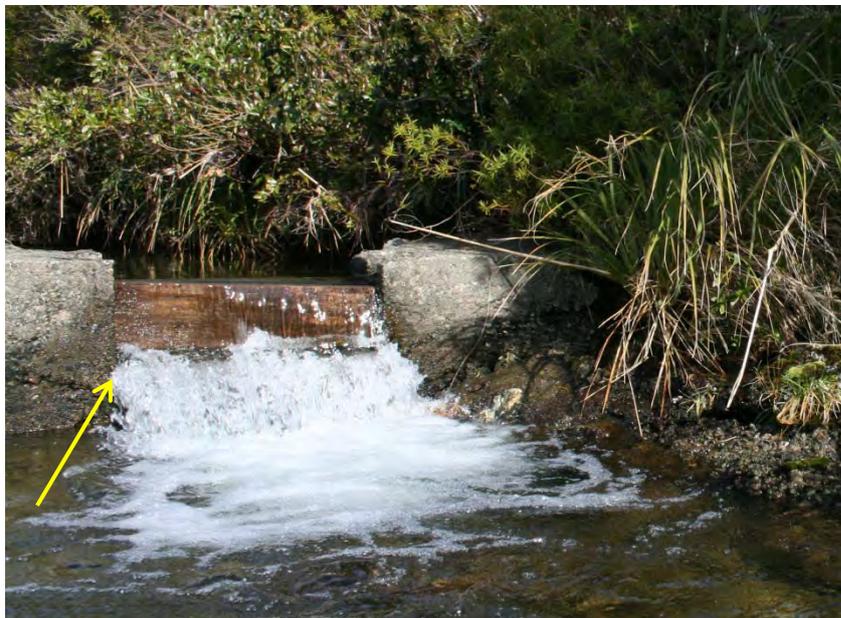
Upland bullies were found below and above the weir and along with kōaro, were seen actively attempting to climb the existing fish pass on the true left of the weir during the summer 2013 / 14 survey (Figure 14). Brown trout were well distributed throughout the South Branch with a range of sizes found above and below the weir, suggesting that the existing salmonid fish pass is functioning.

Figure 14. The upper part of the existing Maitai South Branch weir salmonid fish pass showing where kōaro and upland bully attempted to overcome the structure during low flow conditions (yellow arrow). Note: At high-flow periods (as seen in this picture), water velocity presents a passage barrier to all non-jumping fish species, such as kōaro and bully species.

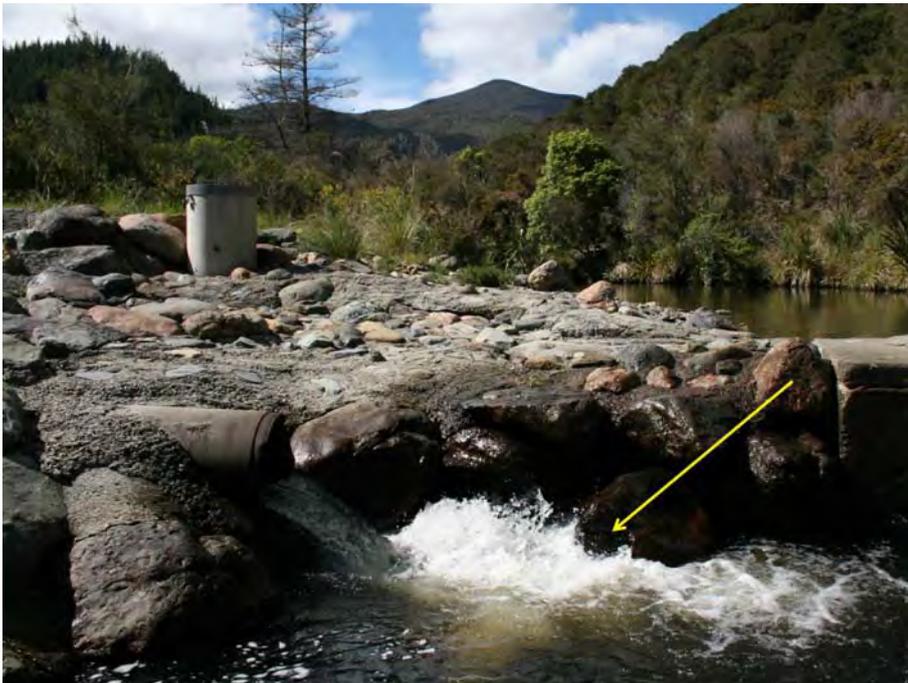
1. The back feed pipe creates an 'attractant flow' for migratory fish species  
Migratory fish species are generally attracted to concentrated flow during their upstream migration as these, under natural conditions, indicate upstream passage. For this reason, it is generally recommended that fish pass entrances be located close to the main body of flow discharging from in-stream structures, to help fish with finding the entrance. Where large discharges enter a river, such as tributary streams they can act as an attractant flow for migrating fish. However, with artificial discharges, such as the back feed pipe at the South Branch weir, fish can be lead into a migratory 'dead-end'.

Figure 15. The back feed pipe discharges water from the Maitai Reservoir into the South Branch potentially acting as an attractant flow for migratory fish species.

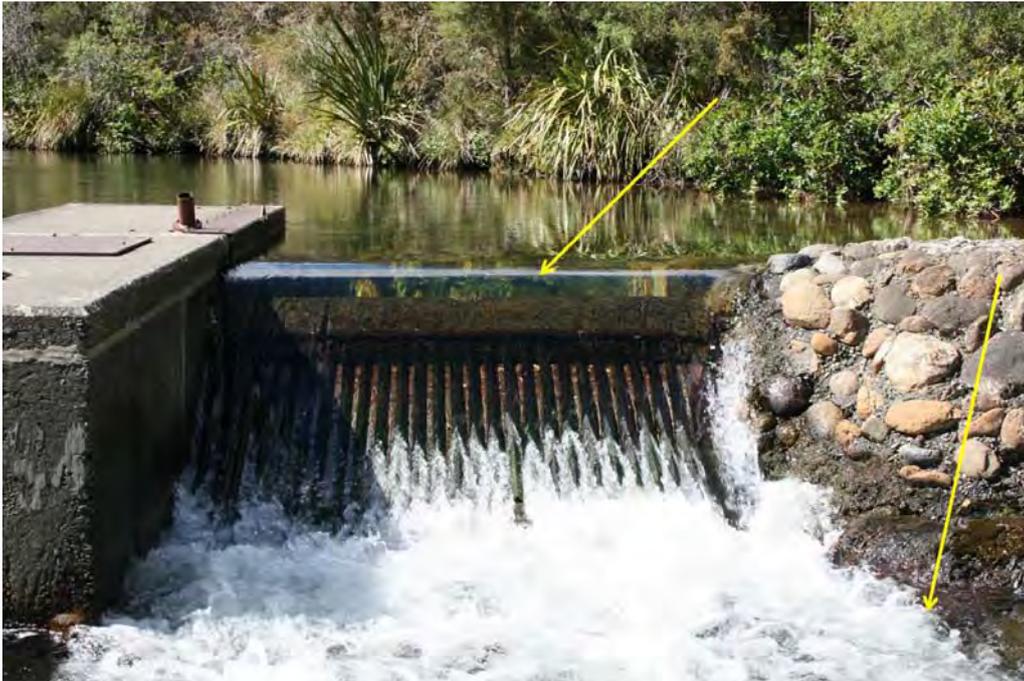
Water from the South Branch is abstracted at an intake grid to supply Nelson City with drinking water (Figure 16). The drop over the weir at the intake results in high water velocities at and downstream of the structure. In combination with the lack of smooth wetted margin along the edges of the intake, that climbing species could adhere to this part of the weir probably presents an insurmountable fish migration barrier to all fish species present in the South Branch.

Figure 16. High water velocities over the Maitai River South Branch weir present a fish migration barrier.

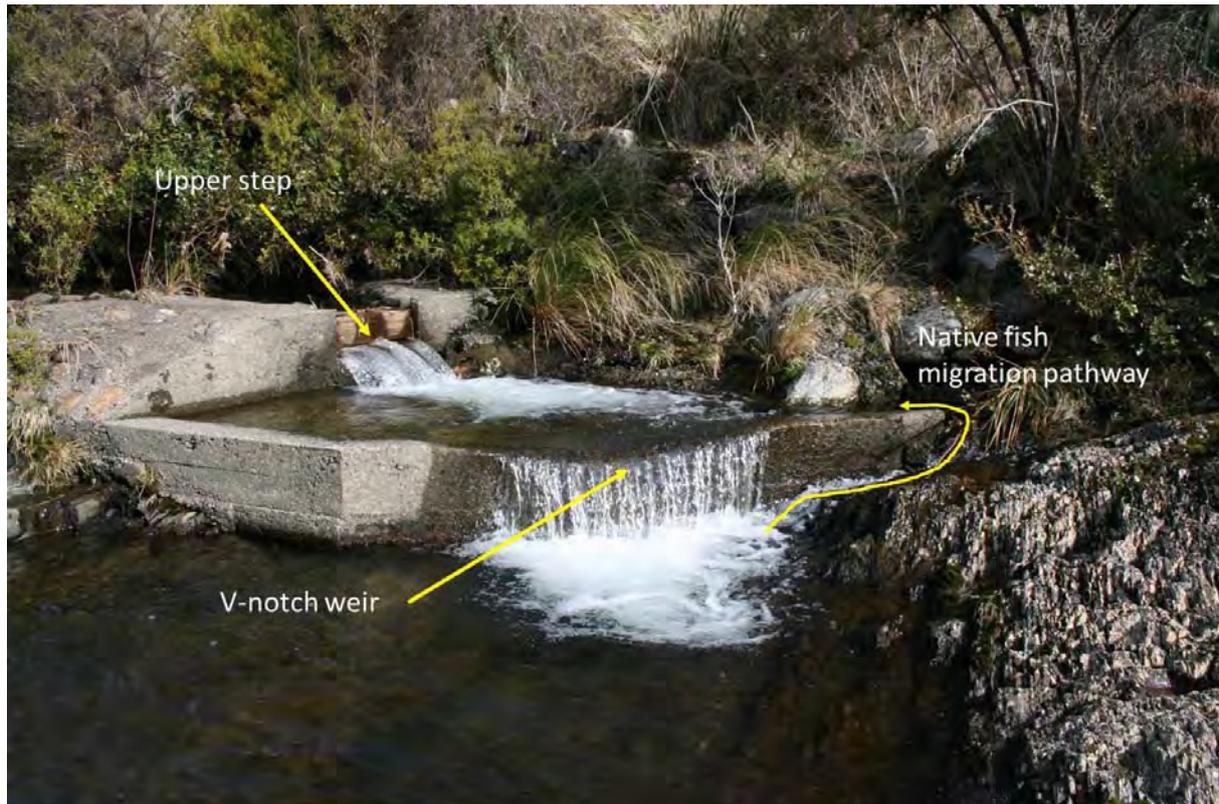
The existing fish pass located on the true left of the river was built in the early 1980s to provide passage for salmonid fish species (*i.e.* trout and salmon) past the intake structure. It is a step-pool type pass, consisting of a bottom 'v-notch' weir and an upper step formed with a removable wooden board to maintain water levels in the upstream pool (Figure 17). The fish pass appears to be functioning well in its current state for salmonids, allowing upstream and downstream passage for trout of all size classes and ages, given the observed trout numbers upstream. However, our knowledge about fish passage requirements has considerably changed in the last 30 years and regional councils have specific responsibilities to manage fish passage in New Zealand's waterways under the Freshwater Fisheries Regulations (1983) and the Resource Management Act (1991) for all fish species.

Currently, the existing fish pass provides passage for jumping fish species that are able to leap using the recirculating water below each fall. It may also provide for non-jumping upstream migrating fish species to gain access up the first step on the true left along a wetted margin, during some flows (Figure 17). However, once non-jumping fish make it into the upper pool, their chance of overcoming the 'upper step' is very low, since water often jets out under the wooden board and there is a lack of wetted margins along the edges for climbing species to cling to. Remediation of these issues is described in detail in Section 4.2.3.

Figure 17. The existing fish pass installed at the true left of the Maitai River South Branch intake Weir was purpose-built for salmonid fish species (*i.e.* trout and salmon) that can jump over the 'v-notch' and the upper step, but will provide compromised passage for native fish species that are climbers, anguilliform or swimmers.

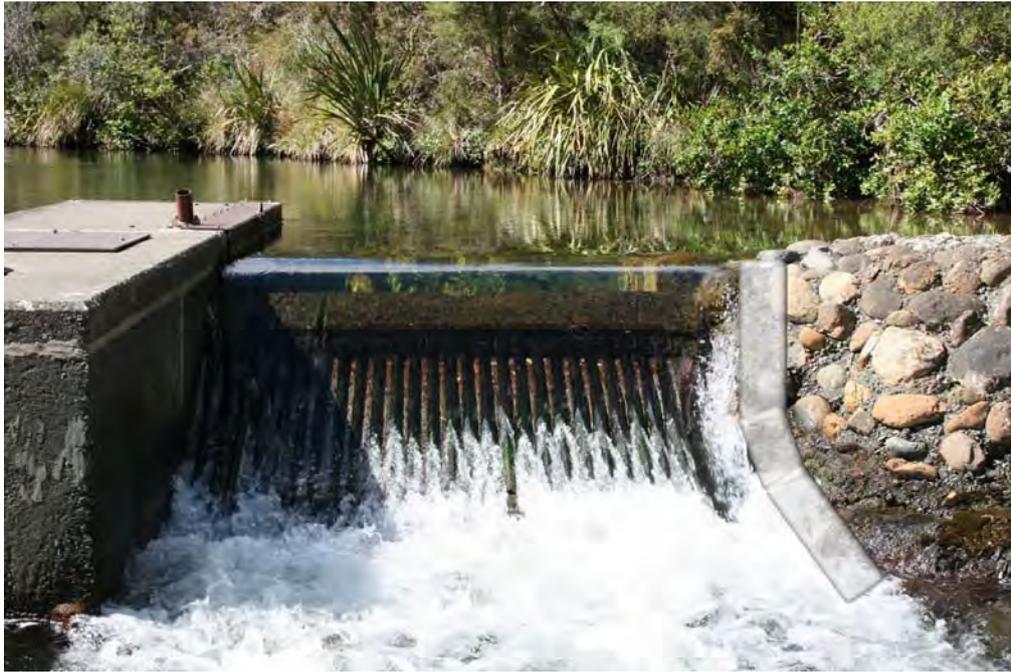
Figure 18. Providing a smooth wetted margin on the true left of the weir will facilitate upstream fish passage for climbing fish species during all flow conditions.

2. Fish passage at the weir intake can be improved for climbing species by providing a smooth wetted margin (similar to the bevel inserts recommended for the dam spillway) along the true left side, using cobbles set in a concrete matrix.

Fish passage at the weir intake can be improved for climbing species by providing a smooth wetted margin along the true left (Figure 18). The wetted margin should be constructed from concrete, incorporating existing rocks embedded in a concrete matrix. Additional cobble sized rocks (150 mm–200 mm) should be embedded haphazardly, rather than in uniform lines. The cobbles will not only lower water velocities, but also provide small pockets of water on the wetted margins that can act as resting areas for swimming fish species such as bullies. The wetted margin should ideally have a lateral slope of 35 degrees if possible. The splash zone created by the wetted margin should begin as far downstream of the intake as possible and reach all the way to the top, to minimise the slope.

During construction, water levels at the intake should be dropped as low as possible. Sandbag coffer dams may need to be used for the construction area to be dewatered. This would reduce the likelihood of high pH water poisoning aquatic organisms in the vicinity through concrete contamination. Nelson City Council should also consider the appropriate management of the drinking water supply to avoid contamination during any construction activities.

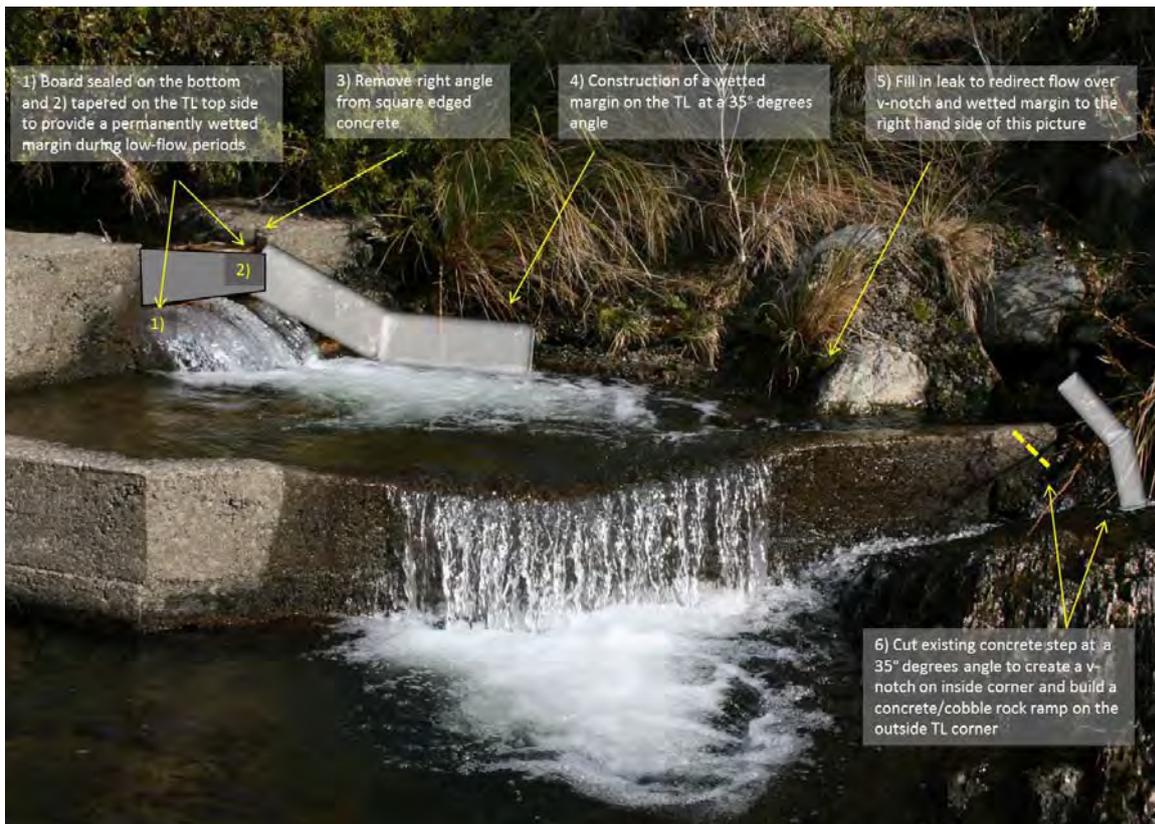
Figure 19. Suggested retrofits to the existing salmonid fish pass to allow fish passage for non-jumping fish species.

3. We also recommend six retrofits to the existing step-pool salmonid fish pass to improve fish passage for non-jumping fish species:
  - i. Reconstruct water level regulator (wooden board): Ensure that the bottom of the board forming the upper step of the pass is sealed so that water flows only over the top, to avoid the current problem of high velocity water jetting under the board.

- v. Fill the leak adjacent to the large boulder immediately above bottom step on the true left with concrete and cobble to stop water seeping underneath this large boulder, so that flow is redirected over the v-notch native fish pass.

underneath this large boulder so that flow is redirected over the v-notch native fish pass.

6. Cut the concrete on the true left of the existing lower step to a 35 degree angle to allow fish passage at a range of flows. Construct a concrete and cobble rock ramp along the true left edge of the lower weir, following the methodology described above.
