REPORT NO. 3015

**IMPACTS OF VEHICLE ACCESS AT DELAWARE
(WAKAPUAKA) INLET**

Prepared for Nelson City Council

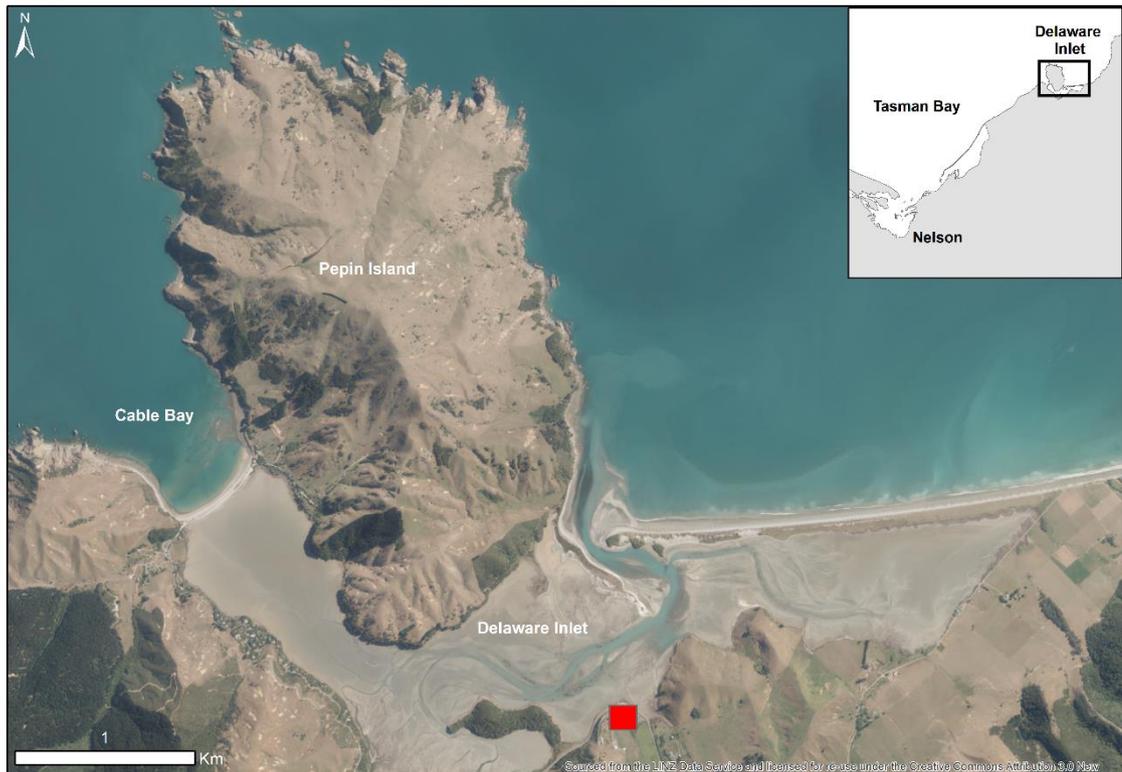
Figure 1. Delaware Inlet (pictured at low tide) and Cable Bay. Inset shows location relative to Nelson and Tasman Bay. The red area shows where vehicles can access the estuary.

An increasing number of vehicles are using an informal boat launching site at Delaware Inlet that involves vehicles driving across exposed tidal flats (Figure 1). This has caused offence to the local hapū and Māori owners of the adjacent Wakapuaka 1B block who, among other things, are concerned about the damage caused by vehicles to the ecology of the estuary. The Nelson City Council (NCC) is reviewing its coastal plan and would like to include new provisions governing access to the estuary that address and, as far as feasible, reconcile the interests and concerns of local Māori, residents and boat users. The Council commissioned Cawthron Institute (Cawthron) to assess the nature and extent of boat usage, views of boat users, local residents and Māori, and the ecological impact of vehicle traffic on the estuary.

Delaware Inlet is an estuary situated on the eastern side of Tasman Bay at the mouth of the Wakapuaka River and approximately 19 km northeast of the city of Nelson. It is separated from adjacent Cable Bay only by a narrow tombolo, which connects Pepin Island to the mainland. The inlet opens to Delaware Bay through a narrow channel and is classified as a permanently open tidal lagoon (Hume et al. 2016). It is approximately 353 hectares in size and mostly consists of estuarine tidal flats that are exposed at low tide (Figure 1).

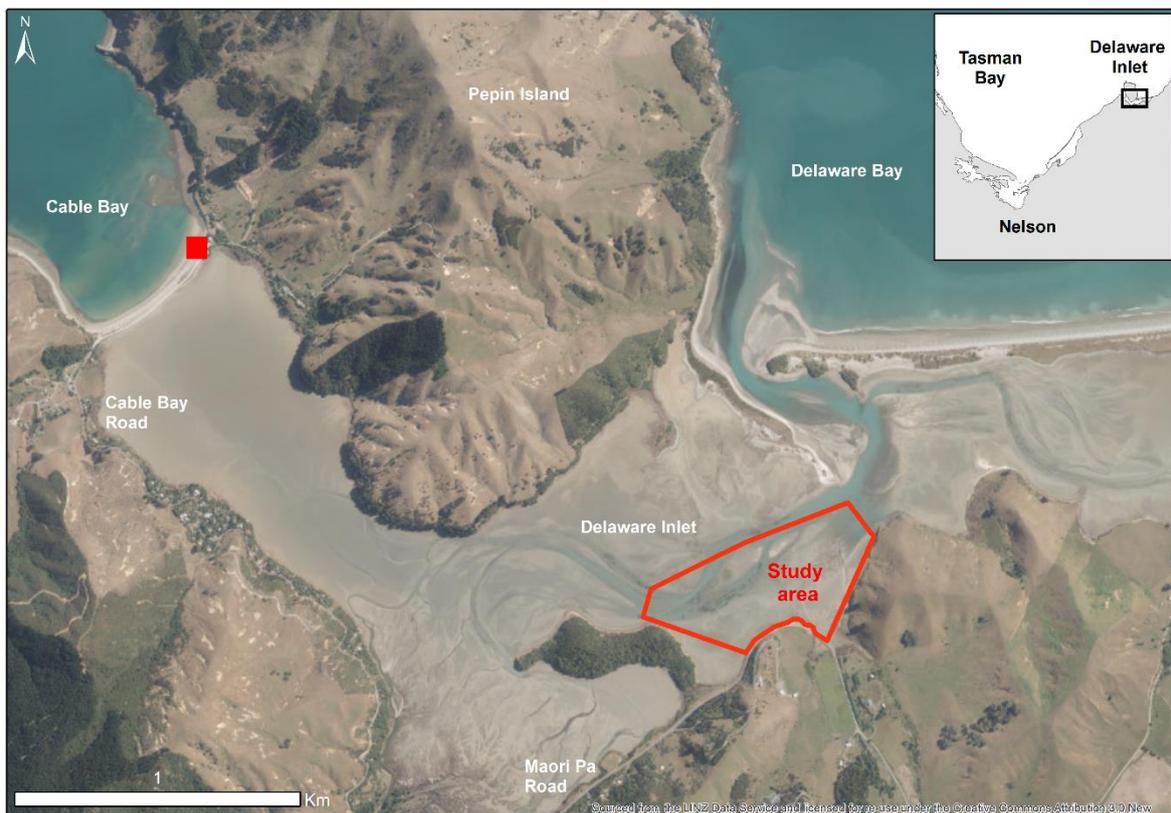
Figure 2. Delaware Inlet in relation to Tasman Bay, showing the ecological study area and Cable Bay boat launching location (marked with red square).

The study area for the ecological assessment was located on the eastern side of Delaware Inlet and adjacent to a car pull-off area on Maori Pa Road from which vehicles drive onto the tidal flats (Figure 2). This area was chosen to encompass the intertidal habitat being driven over by vehicles, largely for the purpose of launching and retrieving boats. Immediate surrounding areas subject to low (or possibly no) vehicle usage were also included for the purpose of providing survey comparisons.

The boat users' survey and fixed camera-based vehicle count focused on the study area for Delaware Inlet as well as the northern end of the tombolo at Cable Bay, both marked in red in Figure 2. Local residents of Maori Pa Road and Cable Bay were included in the study interviews.

The field team conducted ground-truthing for the majority of the study site (red area in Figure 2), but restricted this to habitats exposed by the low tide on the boat launching (south-eastern) side of the main channel. A Cawthron scientist used GIS software (ArcMap 10.4) to digitise habitat features with reference to the ground-truthing exercise explained above.

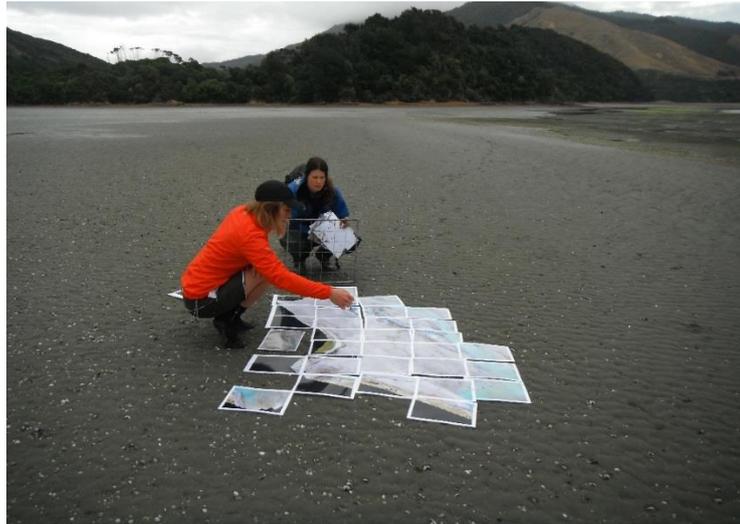
Figure 3. Cawthron scientists conducting ground-truthing for habitat mapping in the Delaware Inlet.

A field team of Cawthron scientists ground-truthed⁷ the aerial orthophoto by identifying and delineating dominant habitats at low tide on 2 February 2017 (Figure 3). They recorded boundaries between areas of dominant substrata or biota using GPS tracking and sketched these directly onto a laminated orthophoto. They classified these areas by describing the dominant substrate types and the presence and density of vegetation. The classification system was based on an interpretation of the Atkinson (1985) system and the estuarine national classification system developed by Ward and Lambie (1999). Habitat types were coded according to EMP protocols and, where applicable, habitat names were aligned with previous mapping efforts that also followed EMP protocols within Delaware Inlet (e.g. Gillespie et al. 2011b). Substrate classification was based on surface layers only and did not consider underlying substrate (e.g. gravel fields covered by sand would be classed as sand). To reduce subjectivity, soft sediment substrates were categorised as either soft (grouping together 'soft' and 'very soft') or firm.

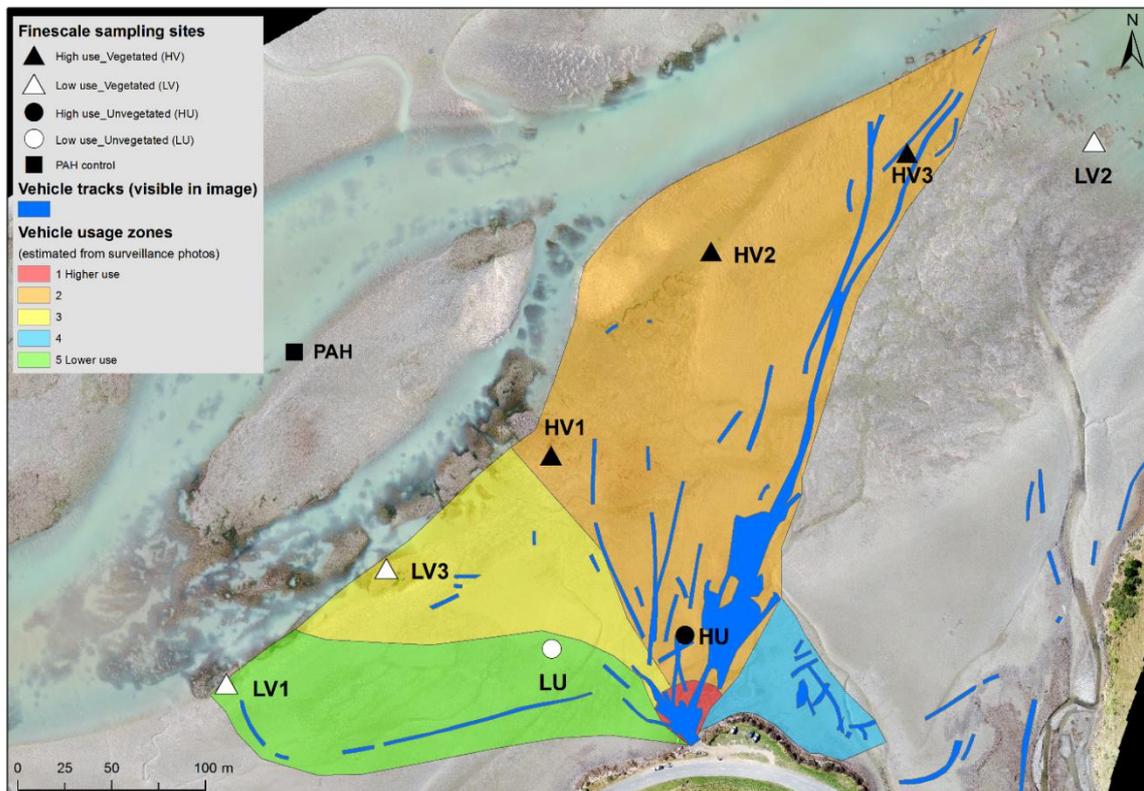
Figure 4. Map of the study area in Delaware Inlet showing the position of the eight main fine-scale sites, as well as the polycyclic aromatic hydrocarbon (PAH) control site, and vehicle usage zones. Visible vehicle tracks are also displayed.

Where possible, vehicle tracks noted in the orthophoto were verified by the field team during ground-truthing. The longevity of visible vehicle tracks within the study area was unknown and likely dependent on substrate type and the amount of interstitial water present. Therefore, in order to determine the boundaries of zones subject to differing amounts of vehicle usage, the abundance of vehicle tracks, a photographic time series from a fixed camera, and field observations of boats being launched were all used in our calculations. We digitised the vehicle tracks and created polygons to represent five vehicle usage zones, for use in planning the positioning of fine-scale survey sites (Figure 4). Vehicle usage intensity zones (considered for the intertidal region only) were categorised using an inverse scale, with Zone 1 having the highest vehicle usage and Zone 5 the lowest (Figure 4). The zones represent usage intensity

Unvegetated habitats within the study area were covered largely by firm shell/sand and gravel field (Figure 6). The area covered by all vehicle zones was 6.6 ha out of a total of 353 ha comprising Delaware Inlet. Zones 1 and 2 covered 3.9 ha and all other zones combined covered 2.7 ha. Visible vehicle tracks imprinted into the substrate covered approximately 58% of Zone 1, 11% of Zone 2, and 1.5–8.8% for all other zones (Figure 4, Figure 7).

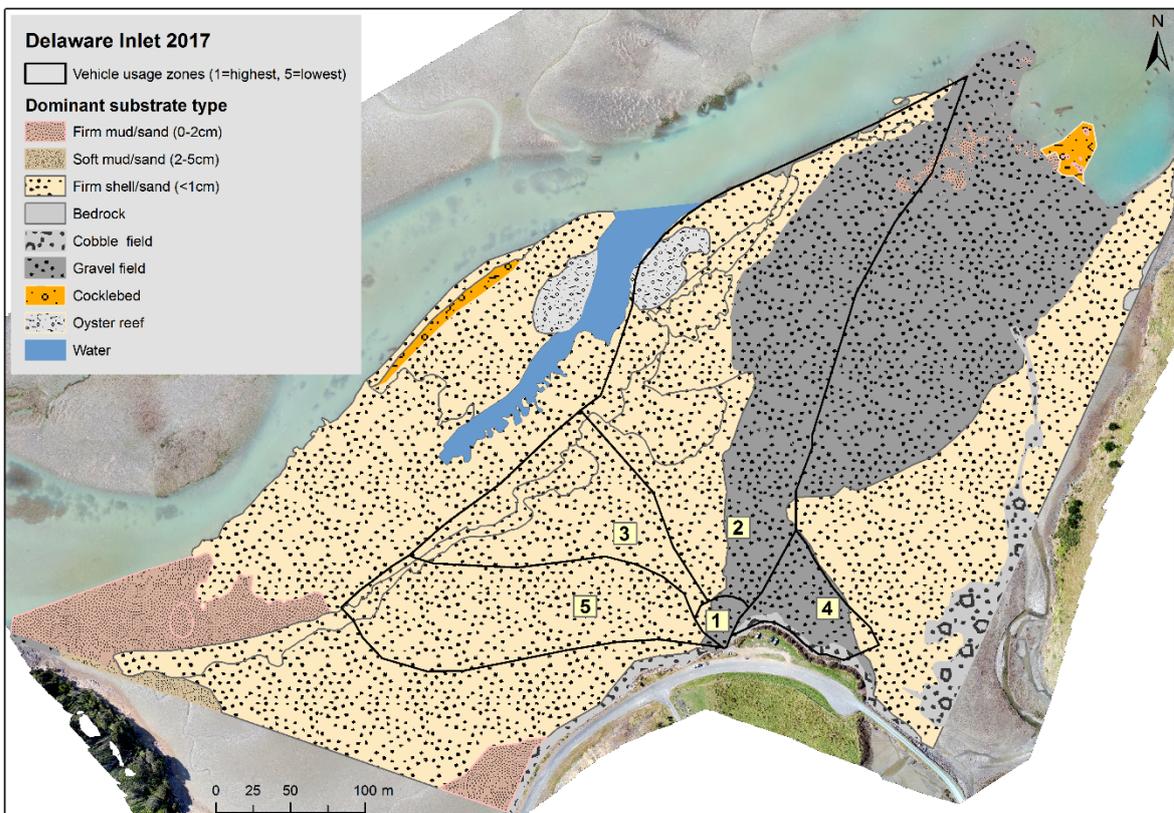
Figure 6. Unvegetated substrate, showing only dominant categories, within the Delaware Inlet study area in 2017. Boundaries for vehicle usage zones (1–5) are also shown and numbered.

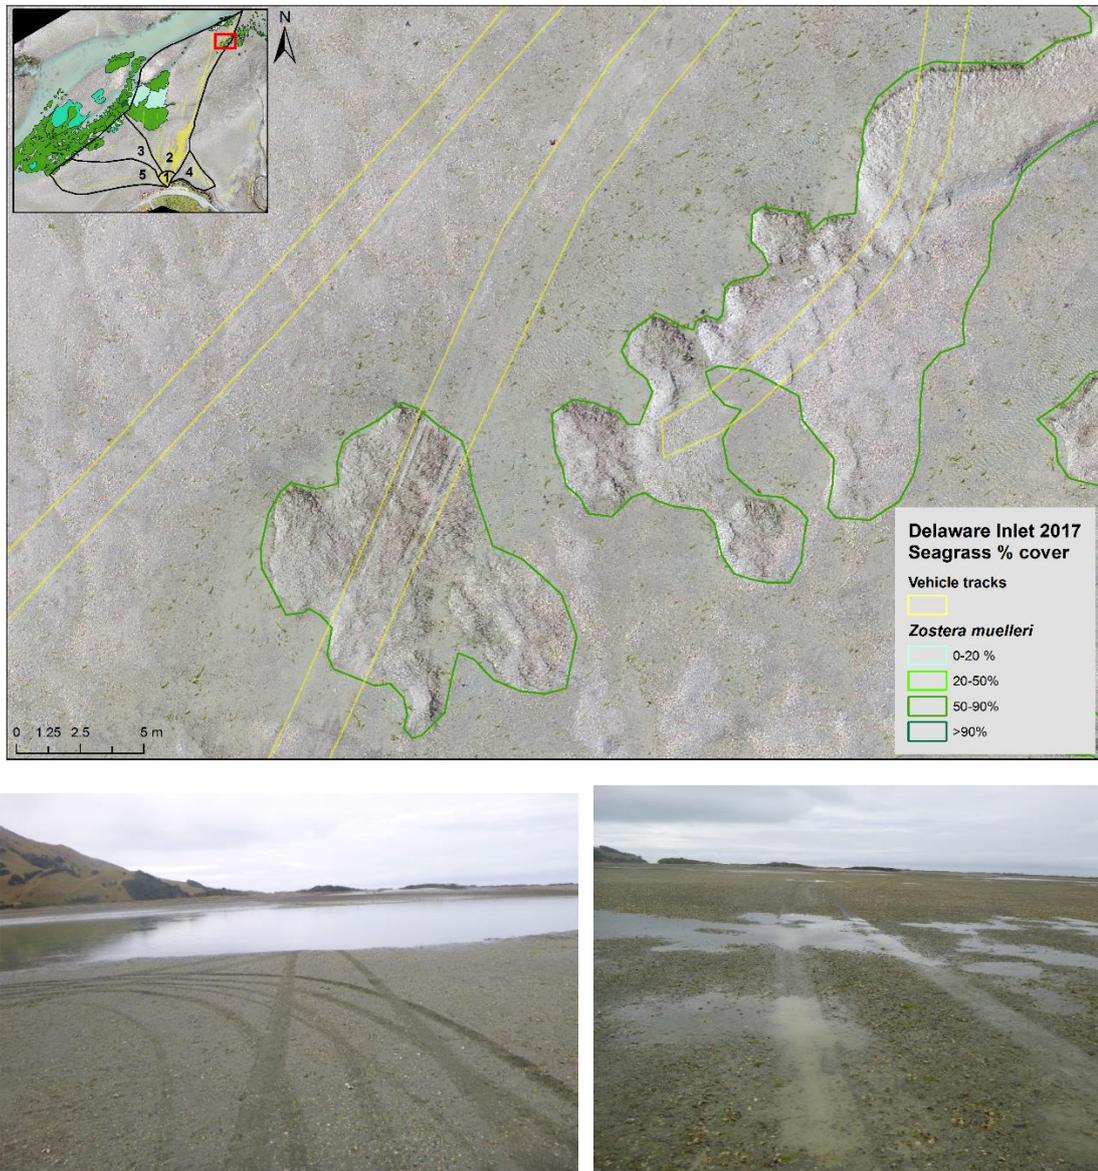
Figure 7. Vehicle tracks on benthic substrates in the vehicle usage zones in Delaware Inlet. Aerial image taken by drone with accompanying map (top), and photo taken by camera (bottom), during habitat mapping 2017.

In this study, we found visible vehicle tracks on benthic habitats (including seagrass) in all vehicle usage zones, as well as outside the zones in some areas, indicating direct physical damage caused by vehicles. Vehicle tracks were also observed in Delaware Inlet in seagrass beds by Gillespie et al. (2011b).

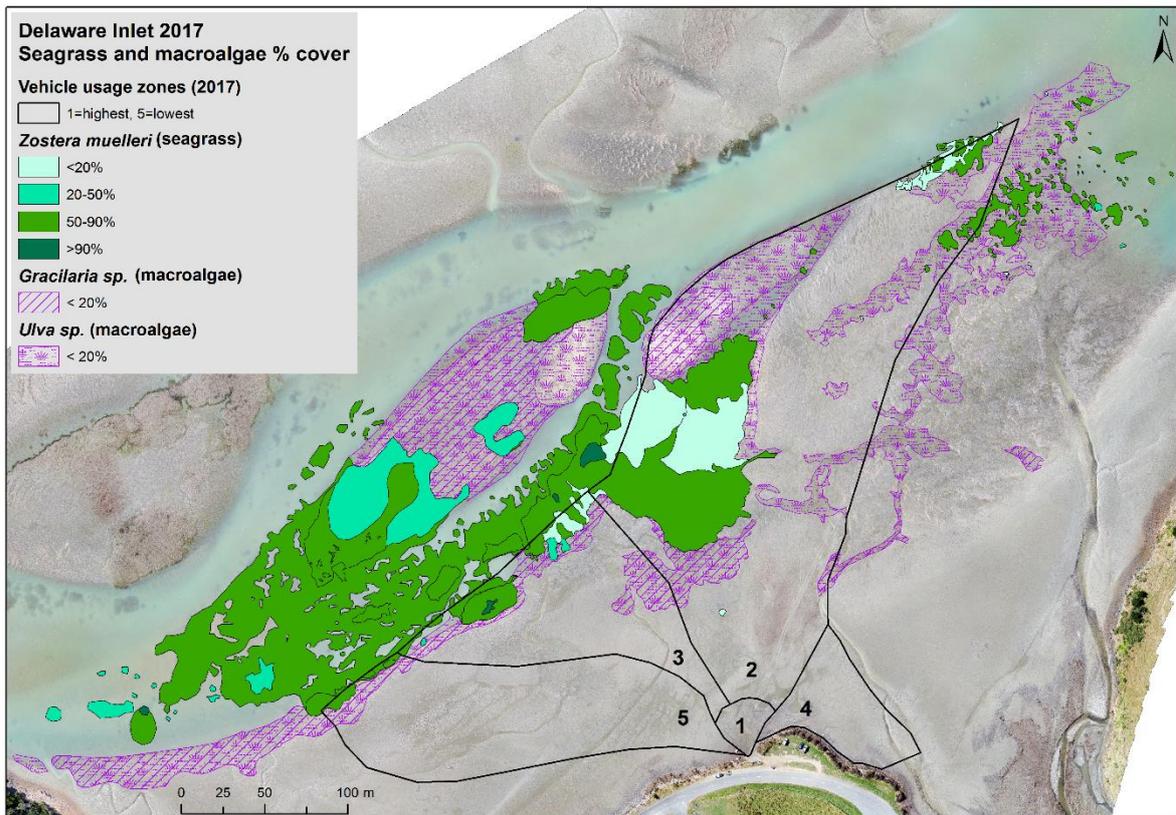
Figure 8. Percent cover of vegetation (seagrass beds and macroalgae) within the Delaware Inlet study area in 2017. Boundaries for vehicle usage zones (1–5) are also shown and numbered.

In 2017, seagrass was present in all vehicle usage zones that extended down to the low shore, and covered 1.0 ha of the 6.6 ha total area of all zones (Figure 8, Figure 9). Vehicle tracks were visible in seagrass habitat (Figure 7). An area generally devoid of seagrass ran along the eastern side of Zone 2 and was subject to relatively high vehicle usage (Figure 8). This area coincided with a dominant surface substrate of gravel field (Figure 6), as well as being an area with a relatively high number of visible

vehicle tracks (Figure 4). Comparisons of seagrass cover in the study area in 2017 (Figure 8) against historical maps from 1988 (Figure 10) and 2009 (Figure 11) indicated that seagrass beds have contracted and expanded over time, both within and beyond the area subject to vehicle traffic. In Zone 2, there was nearly complete loss of some seagrass patches higher up on the shore (approximately 0.14 ha in combined size in 2009); these were present historically (1988 and 2009) but barely observed in 2017.

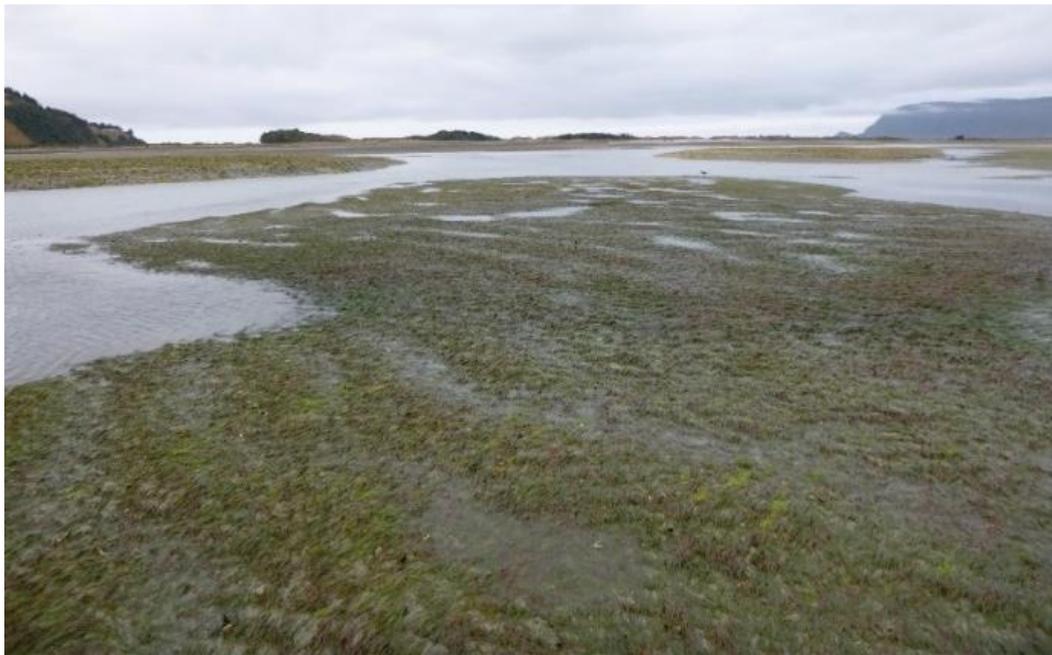
Figure 9. Seagrass beds within the Delaware Inlet study area, 2017.

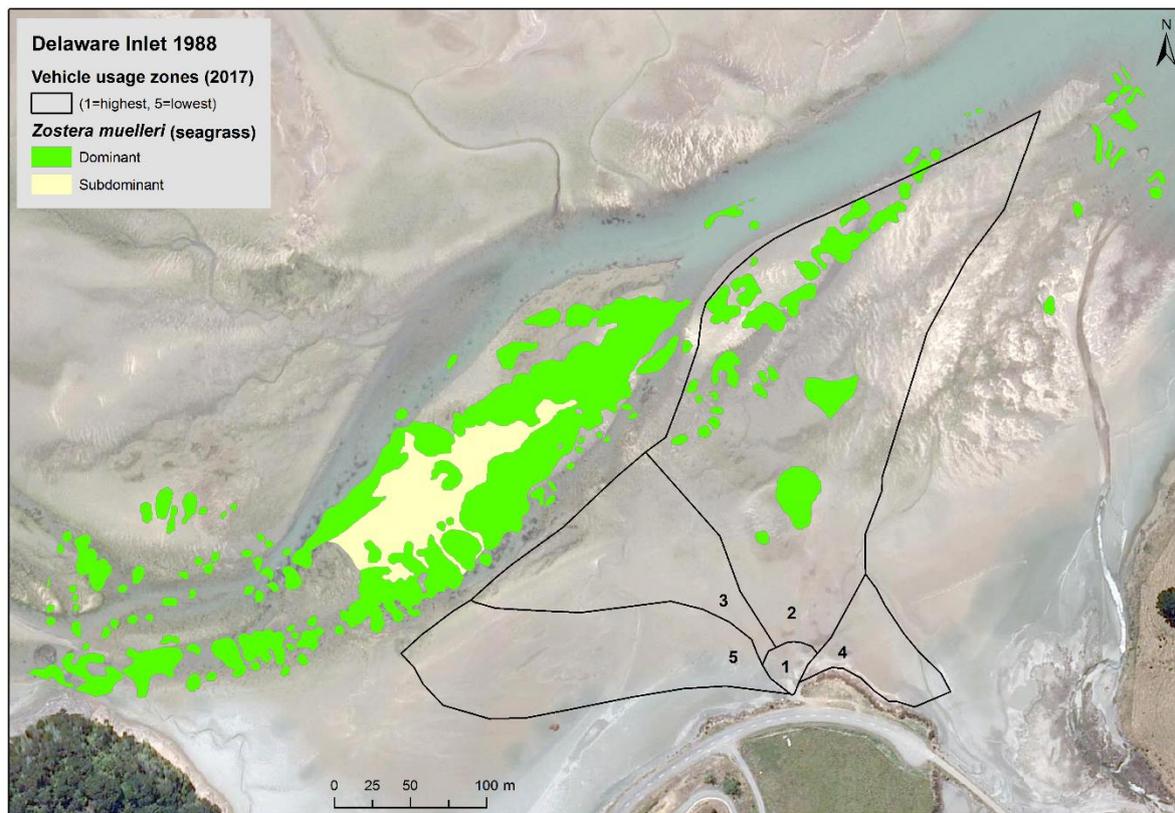
Figure 10. Location of seagrass beds in 1988 (Franko 1988) within the study area. Boundaries for vehicle usage zones (1–5) in 2017 are also shown and numbered.

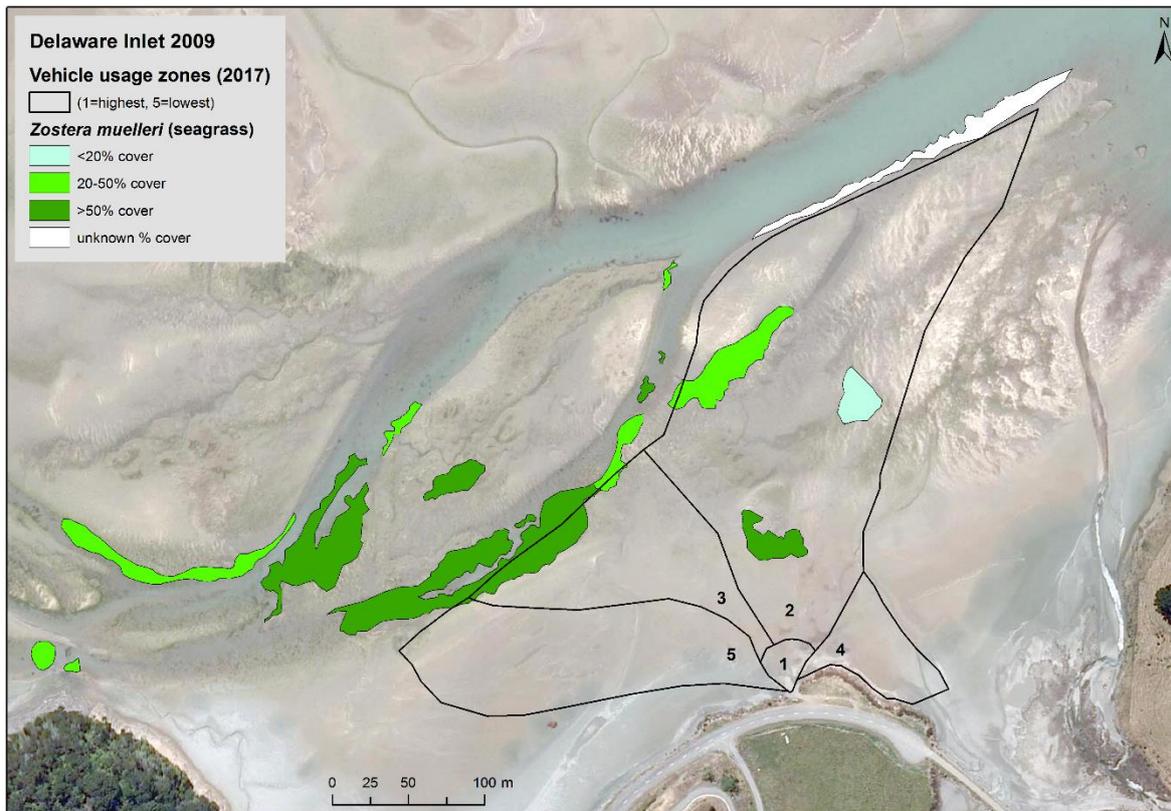
Figure 11. Location of seagrass beds in 2009 (Gillespie et al. 2011b) within the current study area. Boundaries for vehicle usage zones (1–5) in 2017 are also shown.

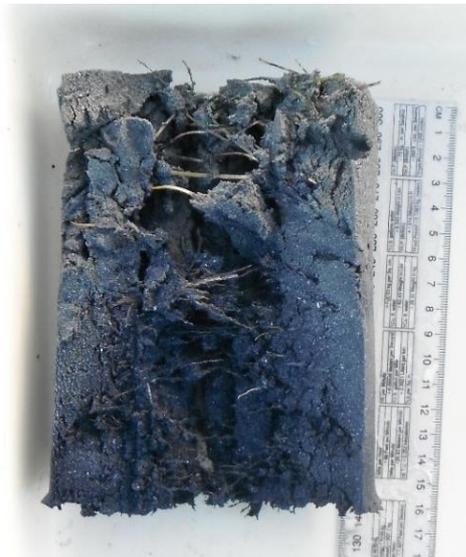
Figure 12. Photograph of a sediment core from one of the vegetated (low shore) sites.

There were no obvious differences in sediment core profiles between the high and low vehicle usage zones at the vegetated (low shore) sites. Cores were generally light brown/medium grey to a depth of 3–8 cm with darker sediment (sometimes becoming black with a slight hydrogen sulphide odour) below this depth (Figure 12). The unvegetated (midshore), sediment cores were light brown in the top 2–3 cm with light grey sediment (from cores taken in the low vehicle usage zone), and medium grey (high vehicle usage) below this depth, with no distinct hydrogen sulphide odour. At the high vehicle usage/unvegetated (midshore) site, sediment was highly compacted, preventing the collection of a core profile below 4 cm.

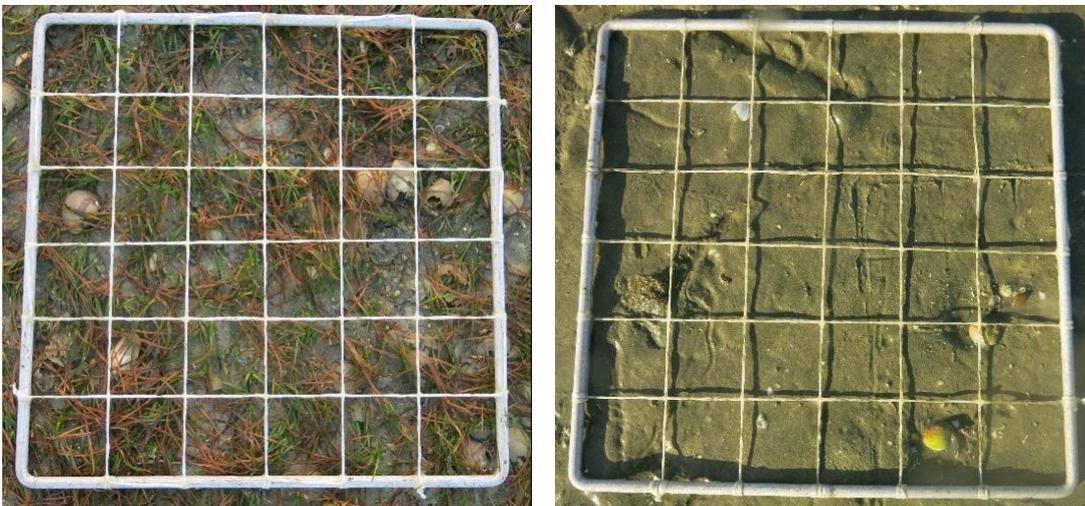
Figure 13. Examples of quadrats from vegetated and unvegetated sites within which epibiota were quantified.

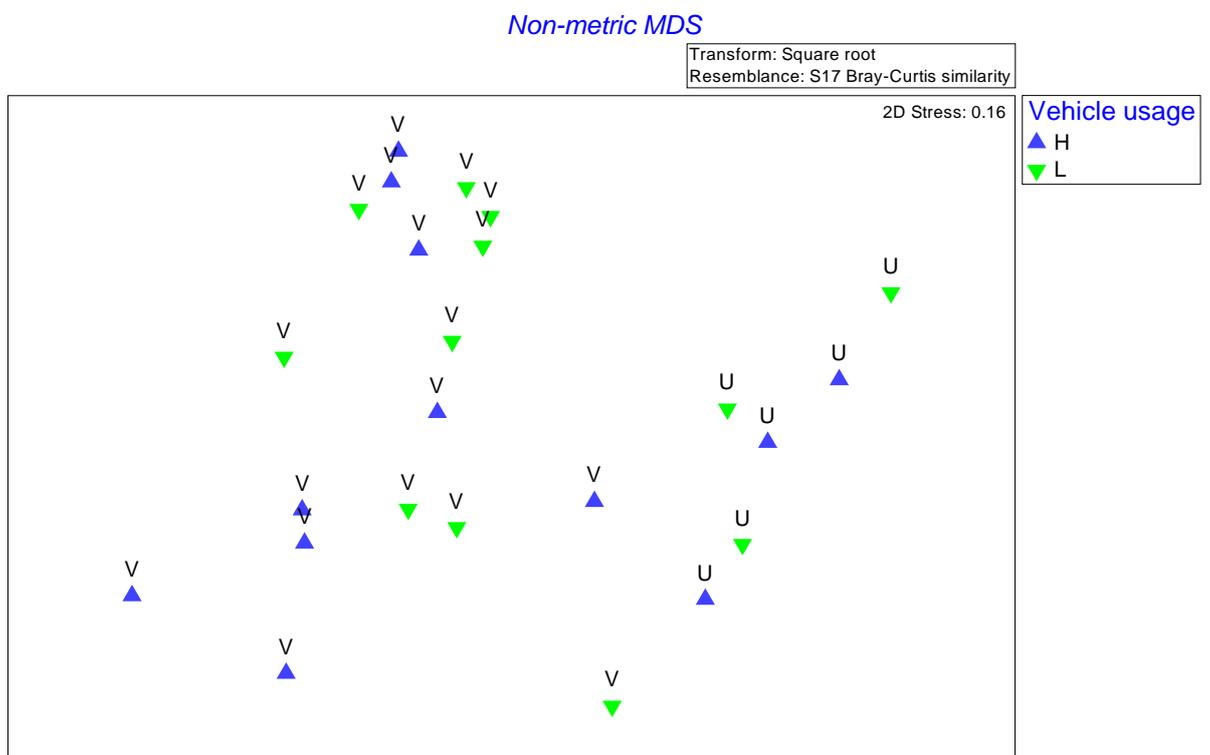
Figure 14. Non-metric MDS showing epifauna communities from vegetated low shore (V), and unvegetated midshore (U) sites subject to high (H – blue triangle) and low (L – green triangle) vehicle usage in Delaware Inlet.

Overall, 18 epifauna taxa were recorded from the fine-scale survey with the small gastropod *Micrelenchus tenebrosus* (topshell) and cockle the most abundant (Appendix 6 and Figure 13). Average epifauna abundance was similar between sites within the vegetated (low shore) and between sites within the unvegetated (midshore) (Table 3). In the low shore sites, the number of taxa was slightly higher within the low, compared to the high, vehicle usage zone, with the opposite pattern occurring in the midshore, although very low numbers were present. Multivariate analysis (non-metric MDS) indicated considerable overlap (i.e. no obvious differences) in composition between epifauna communities from the low and high vehicle usage zones from both vegetated and unvegetated sites (Figure 14).

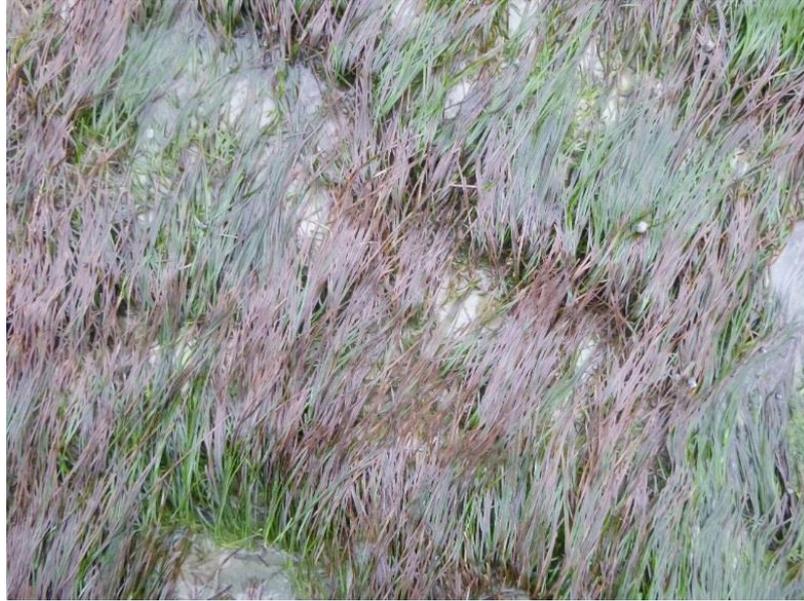
Figure 15. Seagrass from Delaware Inlet showing patches of darkened leaves likely caused by *Labyrinthula* infection.

The average percentage cover of seagrass (low shore), at 81% (± 2.4 SE), was consistently high and much less variable within the low vehicle usage zone, in comparison to the high vehicle usage zone (58% ± 10.0 SE) (Appendix 6). However, this difference falls short of the statistical test for significance, so we are not able to conclude that there is a statistically significant difference in the cover of seagrass between these two zones. Seagrass with darkened leaves (Figure 15), indicative of partial decay likely due to *Labyrinthula* (wasting disease) infection, was common at all

vegetated (low shore) sites, with no obvious differences observed between sites at the high and low vehicle usage zones.

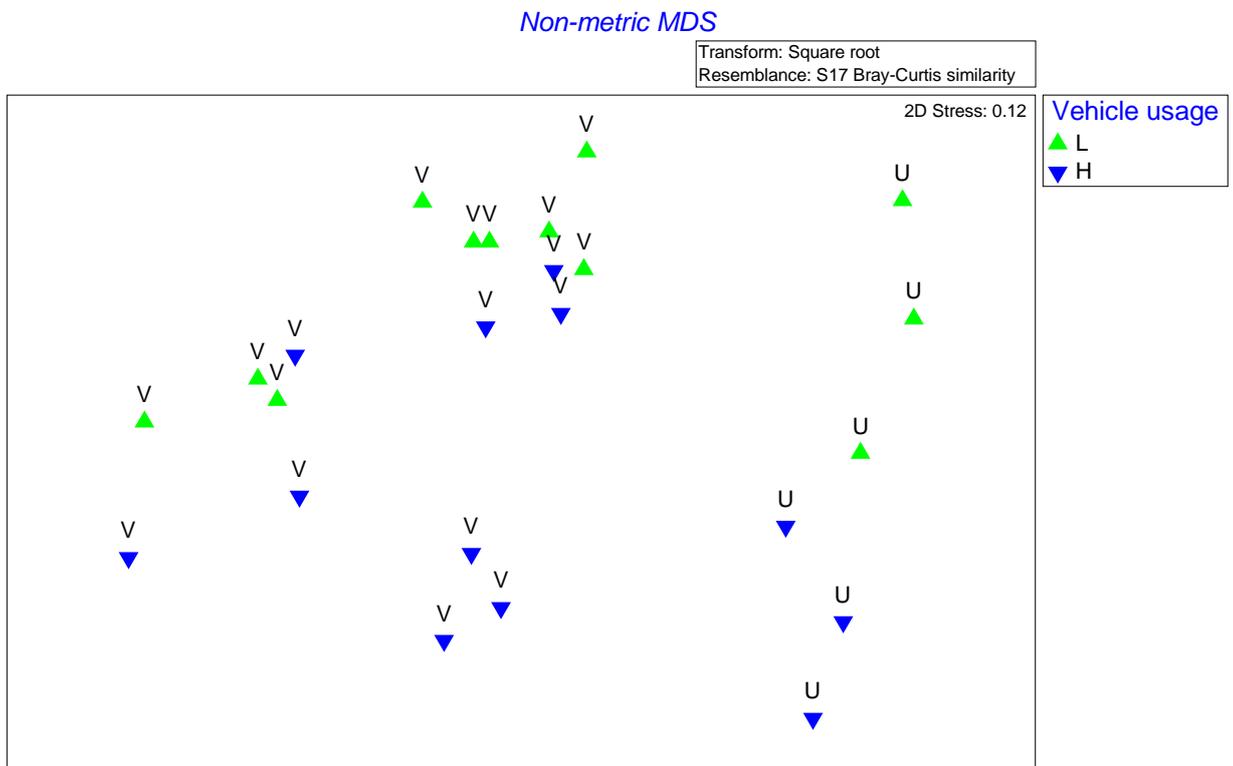
Figure 16. Non-metric MDS showing infauna communities from vegetated low shore (V), and unvegetated midshore (U) sites subject to high (H – blue triangle) and low (L – green triangle) vehicle usage in Delaware Inlet.

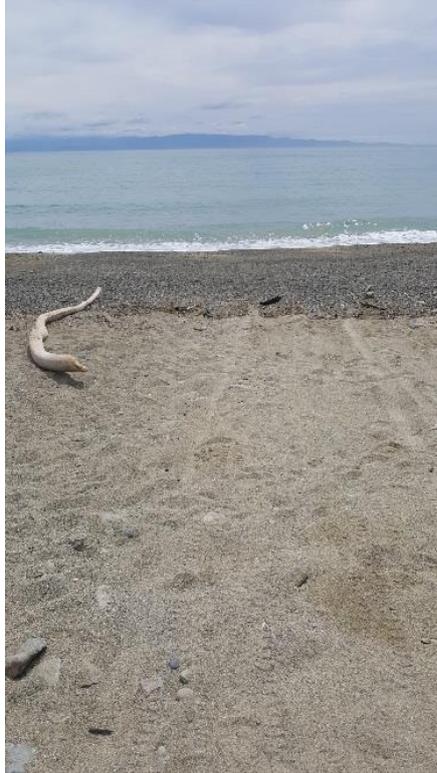
Figure 18. Soft sand at the Cable Bay boat launching area.

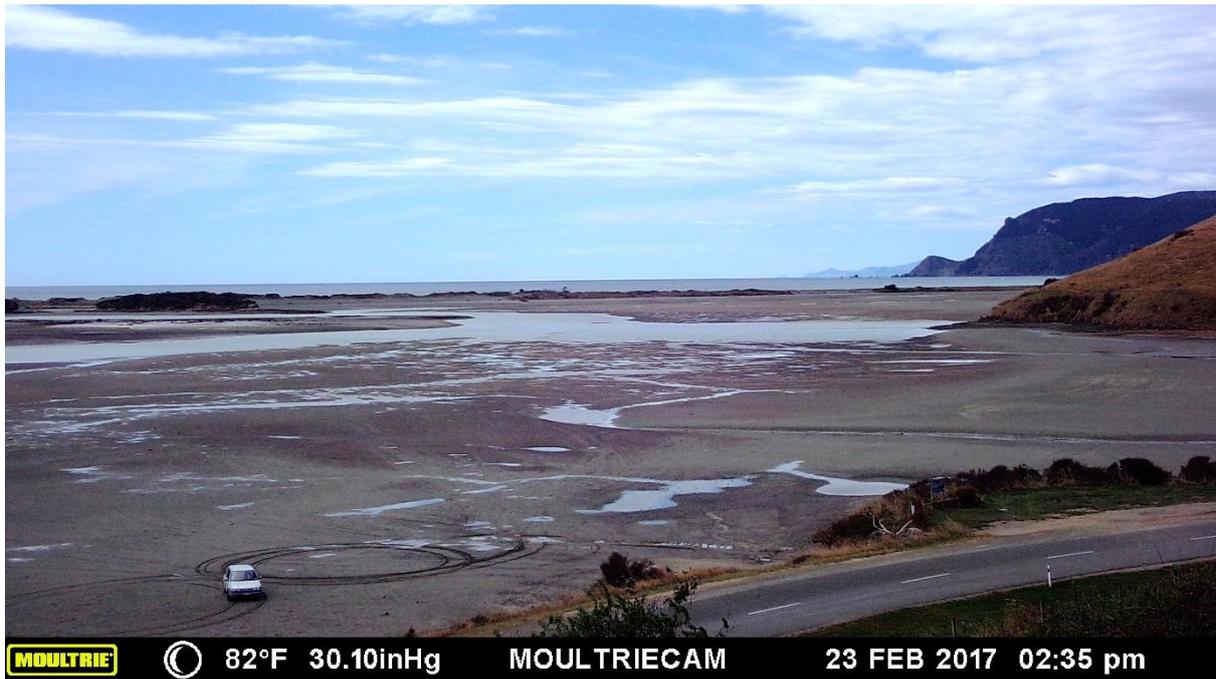
Figure 20. A 'joyrider' at Delaware Inlet captured on the fixed camera at mid-afternoon on Thursday 23 February 2017.

place on it” (*Interview 8 March 2017*). The interviewee noted that most boat users who drive over the estuary to launch or retrieve boats do not get their vehicles stuck: “...it’s only the joyriders that are getting stuck, going into stupid areas” (*Interview 8 March 2017*) (Figure 20, Section 5.8.3).

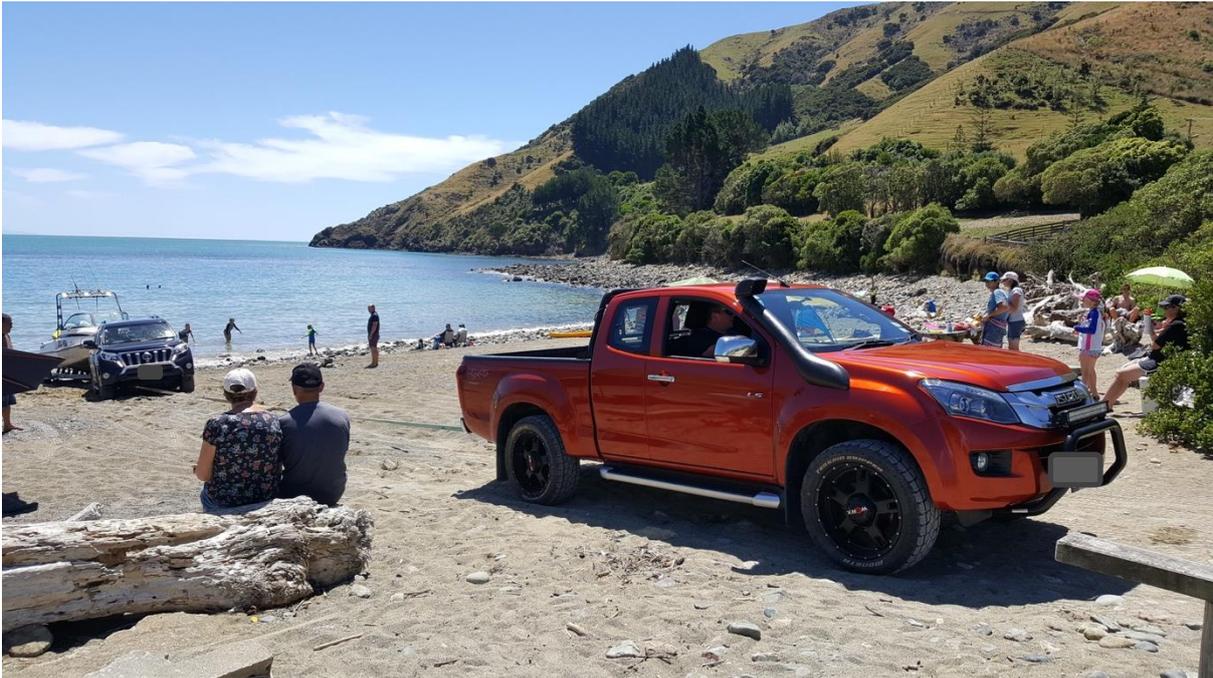
Figure 21. An example of a 4WD vehicle towing another 4WD vehicle with boat trailer that got stuck in the soft sand at Cable Bay. The proximity to swimmers and young families on the beach highlights a safety concern. Photo taken on Saturday 4 February 2017.

Another Cable Bay resident reported that there is already conflict between boat users, swimmers and families on the beach (all congregated at the far end of the beach), and that this would likely escalate with any improvement to the boat launching area: "You're either going to have a concrete ramp or swimmers: you can't have both... Kids running around and people backing boats—it's a recipe for disaster. It's going to end badly one day soon" (*Interview 31 January 2017*). This scenario is illustrated in Figure 21 below.
