## Site Suitability Assessment

205 Lud Valley Road, Hira

Document Number: 18360-RPT-001-C

Date: 25 October 2018

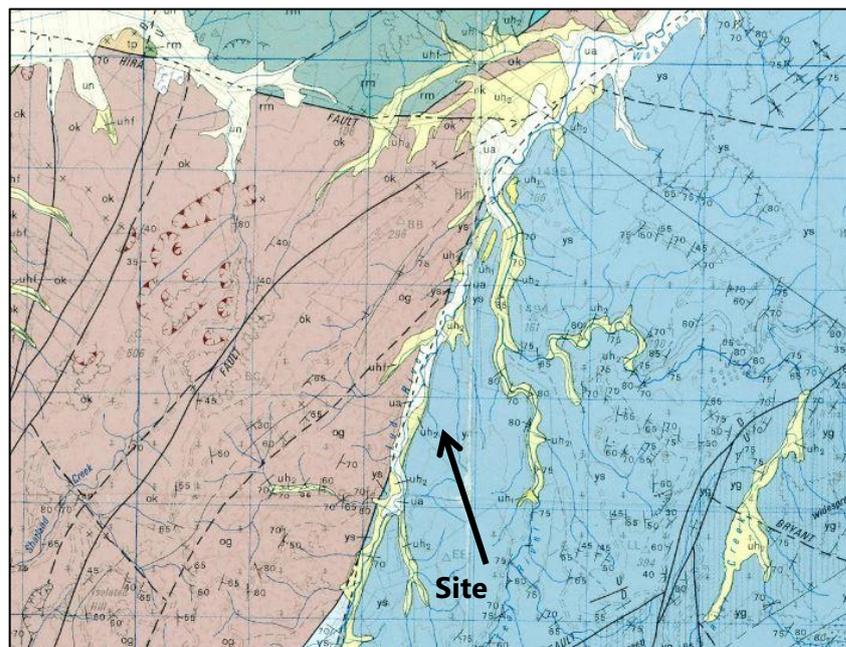
Figure 1: GNS Dun Mountain, 1981, Sheet 027AC – extract.

According to GNS Geology mapping (Geology of Dun Mountain, 1981) the site is underlain by the Maitai Group Stephens Formation (ys) which is described as '*bedded green and grey sandstone, grey siltstone and mudstone with beds of red siltstone, lenses of conglomerate and impure, fossiliferous limestone*', as shown on Figure 1 below.

A branch of the Waimea Fault is located approximately 350 m to the west of the site, near the Lud River. The fault trends from the south to the north.

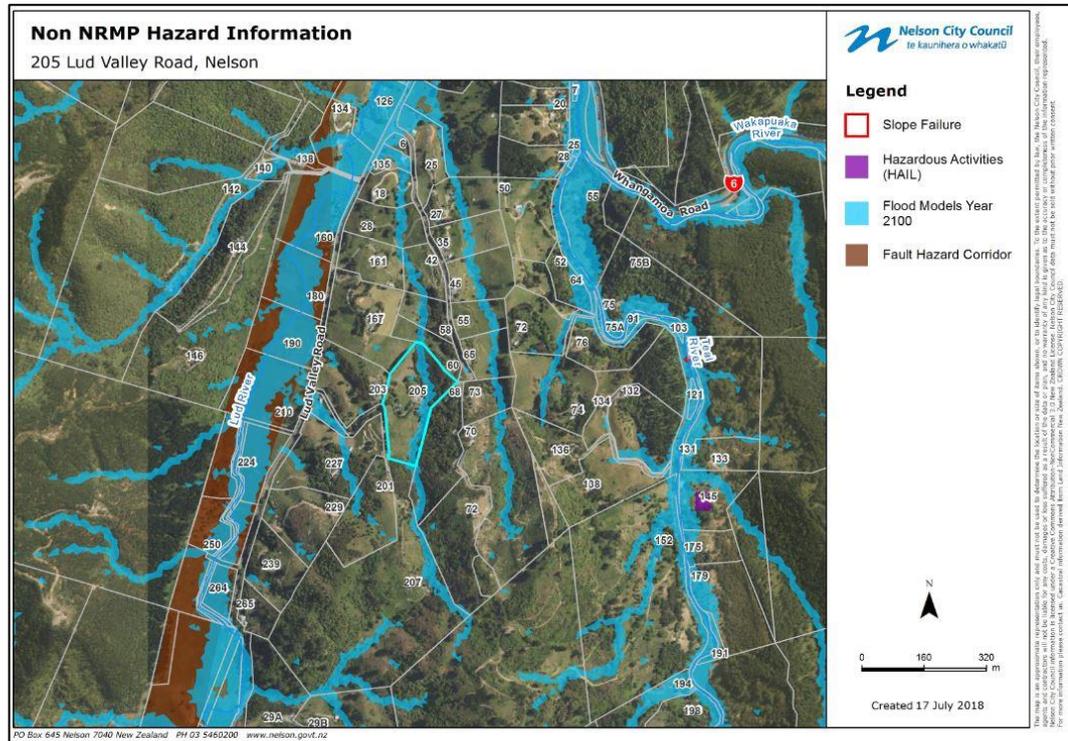
**Figure 2: NRMPM Flooding Hazard Overlay – extract**

An un-named stream is located at the bottom of the valley on the eastern boundary of the site. According to the NCC flood models for the year 2100 the stream is a flood hazard, as shown on Figure 2 below.

The proposed house site is approximately 10-20m in elevation greater than the water level indicated in the 2100 flood model. Overland flow requires diversion around the proposed buildings however the effect of inundation from the gully on the proposed house site is considered insignificant.

CGW did not undertake an inundation assessment as part of this assessment. The proposed building areas are deemed to be well above any potential flood hazard areas associated with the un-named stream on the eastern boundary of the site.

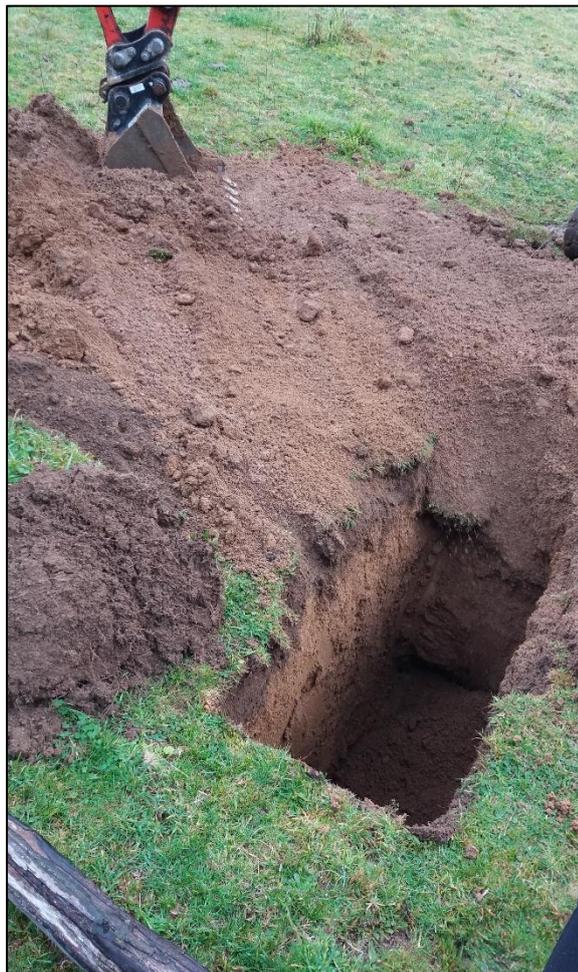
**Figure 3: TP2 Typical shallow soil conditions**

Some variation in soil conditions was observed across the 3 test pits. 150-400mm of top soil was present in all test pits, being the thickest within TP1. Conditions in TP1 and TP3 were similar from a wastewater disposal perspective, with coarser gravels and more frequent gravel deposits observed in TP1.

Typical soil conditions are shown in Figure 3 below. This investigation concluded that the site should be assessed as moderately well-structured sandy clay, Category 5, for the purposes of onsite wastewater disposal.

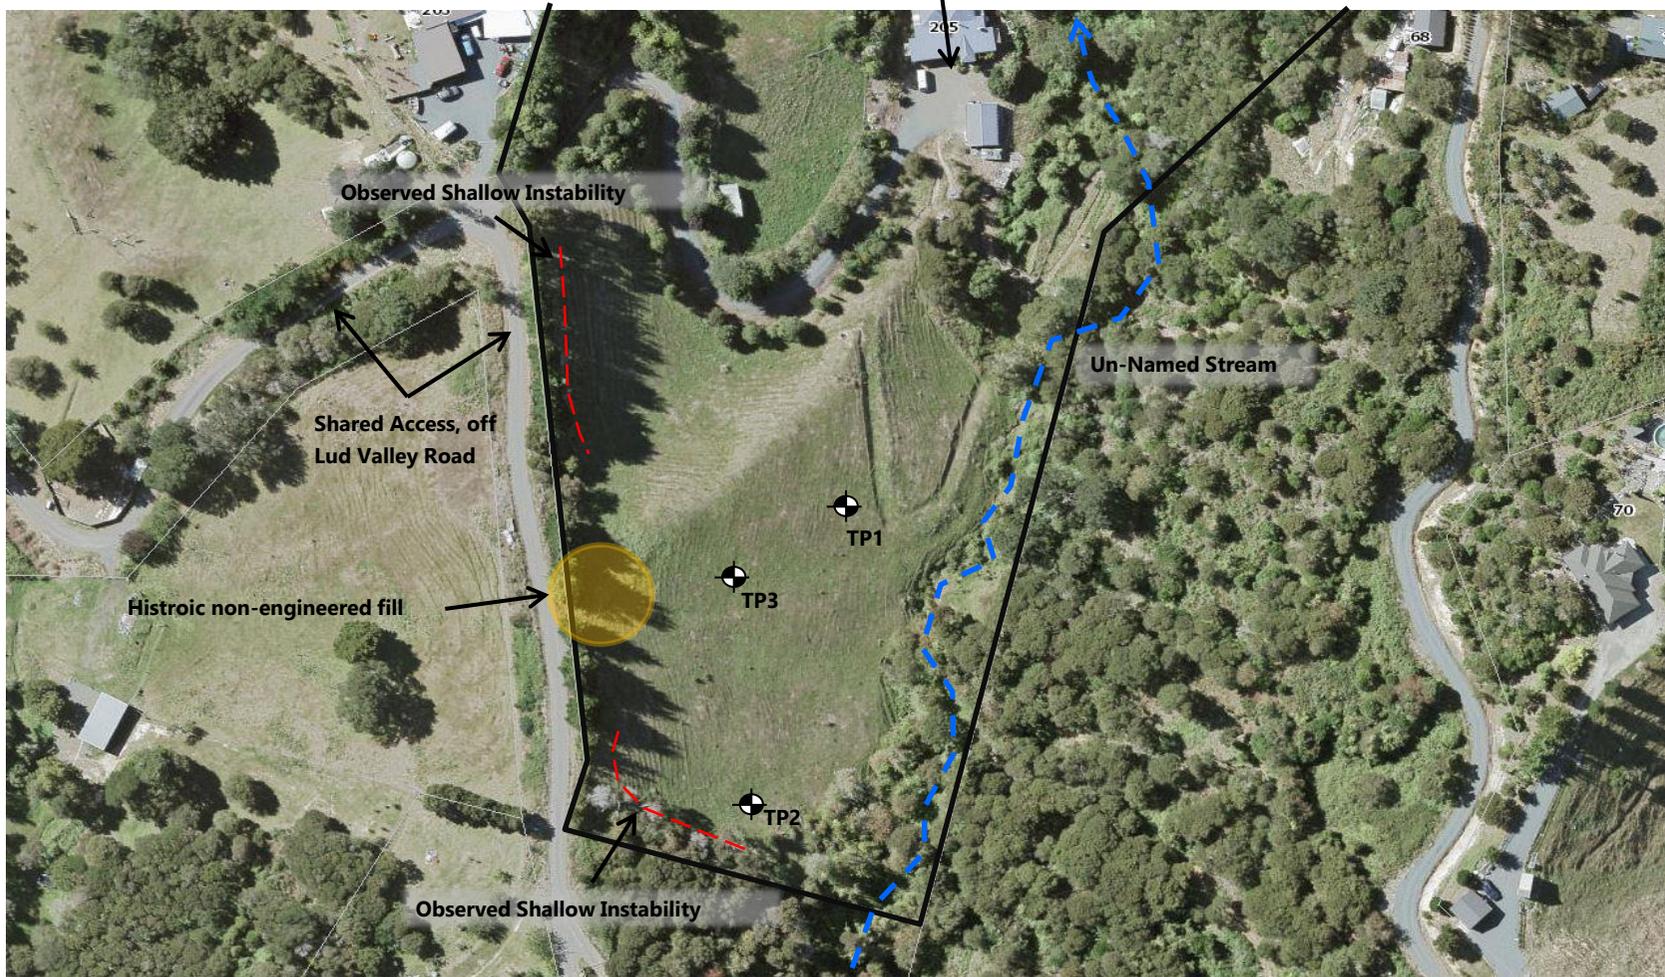
A site features plan is presented as Drawing No. 18360/02 within Appendix B of this report.

CGW undertook a site walkover and site testing on 24 July 2018. Drawing No. 18360/02 presents the site features and investigation locations.

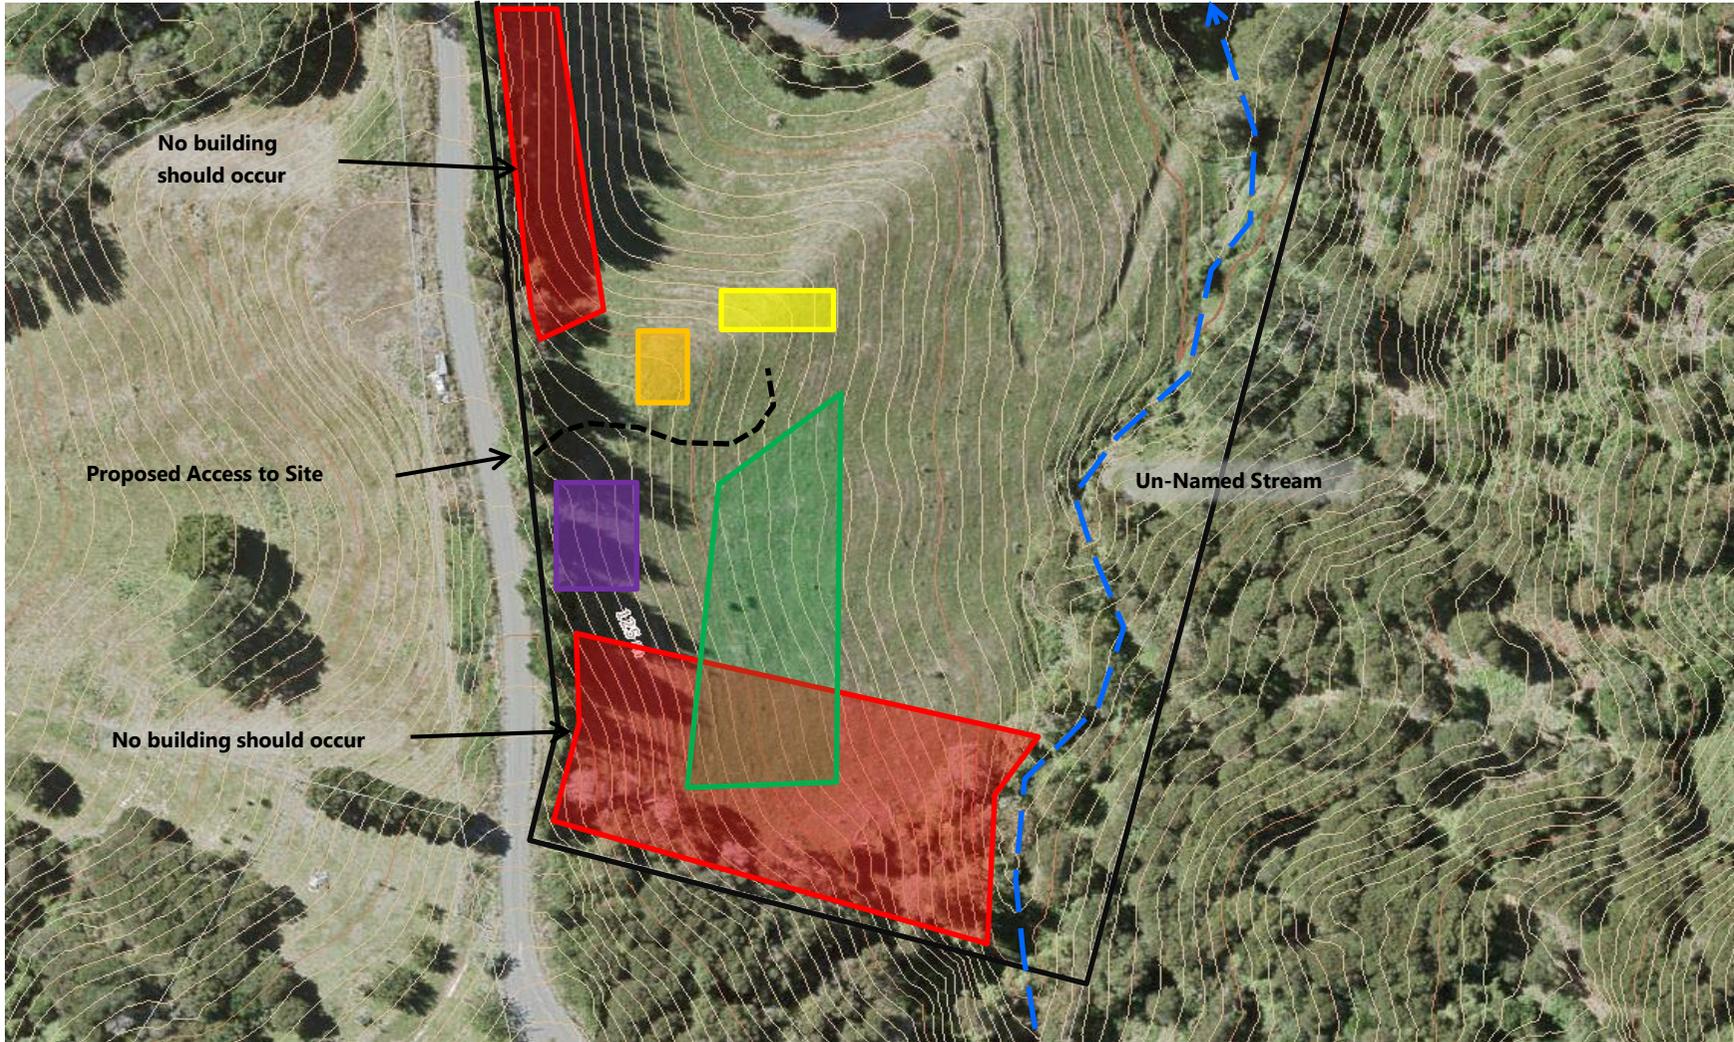
SHEET 3 OF 3

It is recommended that buildings proposed on the site be placed in areas where the competent rock is predicted to be shallow. Therefore building within the gully area on the southern boundary is not recommended, due to the depth to rock and the shallow strata having been affected by groundwater weathering.

It is recommended that buildings for the proposed development not be located in areas shown in red on Drawing No. 18360/03 within Appendix B of this report.

- Areas where no building is recommended
- Area proposed for dwelling
- Area proposed for shed
- Area proposed for temp accomocation during build
- Proposed driveway
- Area proposed for wastewater field

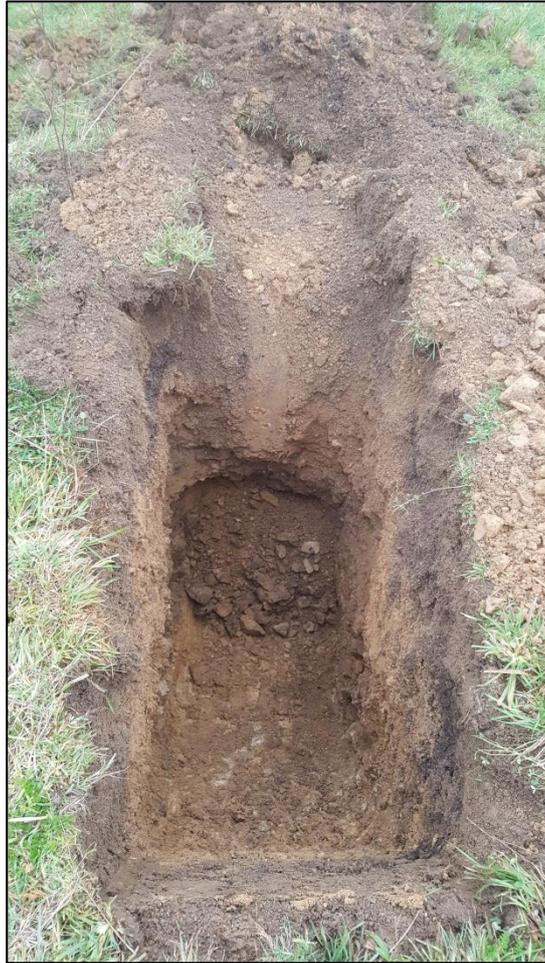
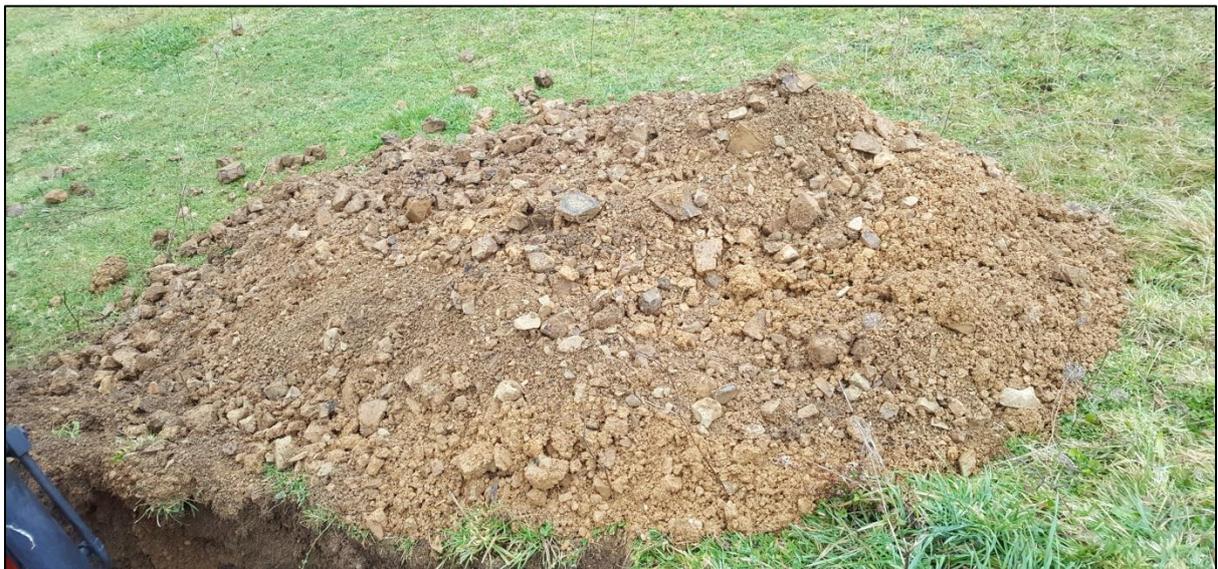
**TP1 Photographs**

Rock encountered within TP1 is described as extremely weak and within TP2 is described as weak in accordance with NZGS logging guidelines.

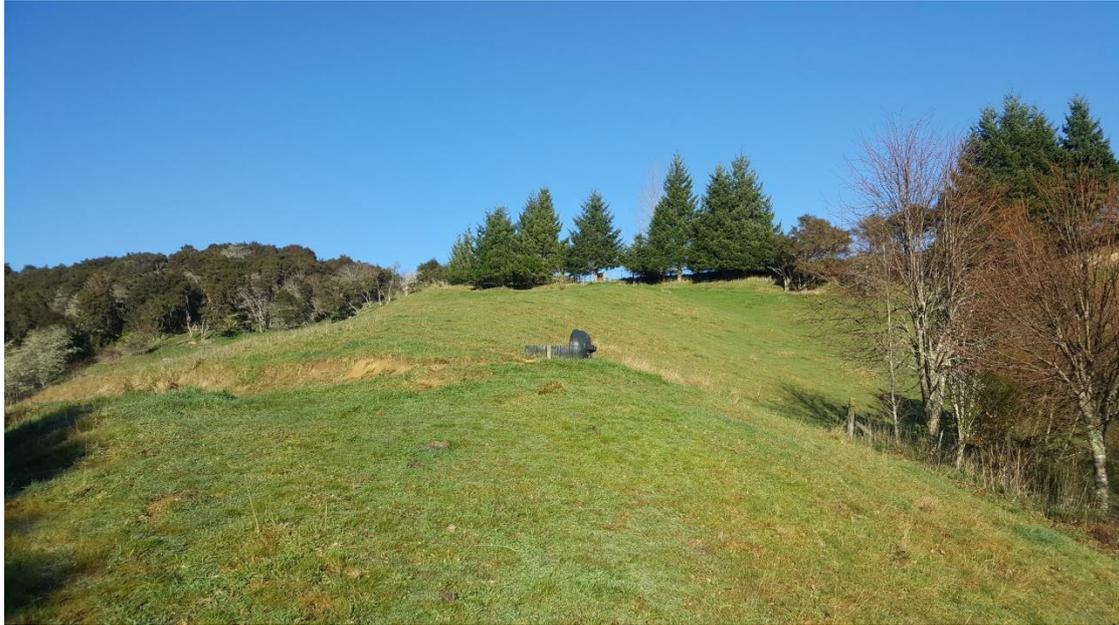
Photograph 1: View up the ridge line from the north east.

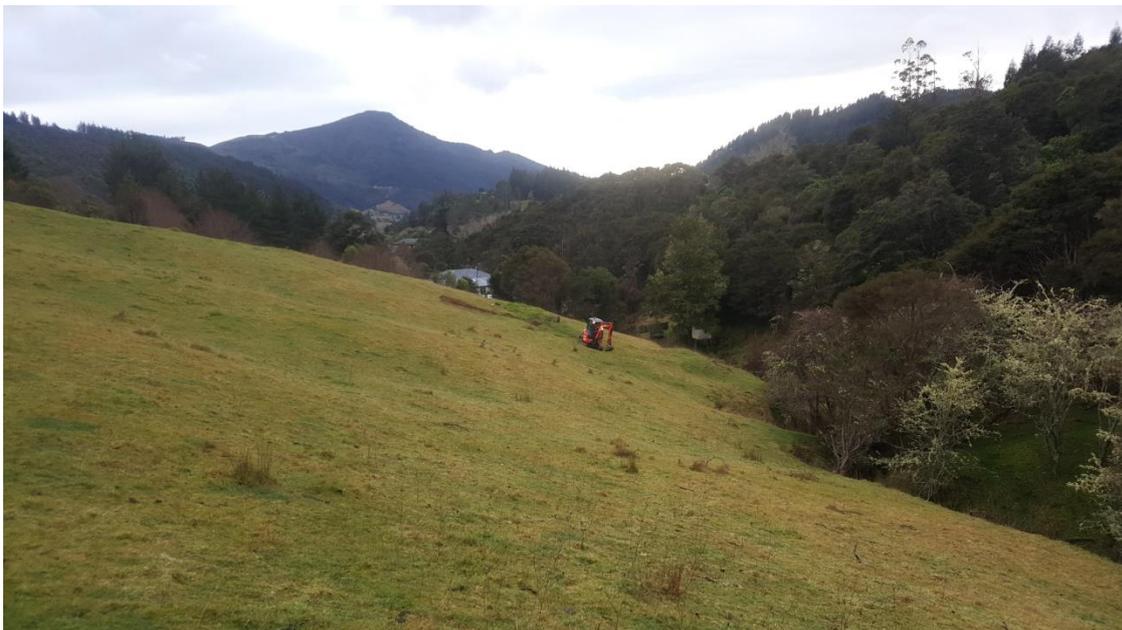
Photograph 2: View looking north across the southern end of the site.

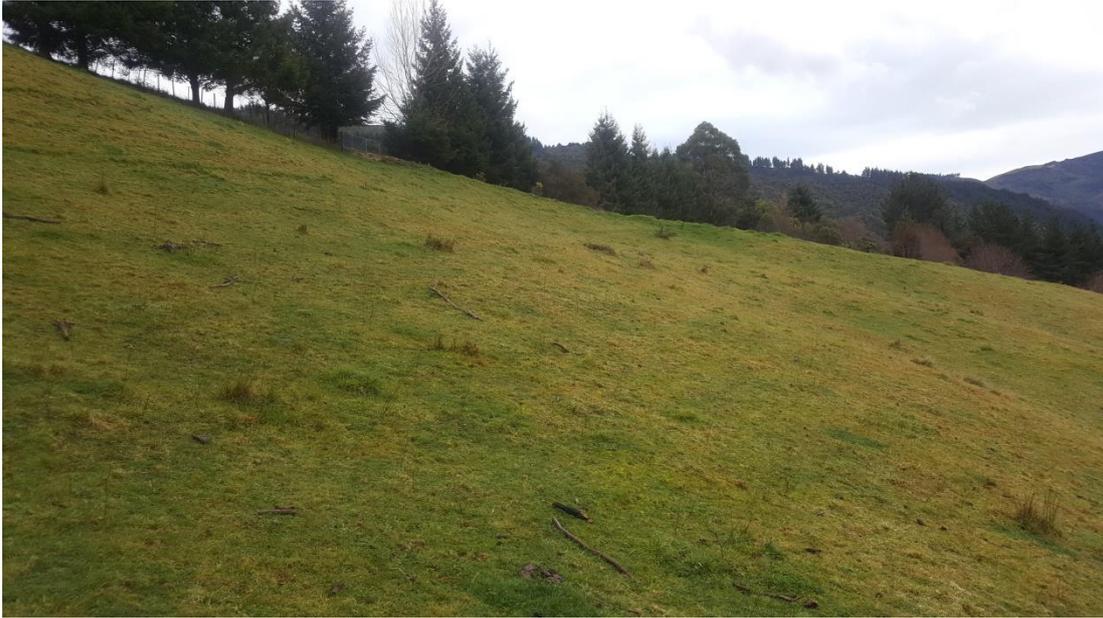
An area at the proposed new entrance to the site was noted to have been historically filled to create an easier access; this is considered to be non-engineered fill material.

Photograph 3: View looking north west, towards the access gate.

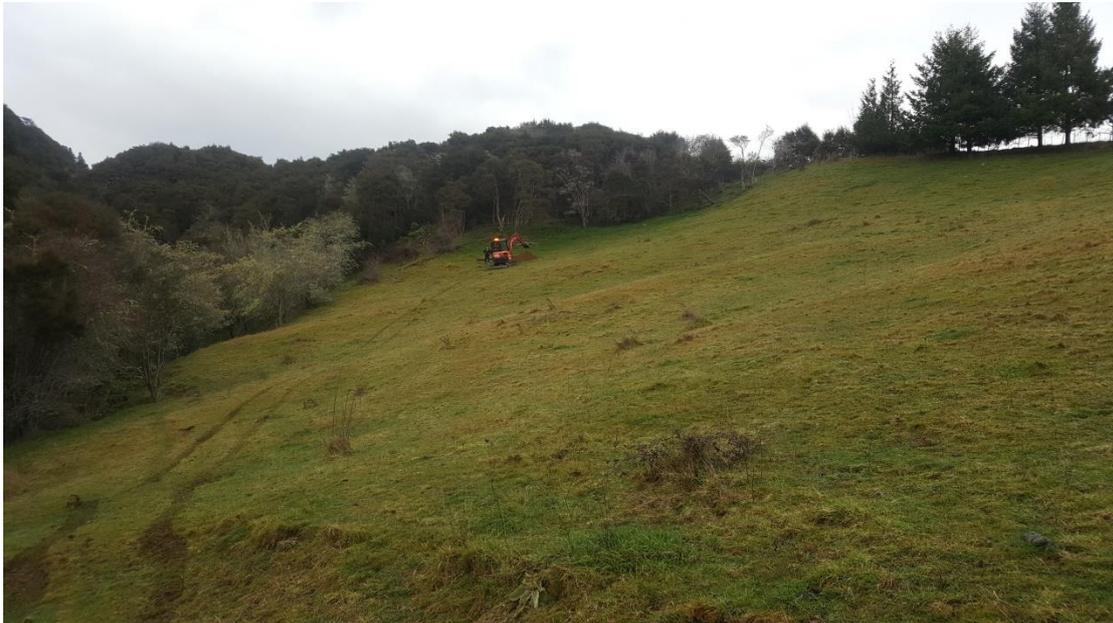
Photograph 4: Looking south across the site

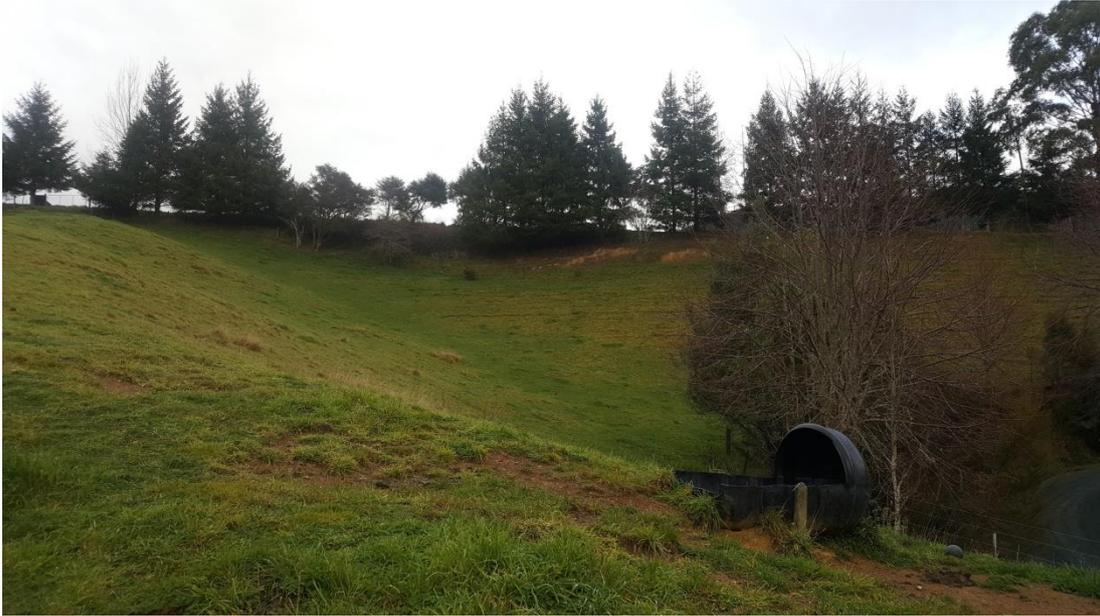
Two areas across the site showed signs of shallow soil creep and were generally steeper than other areas on the site. These included along the southern boundary and western boundary where the site is closest to the neighbour's house.

Photograph 5: Looking north east, soil creep at the top of the slope.

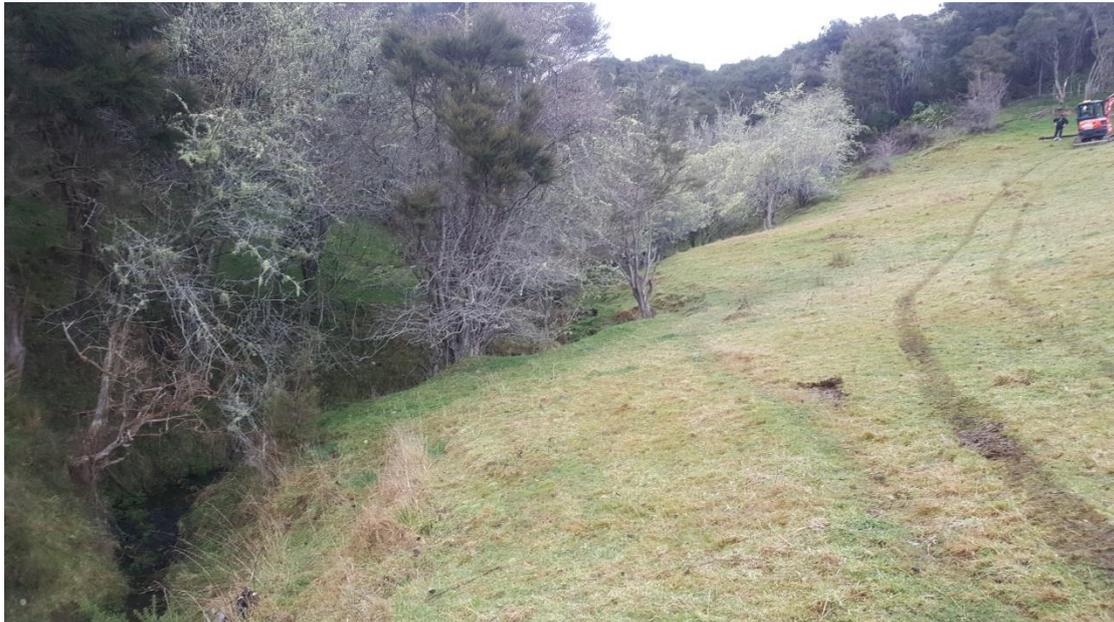
The stream on the eastern boundary was observed to have light flow during the site visit. Evidence of it rising considerably during a storm event was not noted, and according to the owner the stream level did not increase much during rain events. Siltstone was again noted in the base of the stream.

Photograph 6: Un-named stream on western boundary.

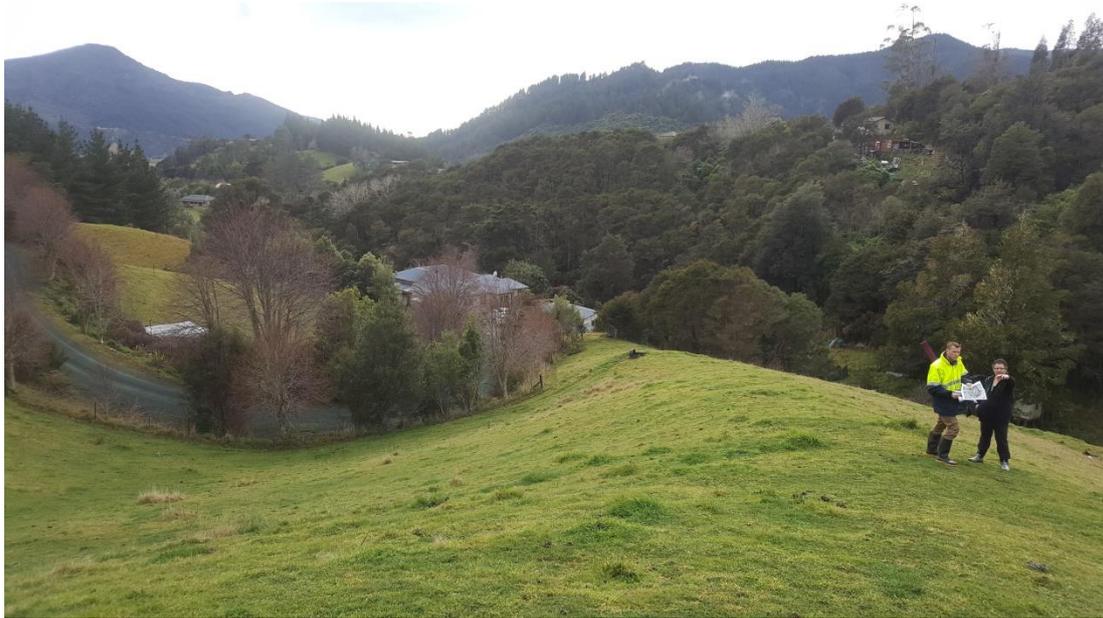
Photograph 7: View looking down the ridgeline, view north east.
