Nelson City Council

Maitai Dam
Intermediate Dam Safety Review
2015

Tonkin & Taylor

May 2015

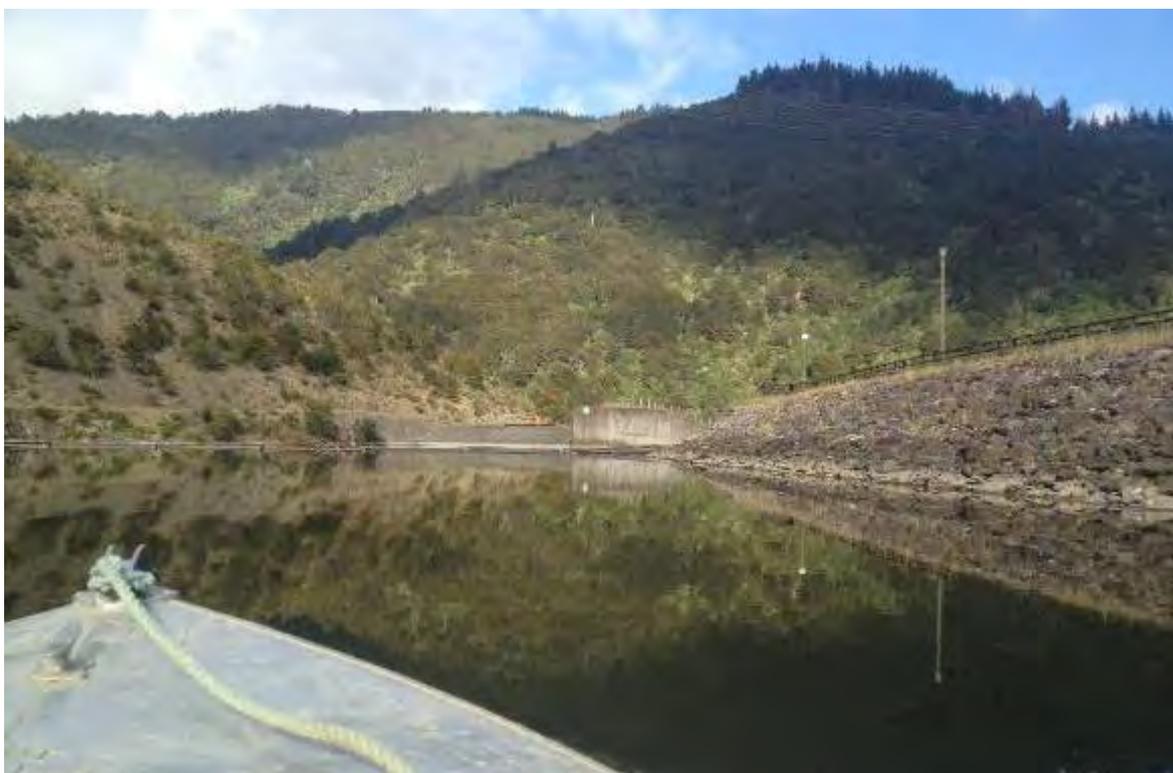
Photograph 3.3 - Upstream face looking towards spillways as viewed from boat.

The embankment and abutments were inspected from a walkover of the toe of the dam, the mid height downstream berm and the dam crest (Photograph 3.1 and Photograph 3.2). The upstream armour above the reservoir level was also visually assessed by boat (Photograph 3.3). The condition of the rip rap is comparable to last year with some “lean” patches to the right of the service spillway.

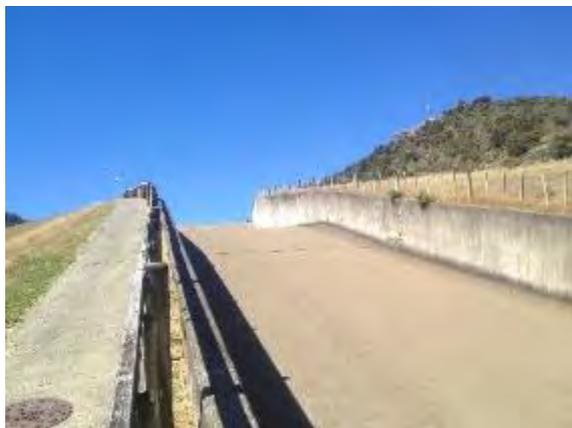
Photograph 4.1 - Service spillway from footpath.

The spillway was dry at the time of inspection (Photograph 4.1 and Photograph 4.2).

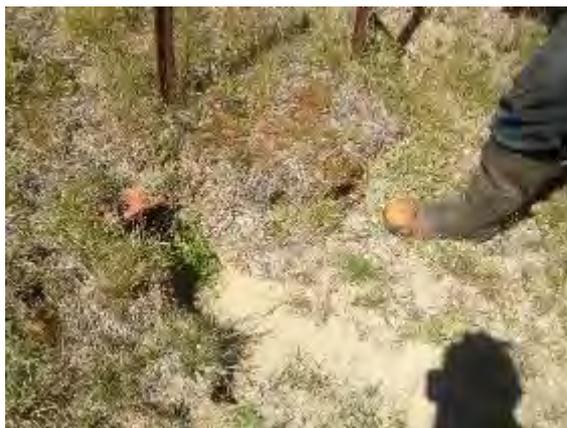
The auxiliary (fuse plug) spillway was inspected for overgrowth, surface erosion, slumps and obstructions and found to be satisfactory (Photograph 4.8). The downstream ground surface shows no sign of surface erosion. No evidence of rabbit burrowing was found during this inspection. The outlets of the overflow priming boxes were exposed and found to be generally satisfactory. The sand at the true right outlet (Photograph 4.9) is thought to be the same as that identified during the 2014 inspection.

Photograph 4.9 - Auxiliary spillway priming box outlets.

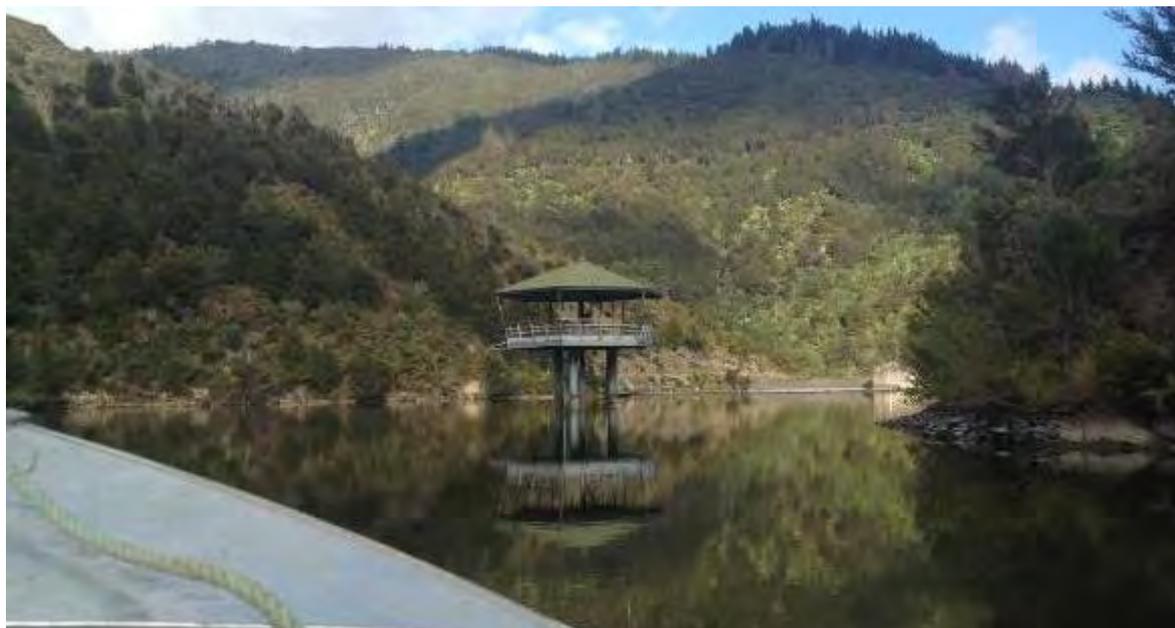
Photograph 5.1 - Intake tower.

- All screens have been cleaned and repositioned.
- Random testing of the bolts has been carried out at all levels with no loose bolts reported.
- All flange bolts were checked and found to be tight. A small amount of pitting on the horizontal member was cleaned and sealed with epoxy.
- All bonding clamps are tight.
- No bolts were replaced this survey.
- 10 small pits on Level 5 were cleaned and filled with epoxy.
- Paint condition is the same as last survey. There are some areas where there is a small amount of pitting with paint loss and needs checking at the next annual inspection.
- Electrical bonding clamps are all tight.
- Recent repairs are in good condition with no signs of corrosion around them.

In addition approximately 250 mm of soft mud was removed from the valve chamber roof where it was pumped over towards the spillway.

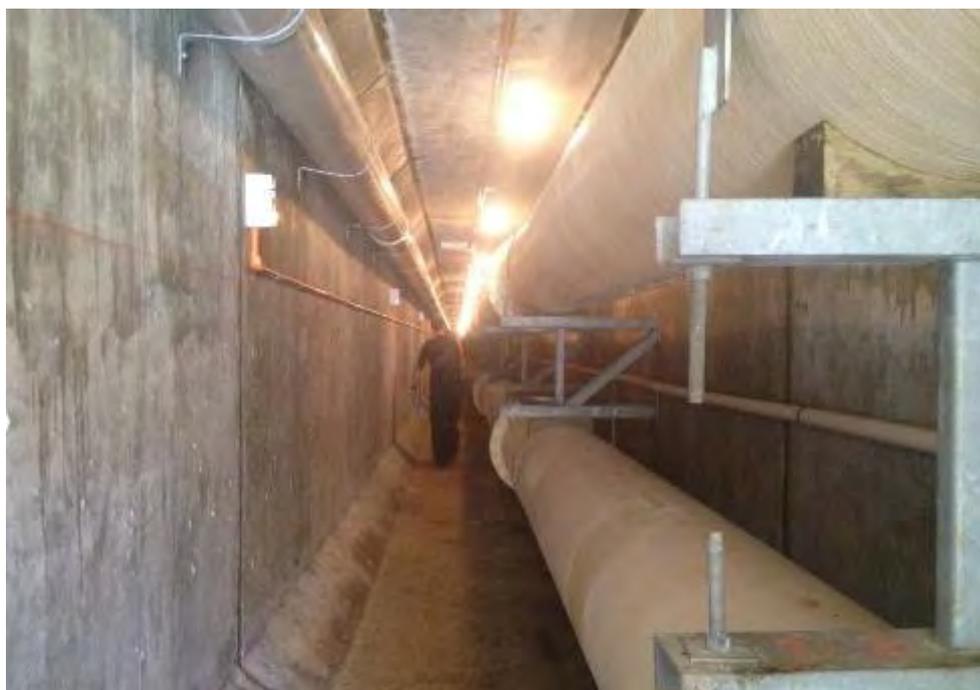
The concrete culvert and valve chamber including lighting and ventilation were generally in good condition. Refer Appendix A for details of culvert layout. Condensation from the upper pipe was evident during the inspection (Photograph 6.1), with water dripping onto the top of the lower pipe and pooling on the floor beneath the pipes.

Photograph 6.1 - Culvert looking upstream from the entrance.

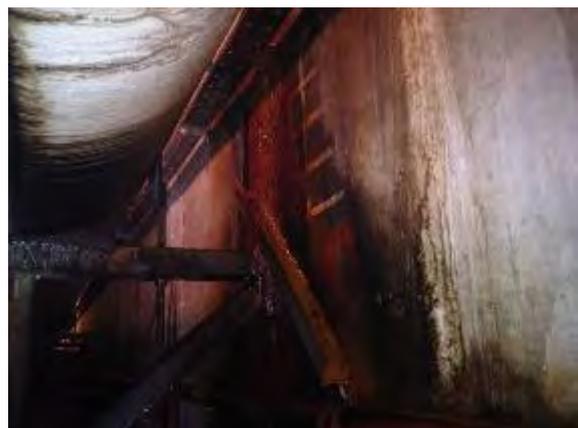
Photograph 6.7 - Leakage diversion away from pipe bracket.

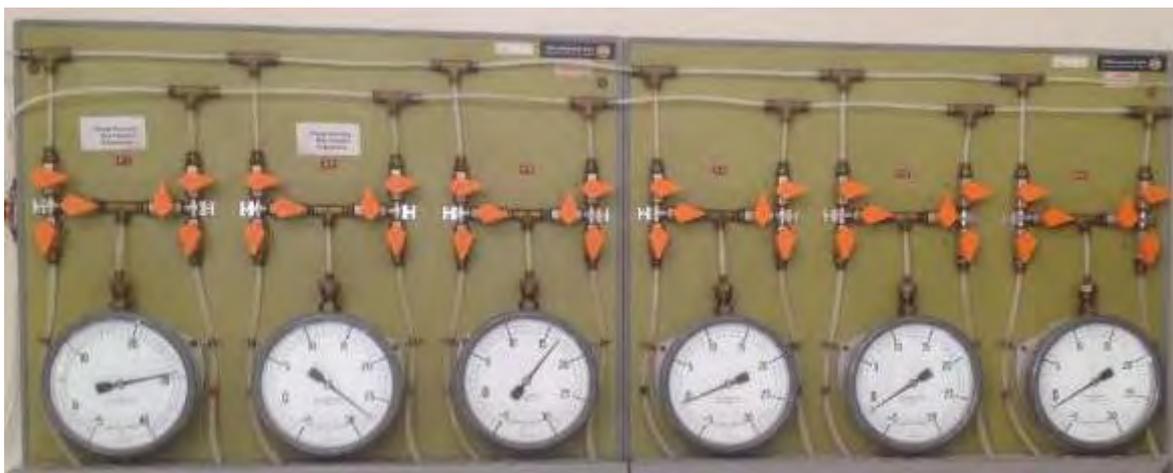
The room for the piezometer gauges is relatively dry. Photograph 6.16 to Photograph 6.20 shows the piezometer gauges at the time of inspection. The humidity in the room is limited by a cover over the collection chamber for the dam's basal drainage system.

Photograph 6.16 – Hydraulic piezometer gauges P1 (left) to P6 (right).

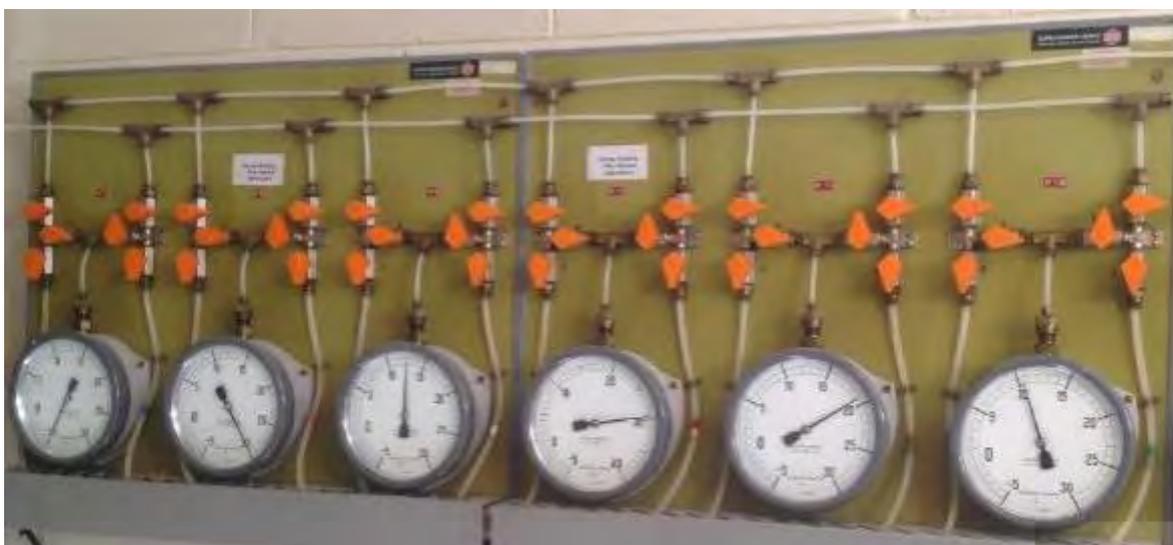
Photograph 6.17 - Hydraulic piezometer gauges P7 (left) to P12 (right).

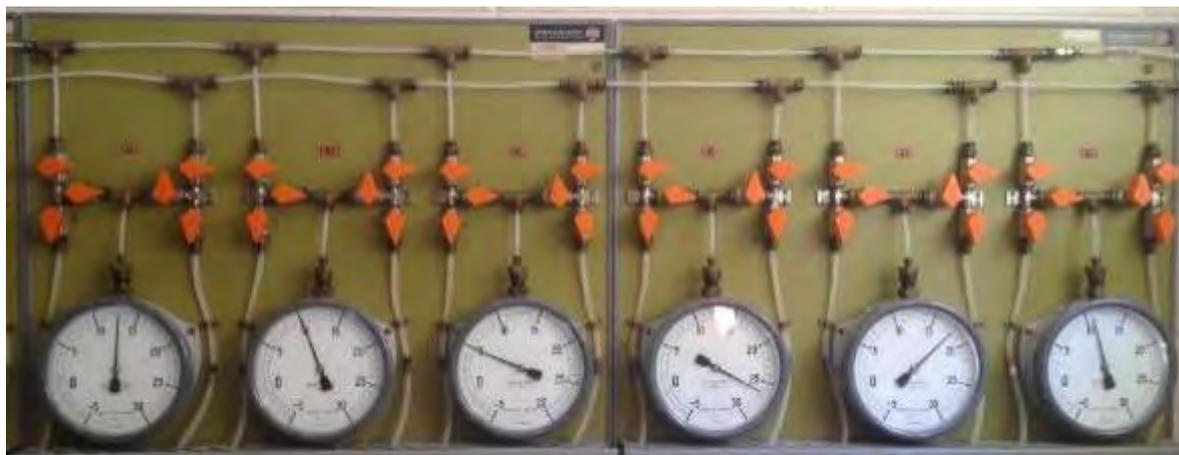
Photograph 6.18 - Hydraulic piezometer gauges P13 (left) to P18 (right).

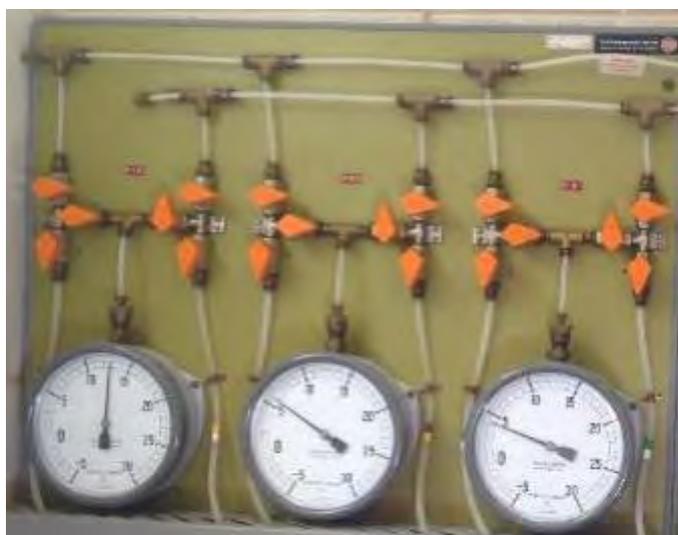
Photograph 6.19 - Hydraulic piezometers P19 (left) to P21 (right).

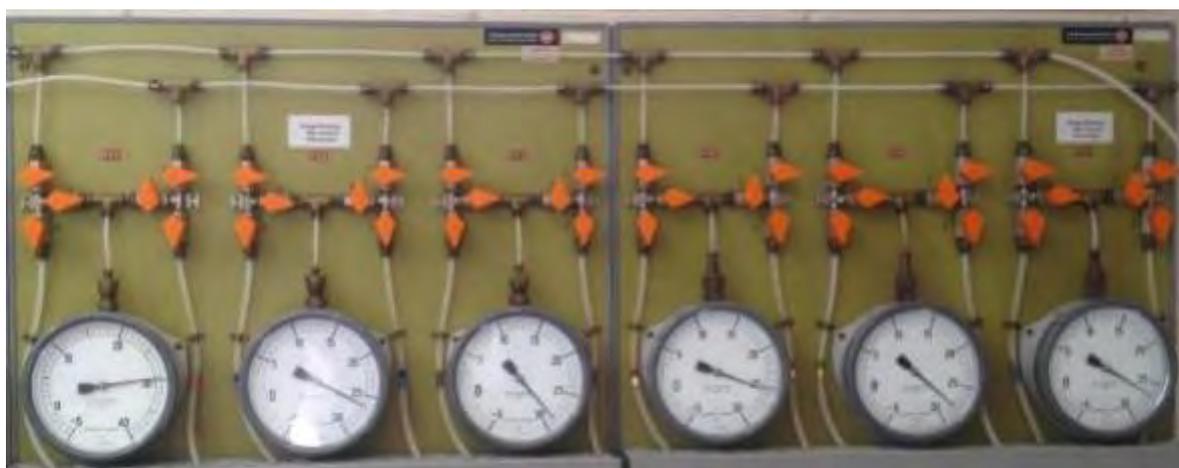
Photograph 6.20 - Hydraulic piezometers P22 (left) to P27 (right).

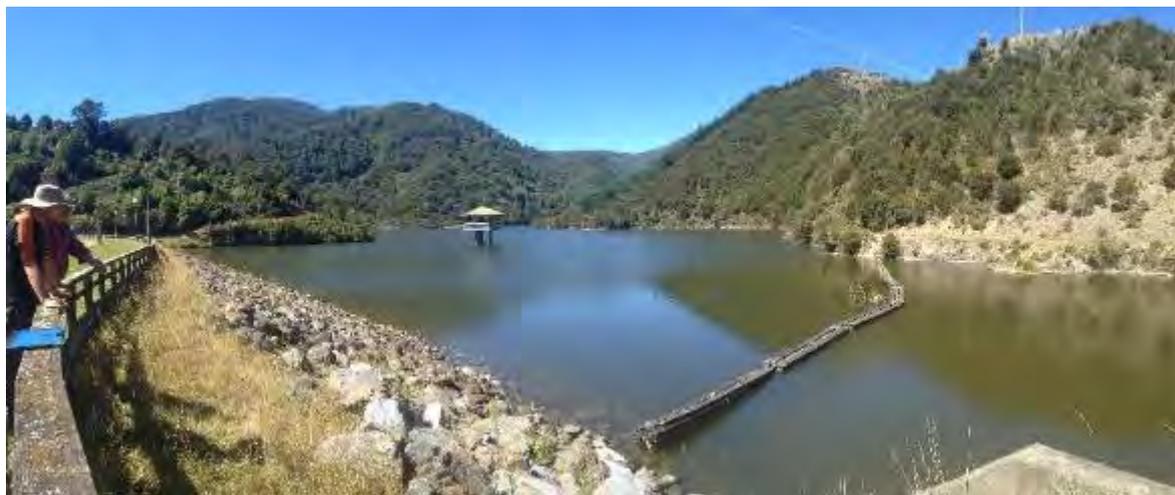
Photograph 7.1 - View of reservoir viewed from dam crest adjacent to spillway.

The reservoir's shoreline was inspected visually by boat and from the dam crest (Photograph 7.1). One minor area of erosion was identified along the left bank of the reservoir (Photograph 7.2). It was also noted that the bank at the inlet of the stream to the reservoir has eroded (Photograph 7.3), most likely from heavy rain in the weeks prior to the inspection. None of the erosion noted was considered significant enough to affect reservoir performance. No specific monitoring is proposed.
