## Tahunanui Slump

Monitoring report November 2022 - April 2024

Nelson City Council

Tonkin & Taylor Ltd

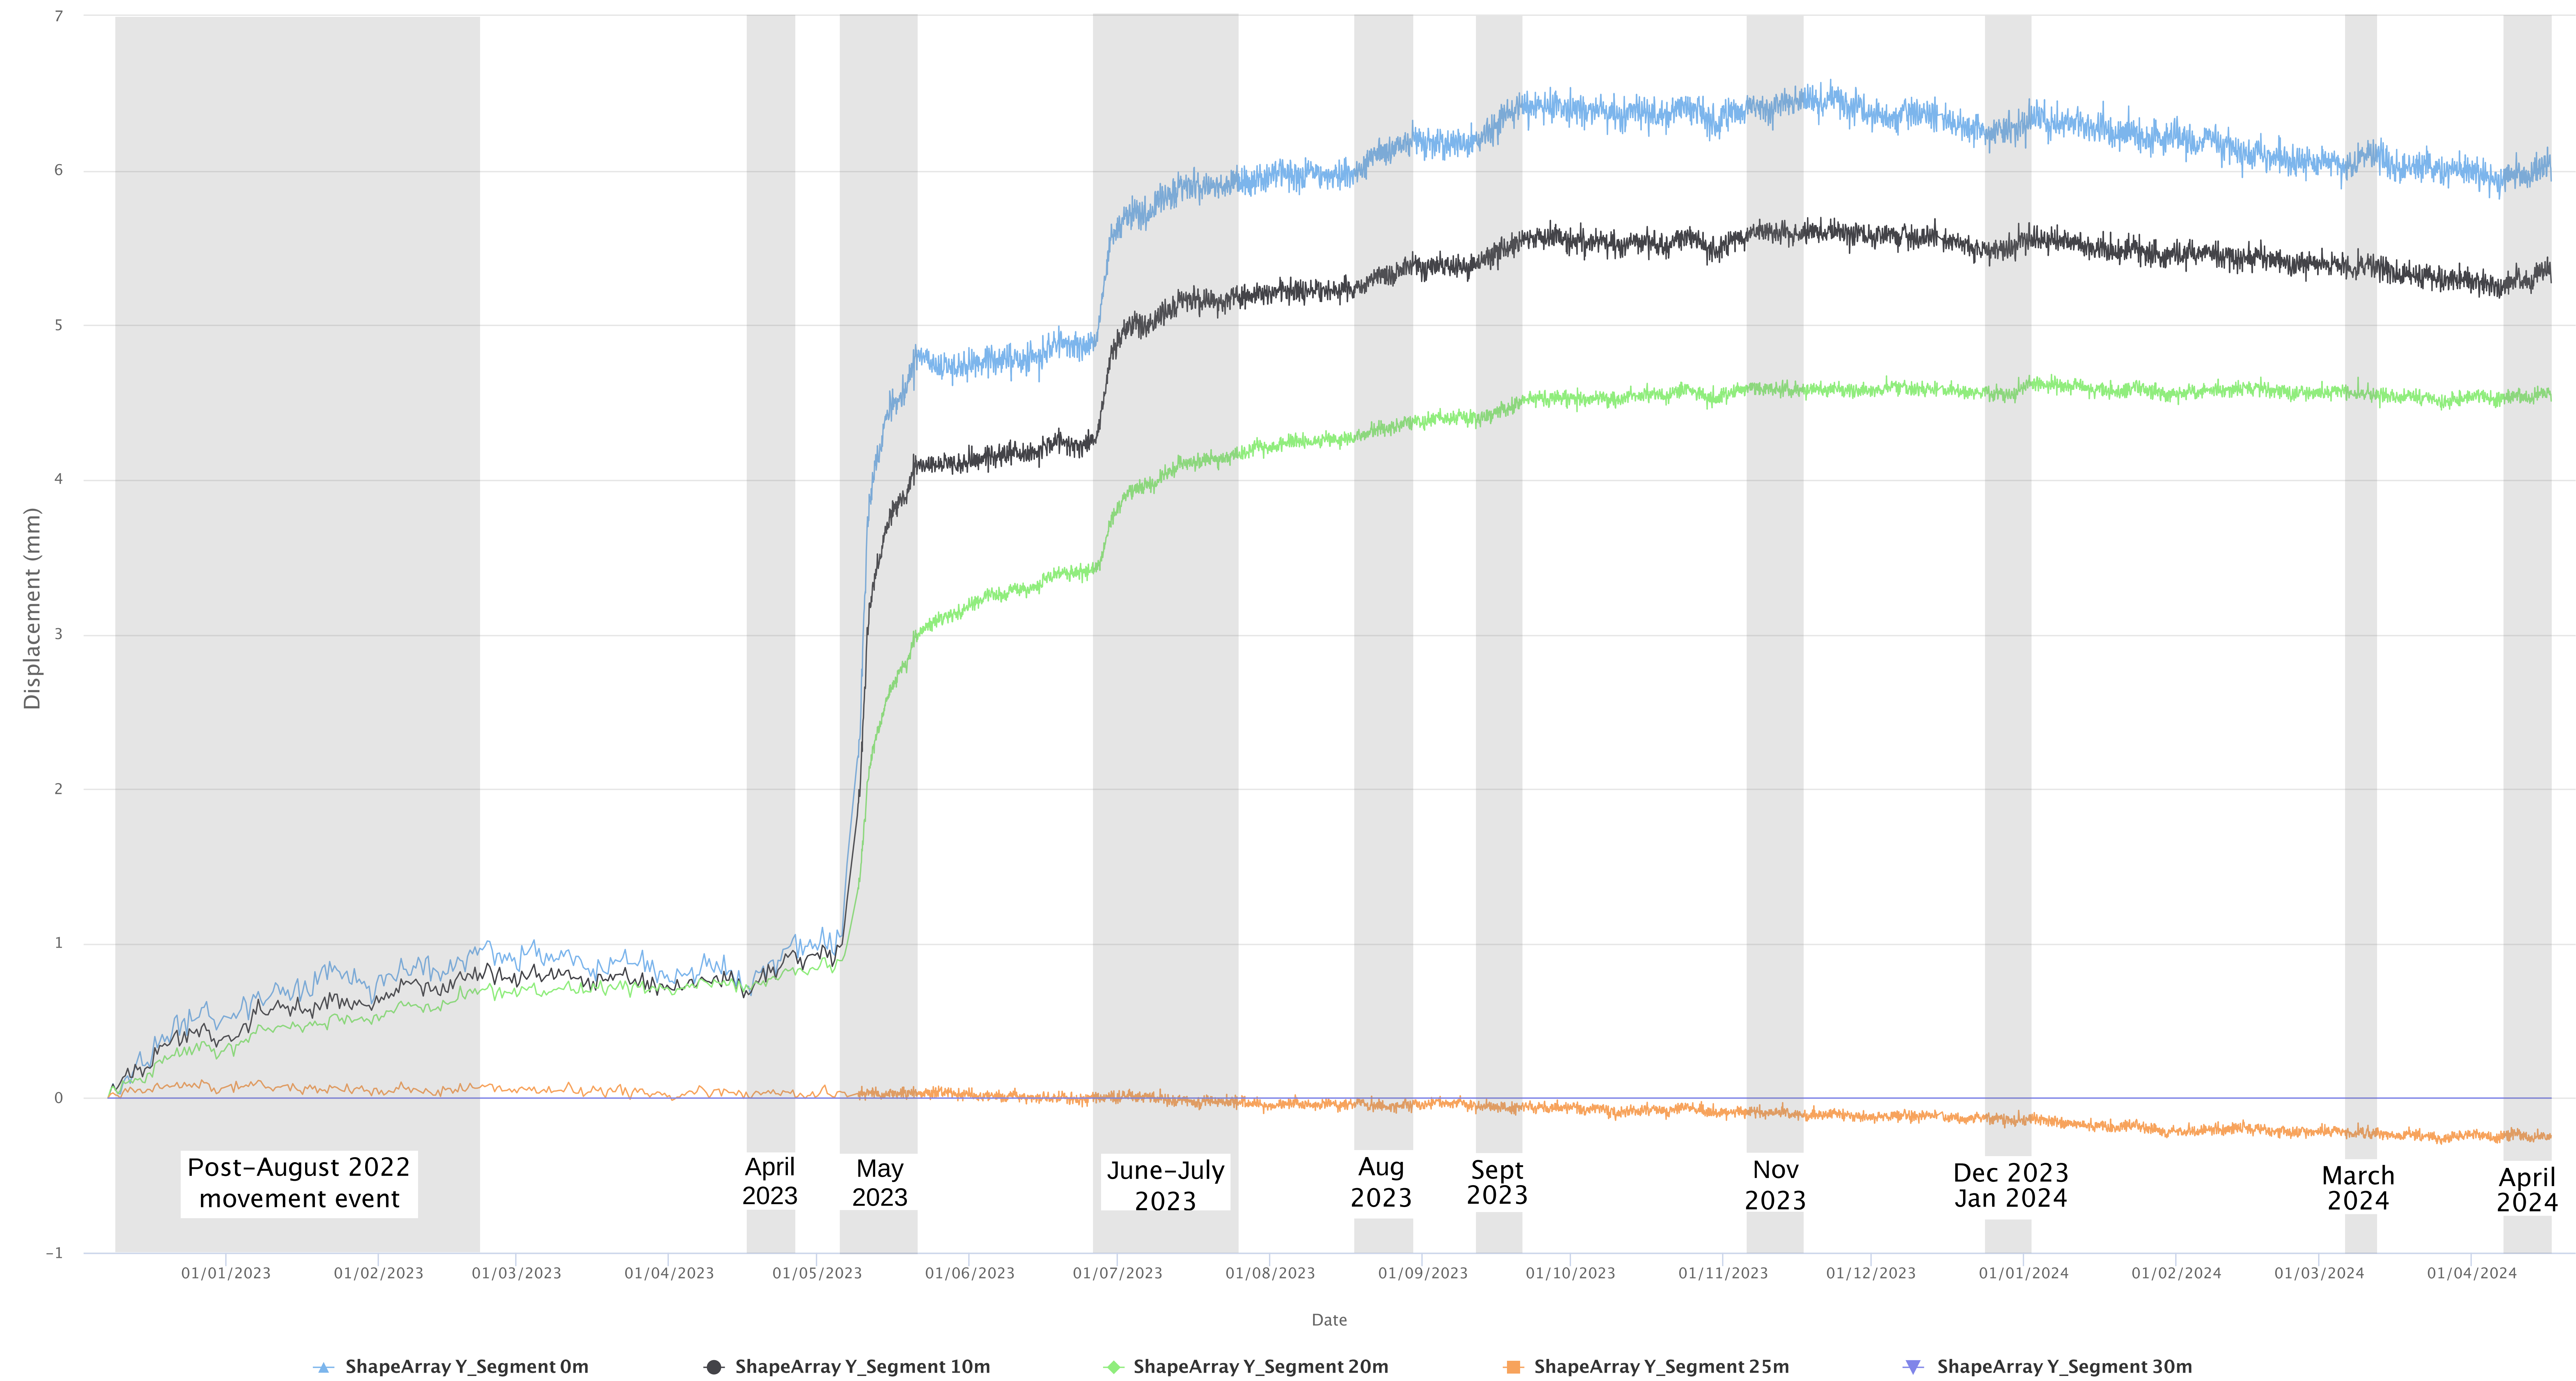
B.8 - ShapeAccelArray displacement (Y-axis – 308 degrees)

The SAA shows deep-seated displacement of the TS to a significantly higher degree of accuracy than inclinometer readings and is therefore more useful than inclinometer data when correlating ground displacements with rainfall or groundwater level data. However, inclinometers provide a cost effective method of tracking cumulative displacements at multiple locations throughout the TS that occur between monitoring rounds. In order to optimise expenditure with respect to inclinometer monitoring, we recommend that future monitoring rounds only occur following displacement recorded in the SAA over a certain trigger level (i.e. 3 mm) and up to a maximum of two (2) times per year.
